Lake Forest Library

Dome and Pedestal Repair Recommendations

This report presents findings from site investigation of the copper dome, masonry pedestal, and rotunda attic space performed December 2018.

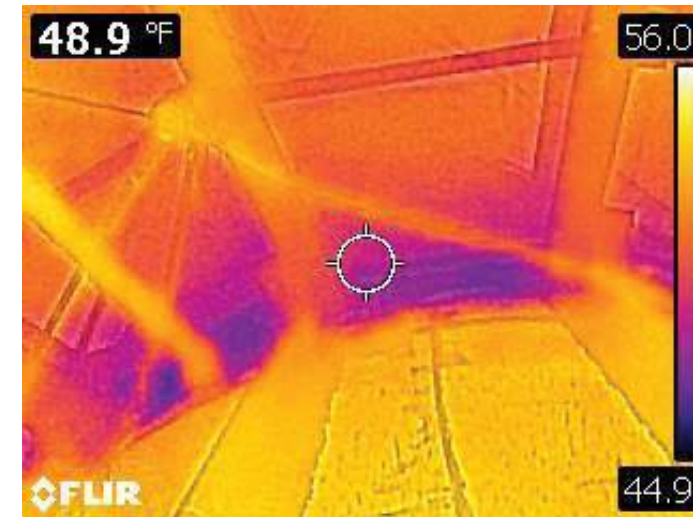
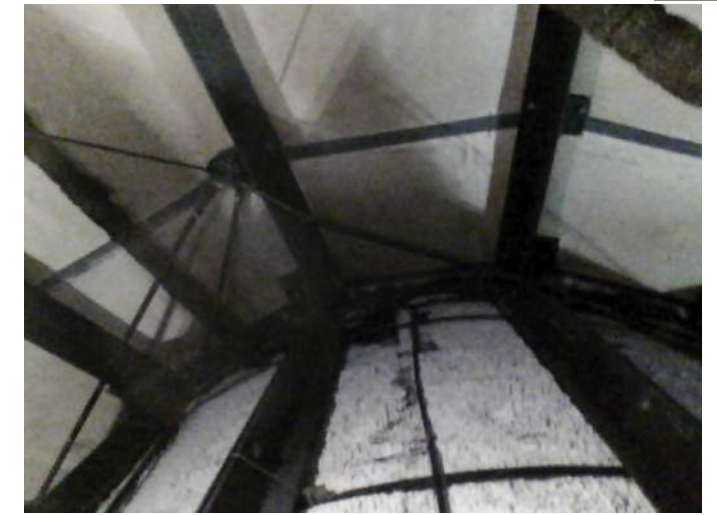
Infrared image and accompanying photo looking up at the juncture of the dome and the plaster light shaft in the attic. These images help to understand where potential water issues exist beyond what is visible to the eye.

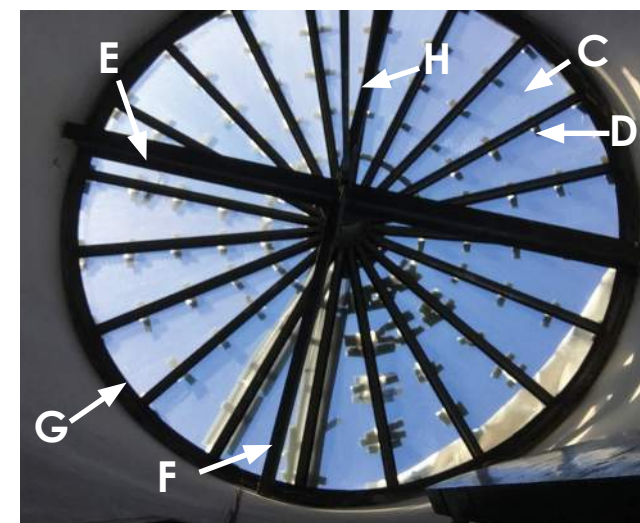
Skylight -view from plaster light shaft (looking up)

1. The conditions of the glazing seals is not known, but assumed to be at the end of their life.
2. The transition detail between the skylight glass and the copper dome roofing is also not known. This detail is critical to keeping water out of the dome.

1. Reglaze skylight glass panes.
2. Repair condensate gutter and connections to condensate drain lines.

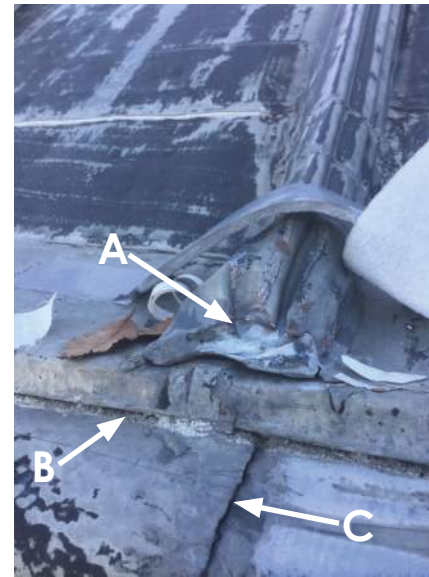
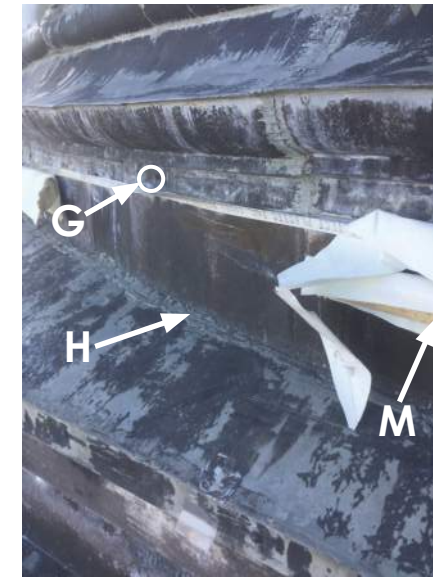
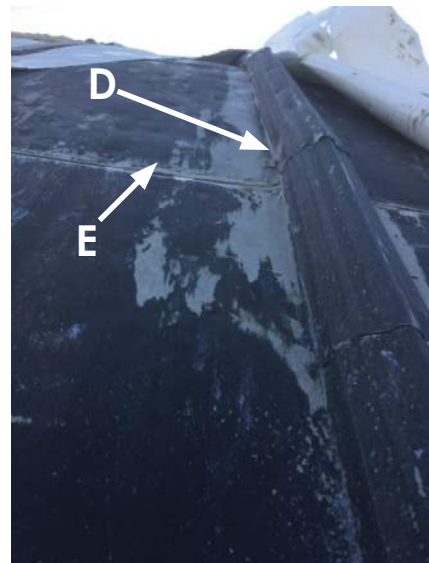
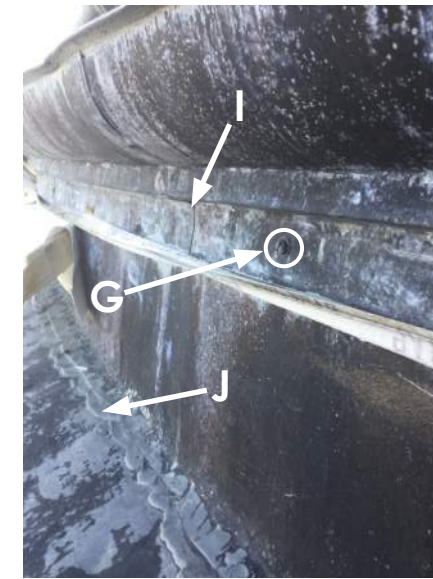
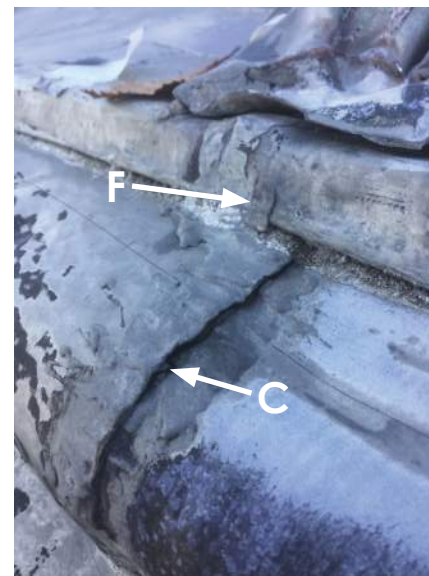
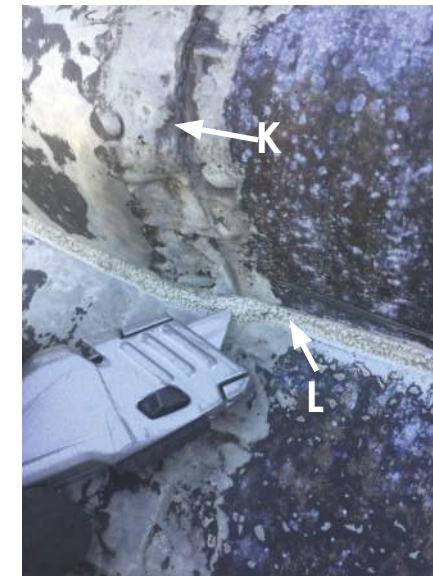
1. Many soldered joints appear to be insufficient and not properly sweated, and some have failed completely.
2. No expansion joints were observed around the copper base that is both pinned and soldered.
3. Newspaper articles indicate the contractor used 50/50 solder with the lead coated copper. Lead coated copper requires 60/40 (lead/tin) solder.

- A. DAMAGED ROOF BATTEN.
- B. JOINT BETWEEN TRANSITION NOT FULLY LOCKED. AGED SEALANT VISIBLE.
- C. FAILED SOLDER JOINT.
- D. TACK SOLDER AT BATTENS.
- E. DOME COPPER PANEL LOCK JOINT.

- J. CRACK IN SOLDER SHOWS INSUFFICIENT LAP OF FASCIA COPPER OVER HORIZONTAL COPPER.
- K. IT IS UNKNOWN IF THE CRACKS IN THESE SOLDERED JOINTS ARE ALL THE WAY THROUGH THE LAP OR JUST PARTIAL.

- L. THE PURPOSE OF THIS OLD SEALANT AT THIS JOINT IS UNKNOWN. THE SEALANT APPEARS TO BE PAST ITS SERVICE LIFE.
- M. WOOD STRIPS USED TO HOLD TIGHT THE TEMPORARY PROTECTION TARP HAVE ANCHORS THAT PENETRATE THE COPPER PANELS. THE ANCHOR HOLES HAVE DAMAGED THE COPPER AND MAY PROVIDE LOCATIONS FOR AIR AND MOISTURE TO PASS THROUGH.

1. Remove all copper pans and battens as well as ornamental cladding and fascia.
2. Remove all paper and membranes.
3. Repair cementitious and wood substrates.
4. Install new copper roofing system including paper and membranes.

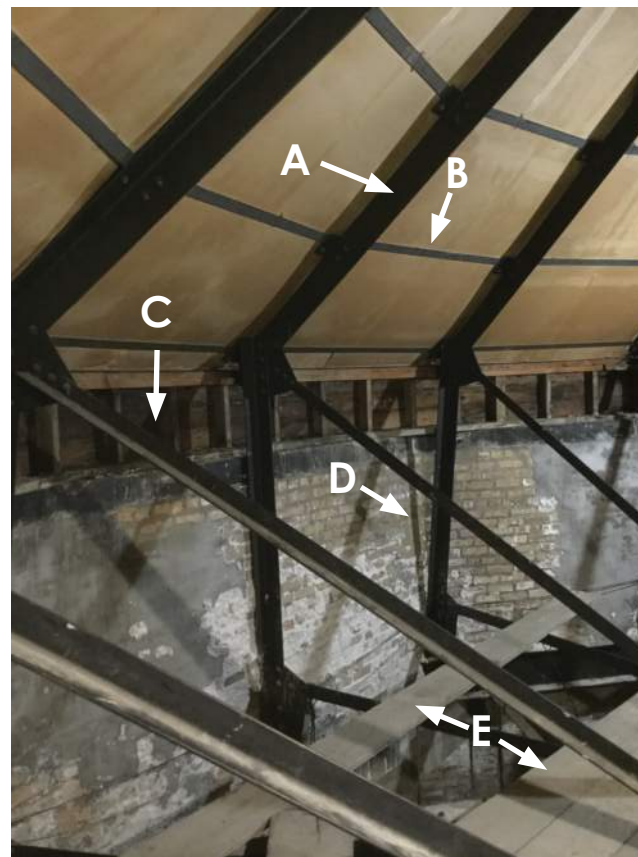
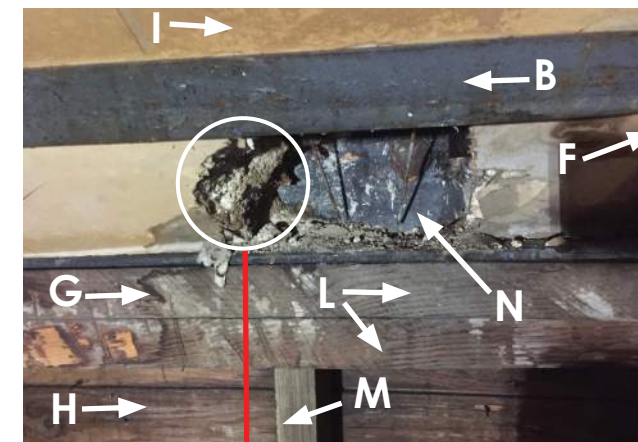
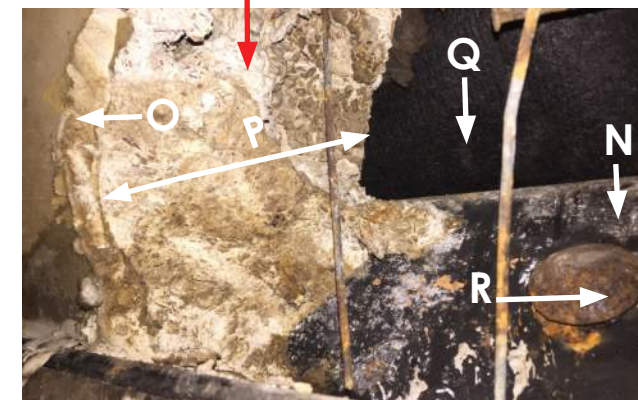
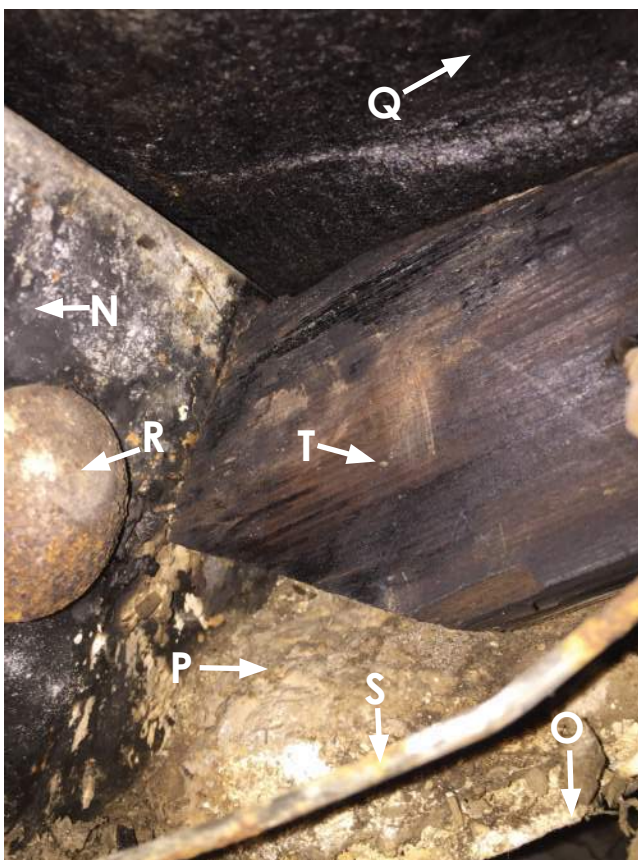
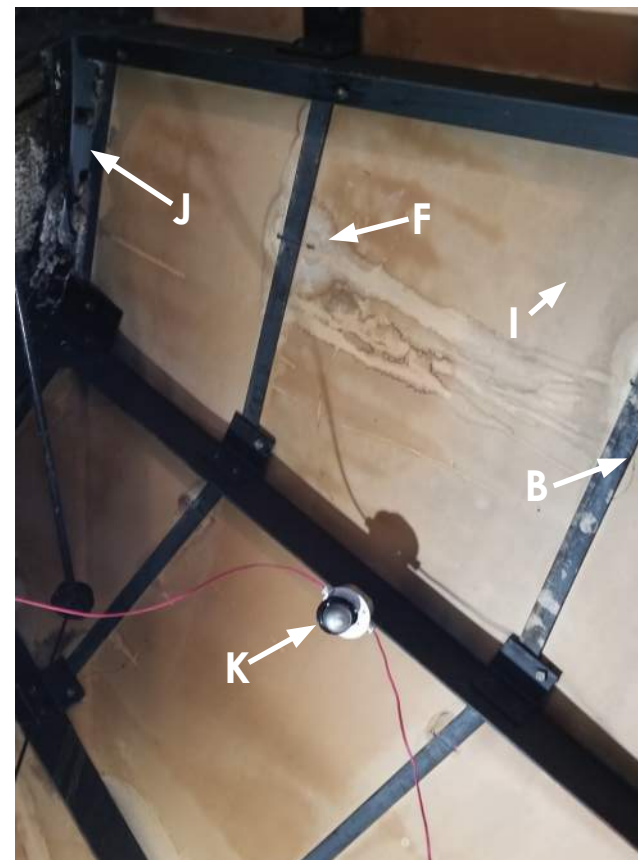
1. Steel assemblies are in excellent condition.
2. Water intrusion through the dome materials does not appear to be substantial. Isolated areas of water infiltration are noted on the underside of the sheathing. Although water stains occur at various locations around the dome, most staining appears at the steel 'T' segments where there are breaks and potentially cracks through the dome substrates. None of the stains appear to be current. The sheathing appears to be solid and no bulges or cracks were noted.

- A. DOME TRUSS.
- B. STEEL 'T' MEMBERS BETWEEN TRUSSES ABOUT 48" ON CENTER.
- C. WOOD KNEE WALL.
- D. BRICK MASONRY WALL OF DOME BASE.
- E. WOOD PLANK CATWALK.
- F. OLD WATER STAINS ON THE GYPSUM BOARD SHEATHING.
- G. OLD WATER STAINS ON THE WOOD KNEE WALL G.
- H. T & G WOOD SHEATHING.
- I. GYPSUM SHEATHING EXPOSED TO ROTUNDA ATTIC SPANNING BETWEEN STRUCTURAL T'S.
- J. COMPRESSION RING CONNECTING ALL THE TRUSSES NEAR THE SKYLIGHT.
- K. LIGHT FIXTURE.
- L. DOUBLE WOOD TOP PLATES.
- M. WOOD STUDS AT 16-INCHES ON CENTER.
- N. 3X5 PERIMETER, CURVED STEEL ANGLE.
- O. GYPSUM SHEATHING.
- P. CONCRETE DOME TOPPING.
- Q. ASPHALT FELT UNDERLAYMENT.
- R. ANCHOR BOLT HEAD. ASSUMED ATTACHES EXTERIOR WOOD SHAPING ORNAMENTAL COPPER.
- S. CONCRETE TOPPING REINFORCING.
- T. WOOD SLEEPER WITHIN THE CONCRETE DOME TOPPING.

1. Further investigation of the dome is necessary to confirm substrate construction and conditions.
2. Seal all penetrations through the sheathing.

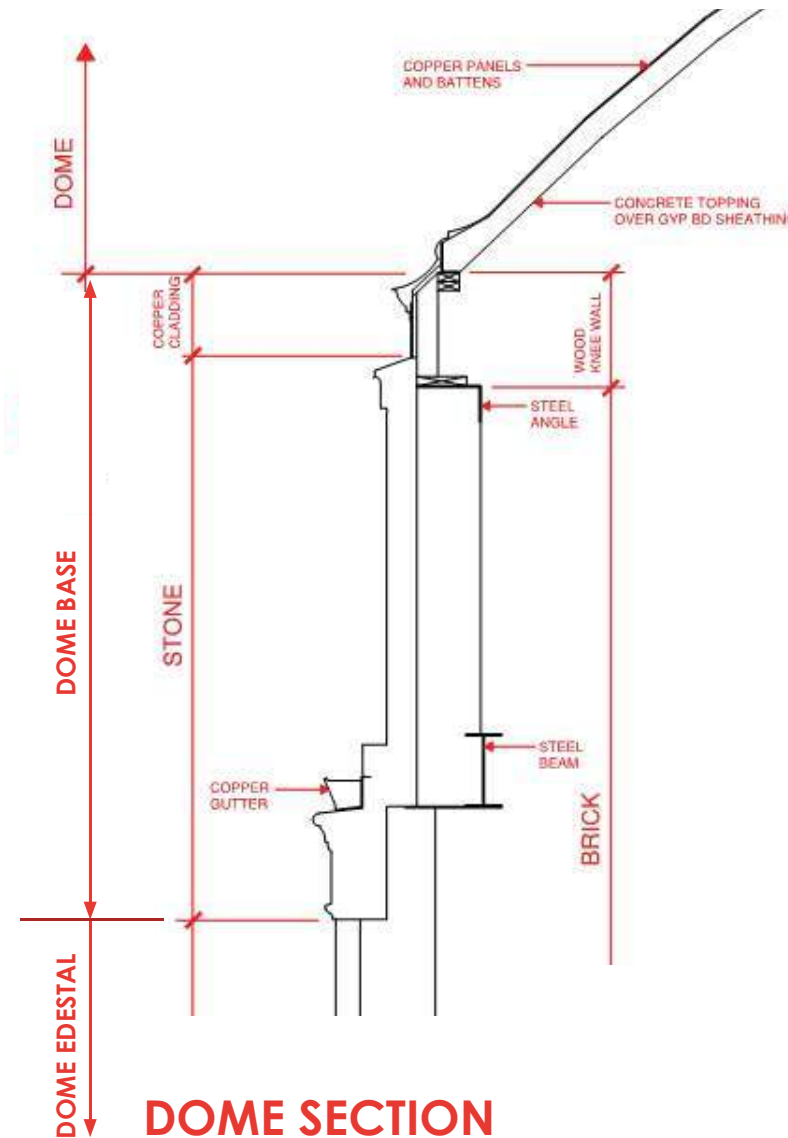
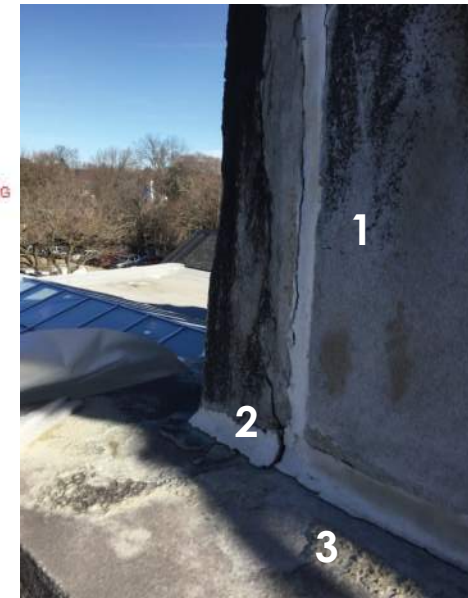
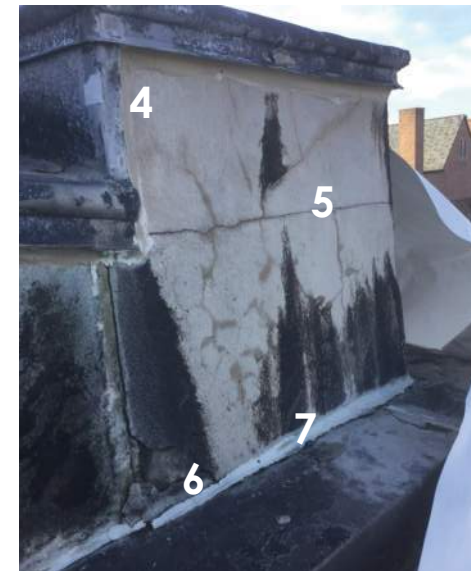
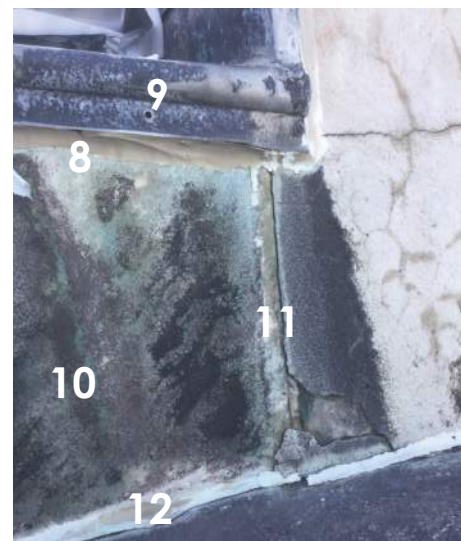
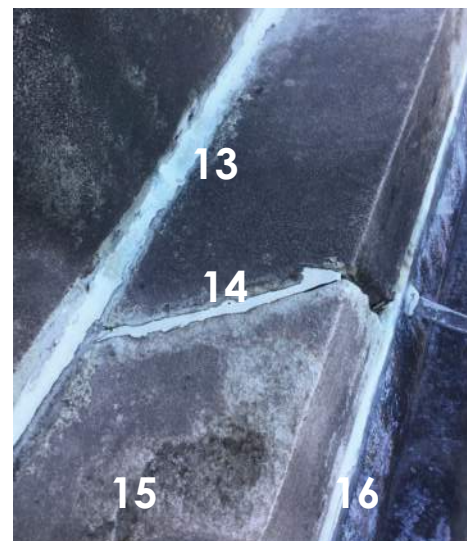
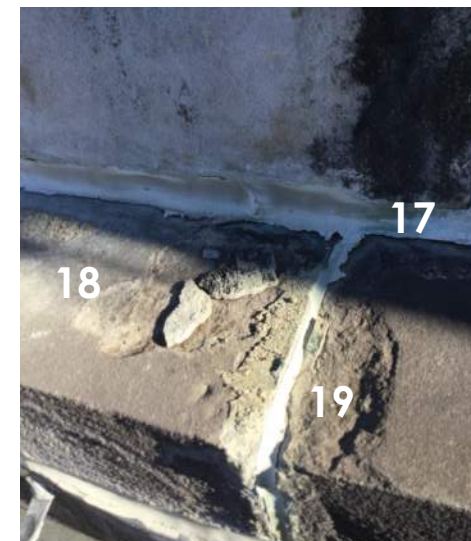
1. Further investigation is required to determine the nature and extent of severe stone damage. Some replacement is anticipated.
2. Sealant may be trapping moisture and preventing natural drying of the stone.
3. Cracks and spalls at joints could be related to ferrous anchor corrosion.
4. Parallel vertical cracks at pier corners could be the result of repeated freeze/thaw activity in combination with anchor corrosion.
5. Horizontal cracks at corner piers are related to outward rotational movement of the panel, likely due to frost action.
6. Joints are deteriorated, comprehensive repointing is recommended.

1. ADHESIVE FAILURES AT VERTICAL AND HORIZONTAL STONE JOINTS (LIKELY DUE TO IMPROPER SURFACE PREP AND/OR PROLONGED SATURATION OF MASONRY BACKUP ALONG WITH OUTWARD VAPOR DRIVE).

2. MULTIPLE STONE CRACKS PARALLEL TO VERTICAL JOINT (LIKELY DUE TO FROST ACTIVITY).
3. WIDESPREAD STONE SURFACE DECAY (POSSIBLY DUE TO HIGH VELOCITY/HIGH VOLUME WATER RUNOFF FROM COPPER DOME ABOVE).

4. WEATHERED SEALANT, IMPROPER INSTALLATION.
5. MULTIPLE CRACKS IN STONE PIER PANEL. THE PANEL IS DISPLACED IN AN OUTWARD DIRECTION AT THE BASE RESULTING IN FORMATION OF A FULL WIDTH HORIZONTAL CRACK. CRACK LOCATION LIKELY CORRESPONDS TO STONE ANCHORAGE.

6. DECAYED STONE (FRAGMENTATION, SPALLING) AT BOTTOM CORNER ADJACENT TO COMPROMISED VERTICAL STONE JOINT (LIKELY DUE TO FROST ACTIVITY).
7. ADHESIVE FAILURE - HORIZONTAL SEALANT JOINT SYSTEM.

8. JOINT SYSTEM FAILURE (SEE 1, 4).
9. POORLY DESIGNED FLASHING DETAIL AT ROOF TRANSITION FUNNELS WATER TO BACKSIDE OF PIER AND CONCENTRATES RUNOFF DIRECTLY OVER VERTICAL JOINT.

10. STONE DISCOLORATION. DARK STAINING CORRESPONDS TO WATER RUNOFF, AREAS EXPOSED TO LONG PROLONGED SATURATION LIKELY HAVE BIOLOGICAL GROWTH IN ADDITION TO ATMOSPHERIC SOILING.

1. Clean stone and repoint joints.
2. Repair cracks.
3. Replace severely damaged stone and rebuild back-up brick masonry as required.
4. Develop an appropriated stone cleaning protocol.

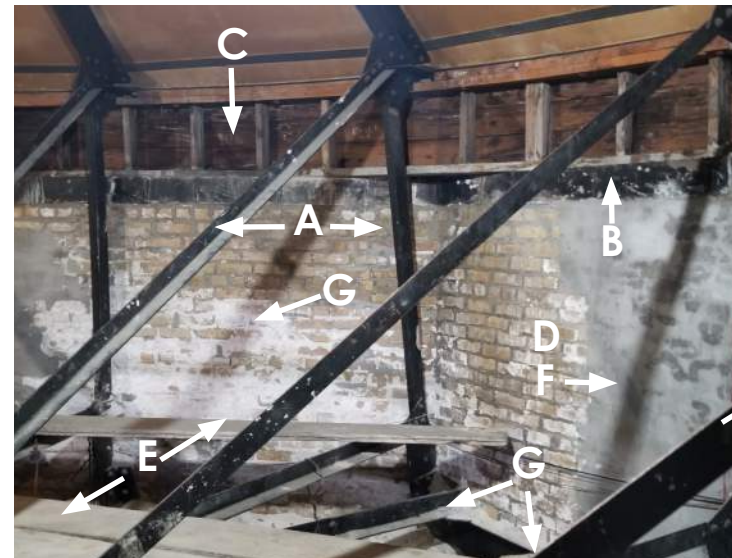
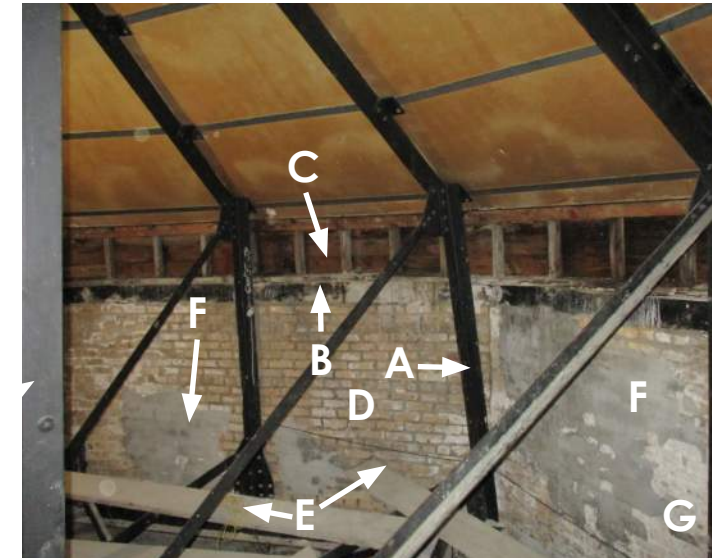
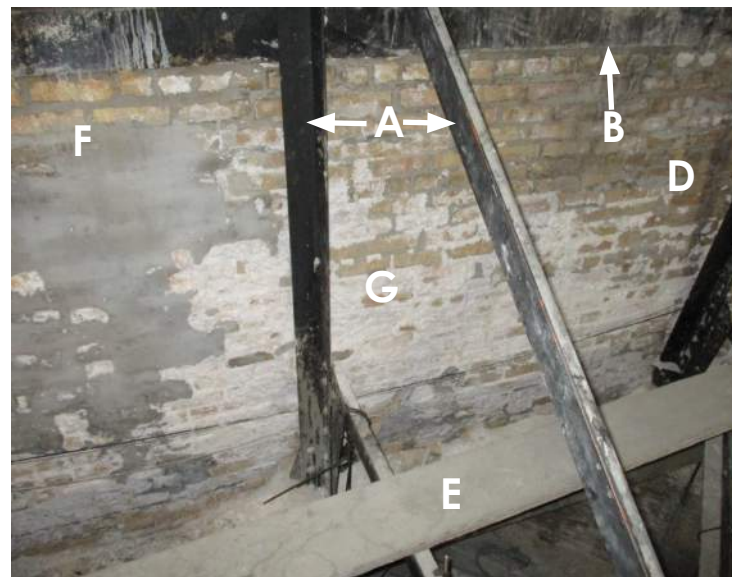
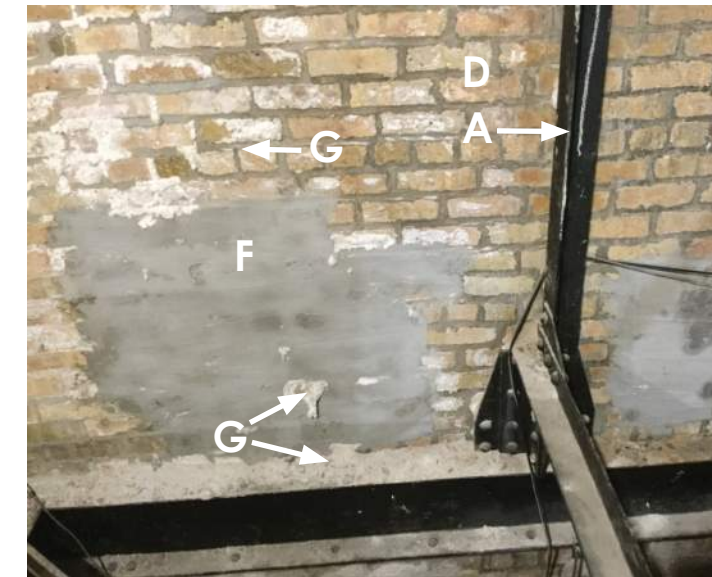
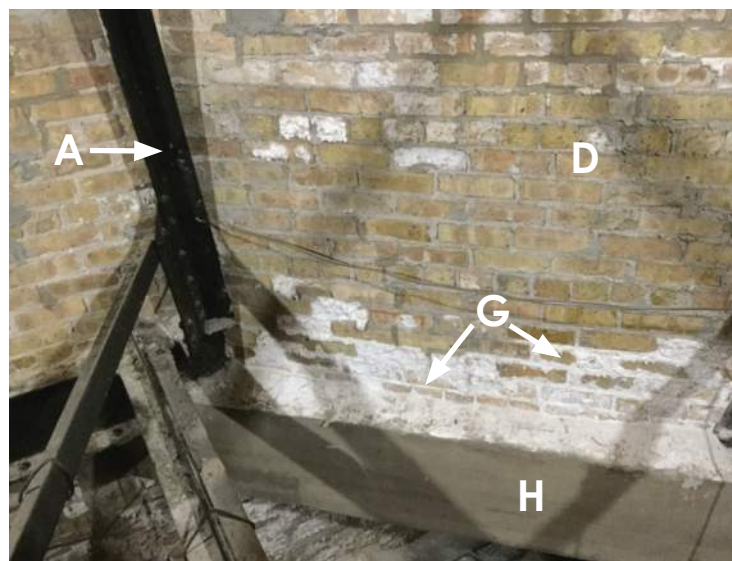
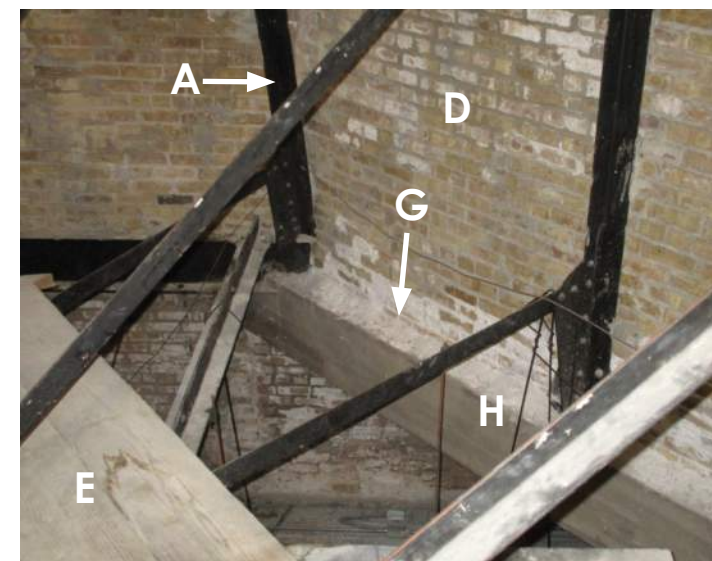
The interior face of the brick pedestal, observed from the rotunda attic, shows sign of extensive water infiltration including: staining and heavy deposits of thick, white efflorescence and evidence of past repairs to brick and mortar.

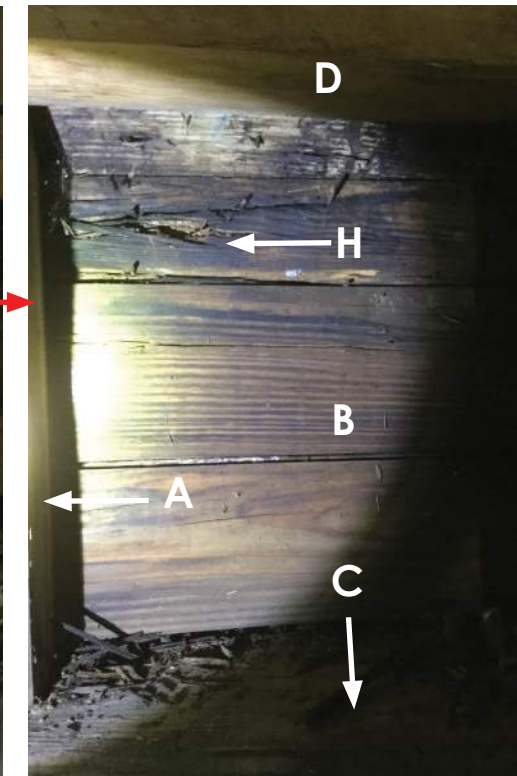
Deteriorated wood sheathing

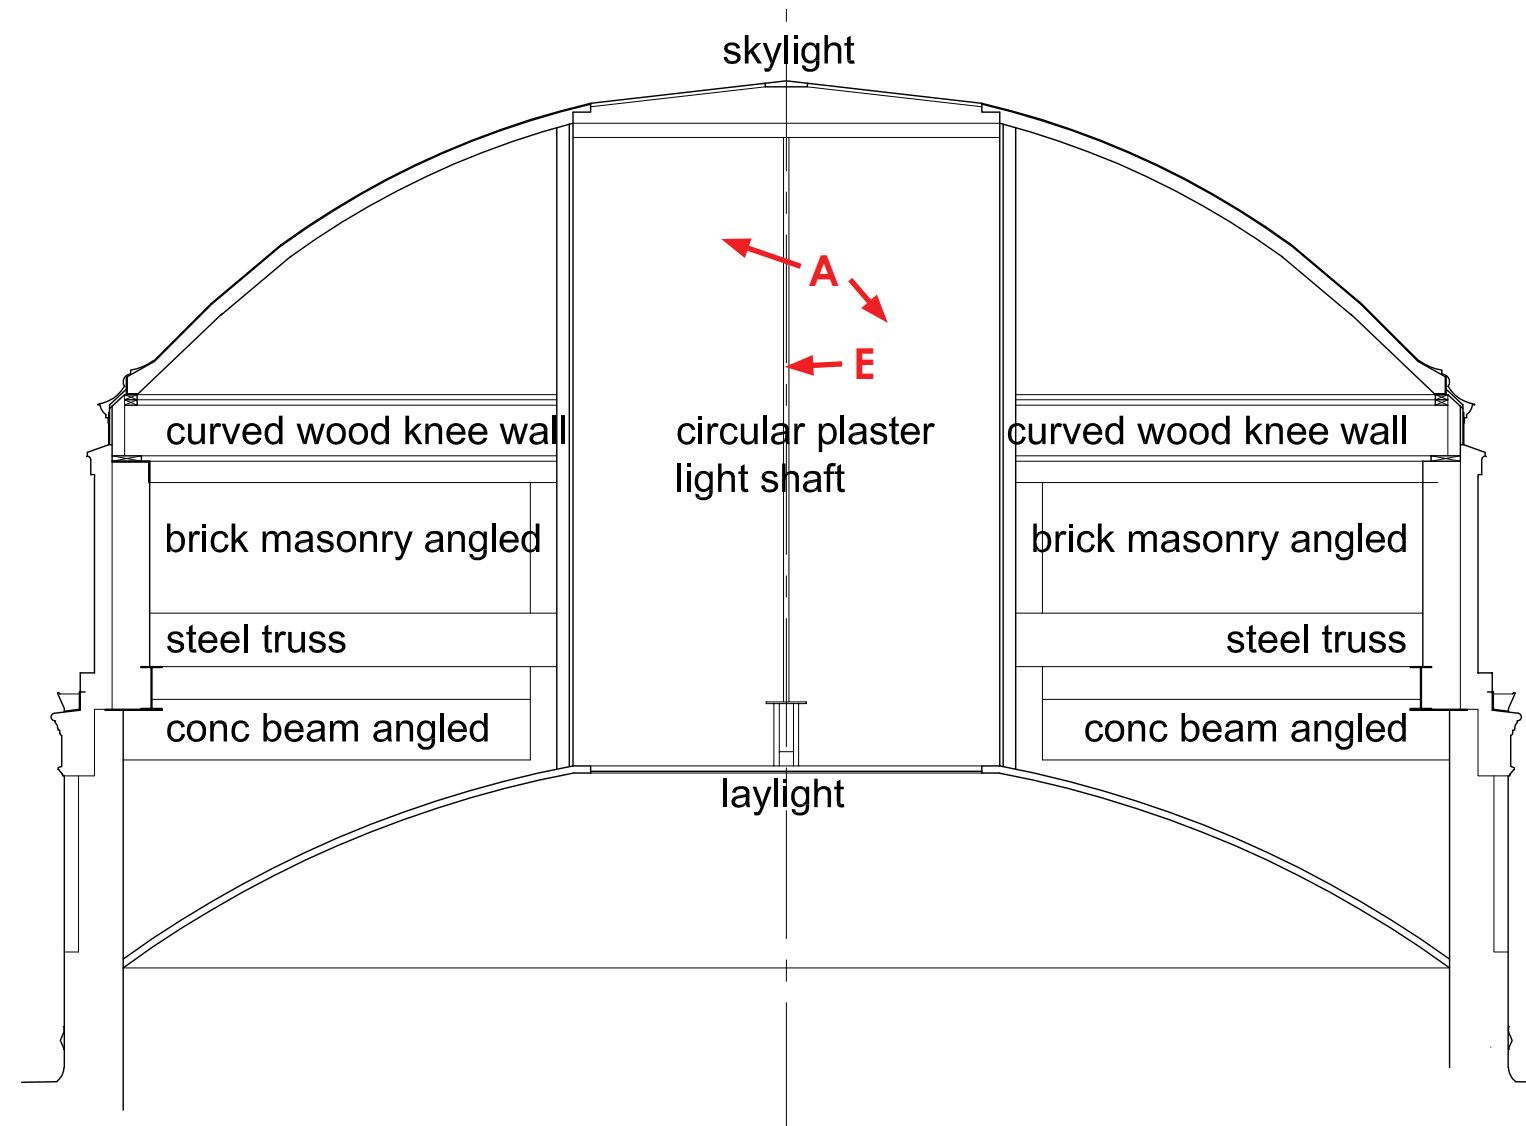
- A. SMOOTH FINISH OF PLASTER LIGHT SHAFT.
- B. STAINING ON INSIDE FACE OF PLASTER LIGHT SHAFT.
- C. METAL LEDGE - ASSUMED TO ACCOMMODATE SUPPORT BOARDS WHEN WORKING IN SHAFT.
- D. LAYLIGHT.
- E. STEEL ROD TO SUPPORT LAYLIGHT AND ROTUNDA CHANDELIER.
- F. EXPOSED PLASTER OF LIGHT SHAFT FROM ATTIC SIDE.
- G. STEEL TRUSS.
- H. WOOD CATWALK.
- I. SKYLIGHT CONDENSATE GUTTER.
- J. SKYLIGHT.
- K. CURVED STEEL DOOR INTO PLASTER LIGHT SHAFT FROM ATTIC.

1. Clean and repaint inside plaster of light shaft.
2. Further investigation is required to determine the cause of the streaks.
3. Add weather stripping to door to seal against air leakage to and from the lightshaft.

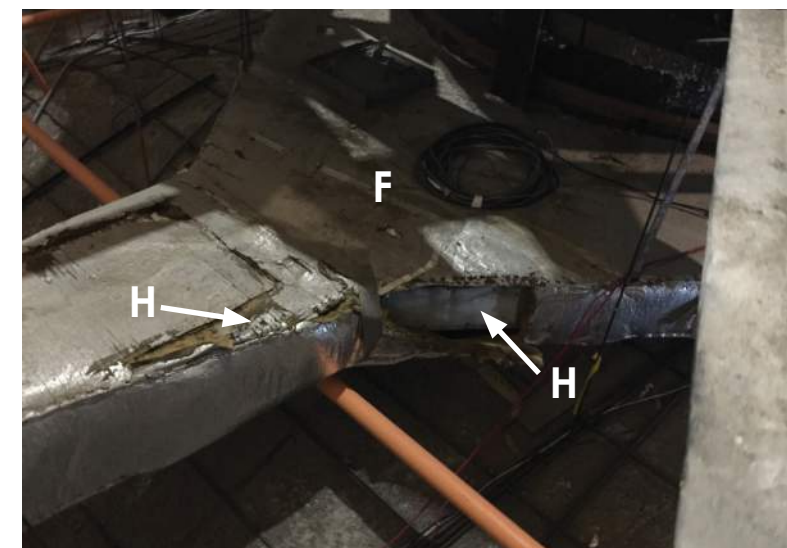
Deteriorated duct insulation

1. Remove old ductwork insulation wrap and install new insulation over ductwork.
2. Separate ductwork from steel truss members to prevent condensation due to thermal transfer.
3. Inspect and repair condensate piping.
4. Remove old condensate piping insulation and install new sealed piping insulation.
5. Repair condensate pipe thru exterior wall. Install new drip spout to prevent water from running on face of masonry.

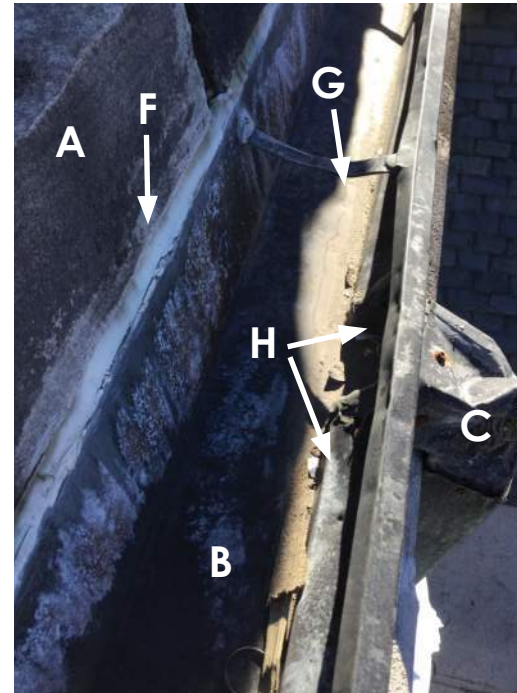
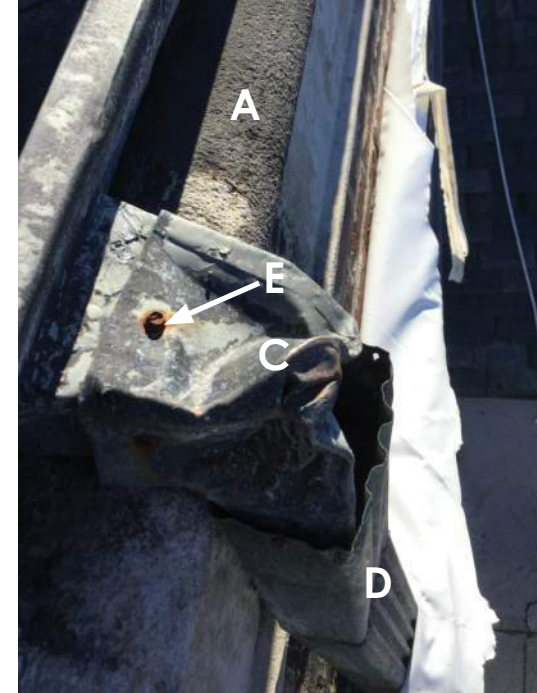
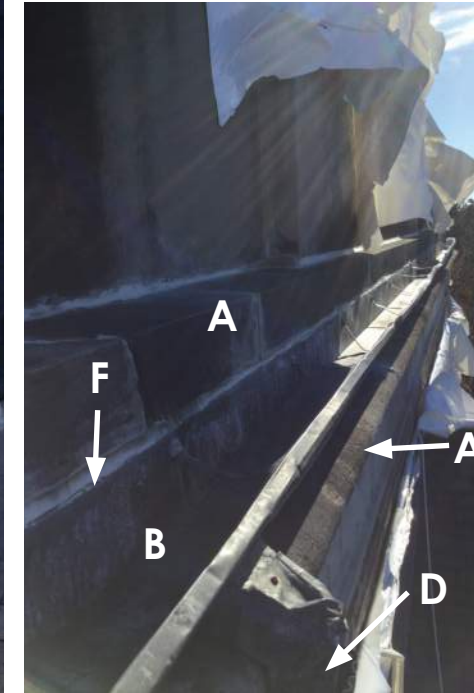
- A. STONE PEDESTAL.
- B. LEAD-COATED COPPER GUTTER AROUND PEDESTAL.
- C. COPPER DOWNSPOUT ELBOW.
- D. COPPER DOWNSPOUT - ONE ON THE EAST AND ONE ON THE WEST SIDES OF THE PEDESTAL.
- E. FERROUS ANCHOR AT ELBOW TO GUTTER SLEEVE.
- F. REGLET JOINT WITH SEALANT WHERE BACK WALL OF GUTTER TERMINATES AROUND PEDESTAL.
- G. DAMAGED GUTTER STRAPS.
- H. SOLDER JOINTS AT SLEEVE AT GUTTER DISCHARGE ARE BROKE

1. Remove the existing gutter and downspouts and Install a new copper gutter system including copper downspouts.
- ▶ Incorporate expansion joints at the gutter
 - ▶ Provide sufficient slope along length of gutter to downspouts.
 - ▶ Review and evaluate reglet terminations
 - ▶ Review gutter anchorage
 - ▶ Size downspouts correctly
 - ▶ Provide splash blocks

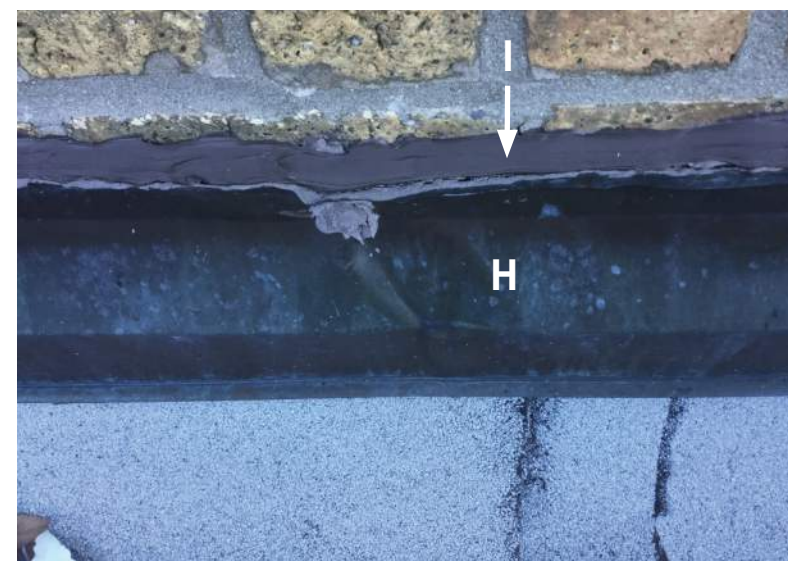
Damaged flashing and sealant patch at north roof

1. Remove and replace all flashing sealants- color to match substrates.
2. Replace flashings with new copper flashings where visible to public.
