Lake Forest Library Feasibility Report

4.0 Condition Assessment

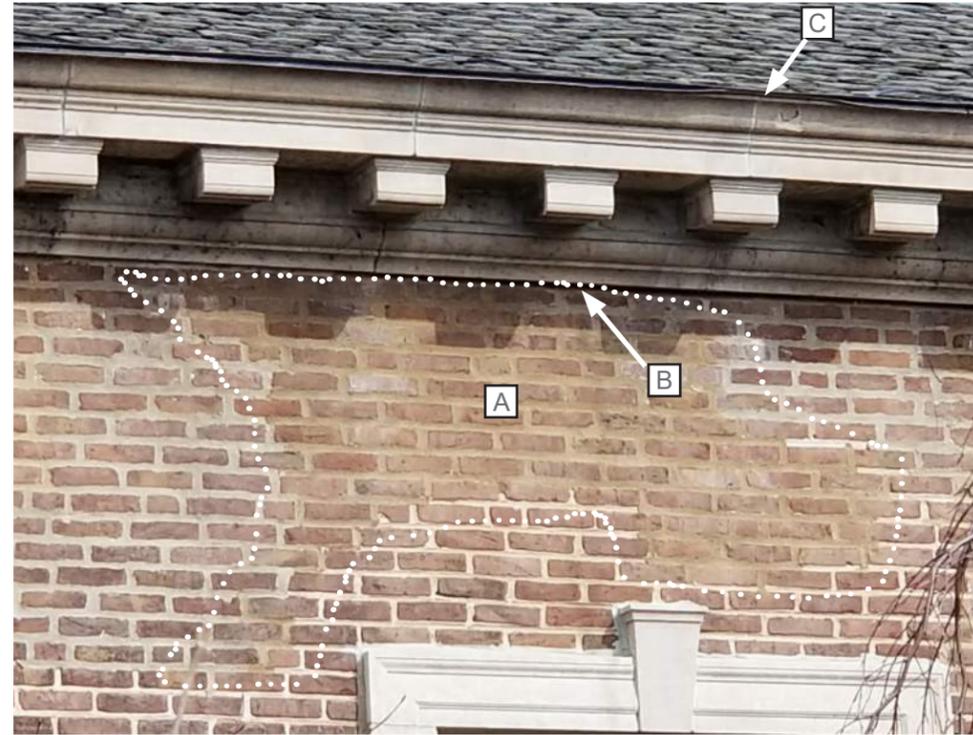
WEST WING - BRICK MASONRY

Ongoing water infiltration from deficient gutter and or roof edge transition has been reported.

REPAIR PRIORITY - **C**

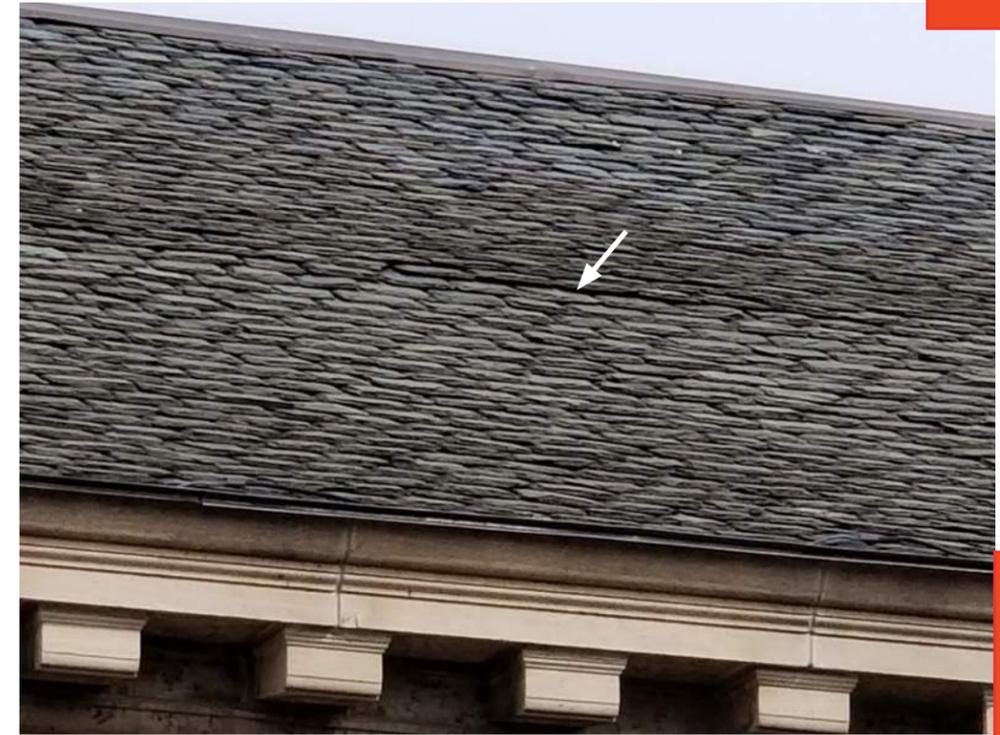
SLATE ROOF- GENERAL CONDITION

Original slate tiles were removed and reinstalled. It is unclear how much of the substrate was repaired or replaced.

REPAIR PRIORITY - **D**

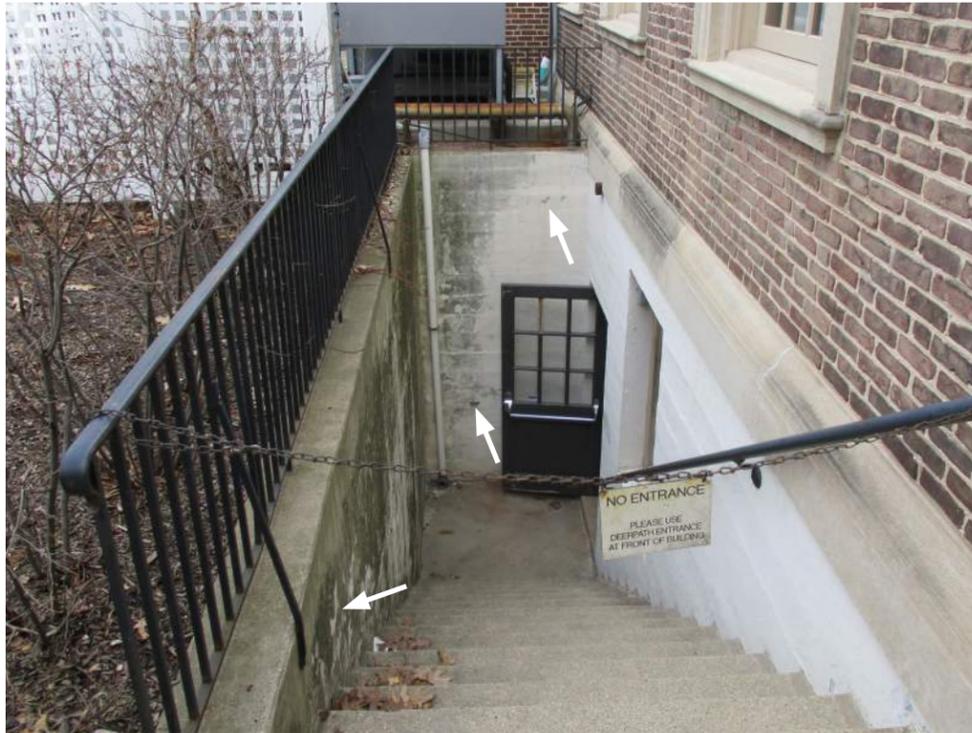
EXTERIOR STAIR (WEST)

The stair well and treads are concrete construction. There is a small drain at the lower landing. The door at the base of the stair opens to the main mechanical equipment room.

REPAIR PRIORITY - **D**

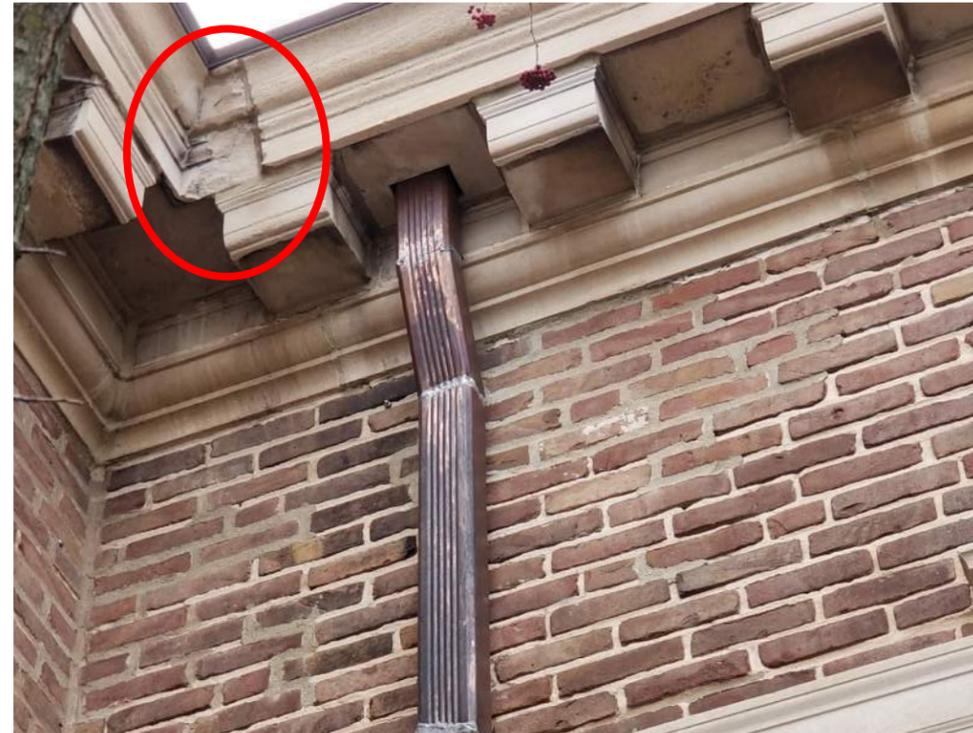
NORTH WING - WEST FACADE

Generally the limestone features are in good condition. Isolated areas of deterioration are likely due to location specific conditions or deficiencies.

REPAIR PRIORITY - **C**

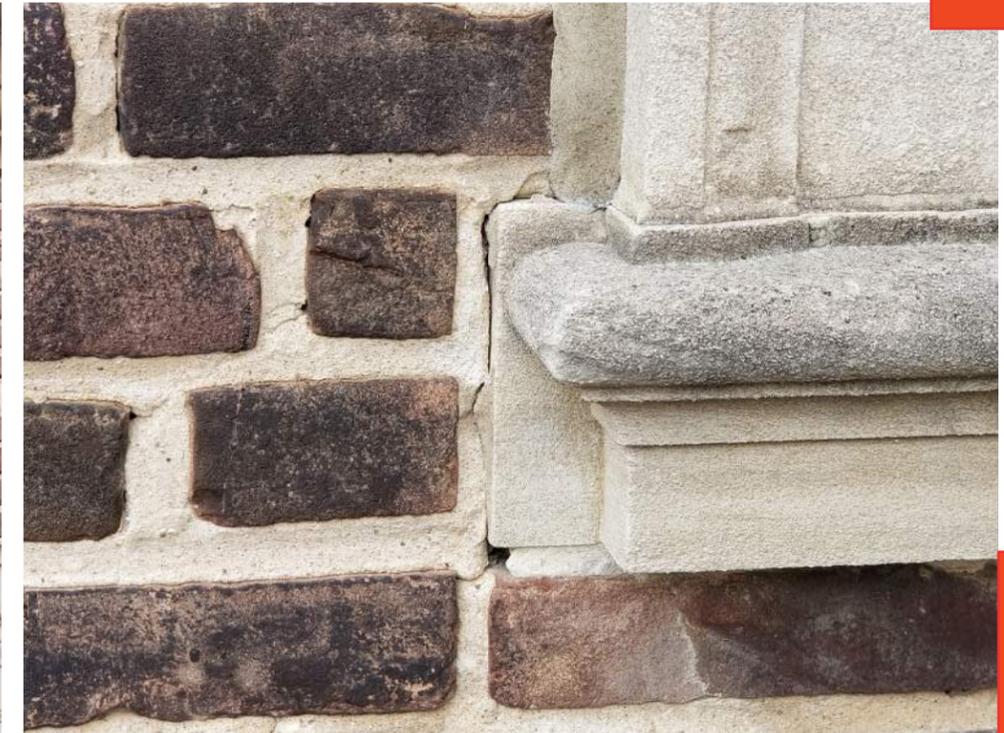
NORTH WING - WEST FACADE

Generally, masonry joint systems are in good condition. Isolated deficiencies include: erosion, in areas subjected to concentrated water runoff; open joints, at transitions between dissimilar materials,

REPAIR PRIORITY - **C**

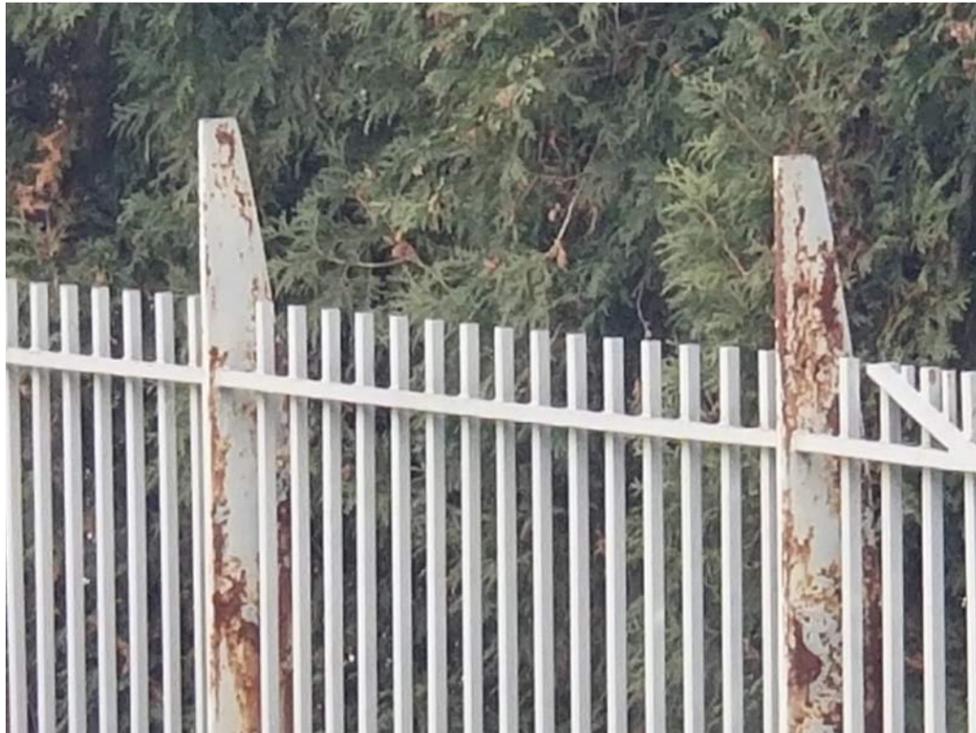
EAST FACADE - LOWER LEVEL ADDITION

A guardrail along the east edge of the lower level addition was constructed as a preventative measure to deter people from climbing on the glass roof.

REPAIR PRIORITY - **B**

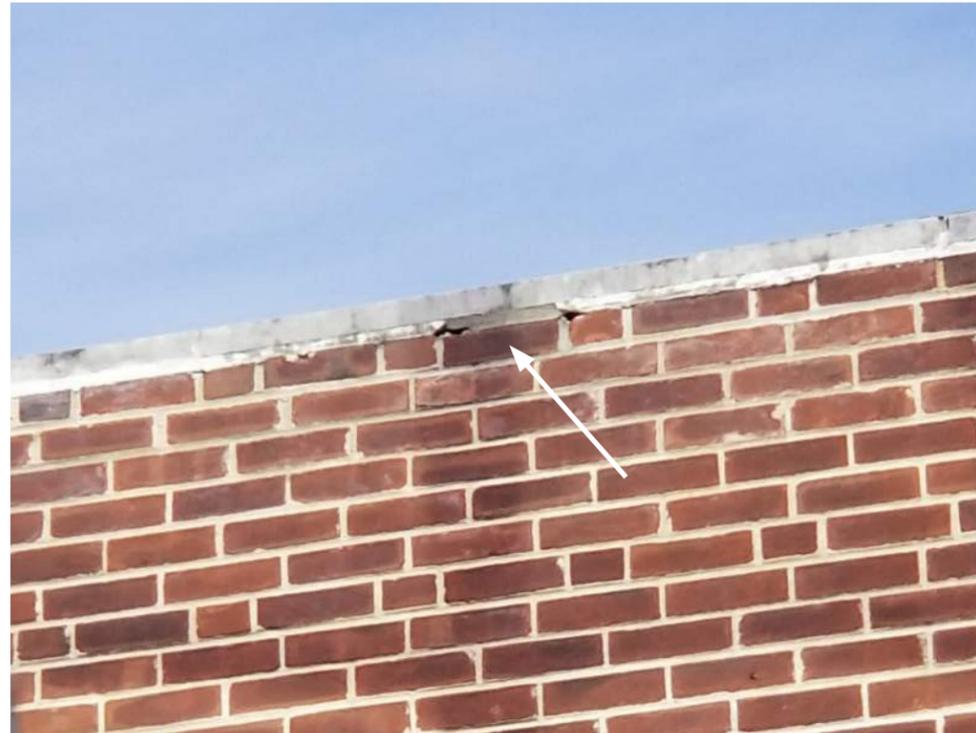
NORTH ADDITION- SOUTH FACE

The perimeter of the north wing addition is capped with a shallow coping unit. Built-up roofing extends over the top of the coping all the way to the face of the wall. The rationale was likely to prevent water intrusion through skyward facing coping joints. However, the installation prevents proper repair and maintenance of vertical coping joints.

REPAIR PRIORITY - **B**

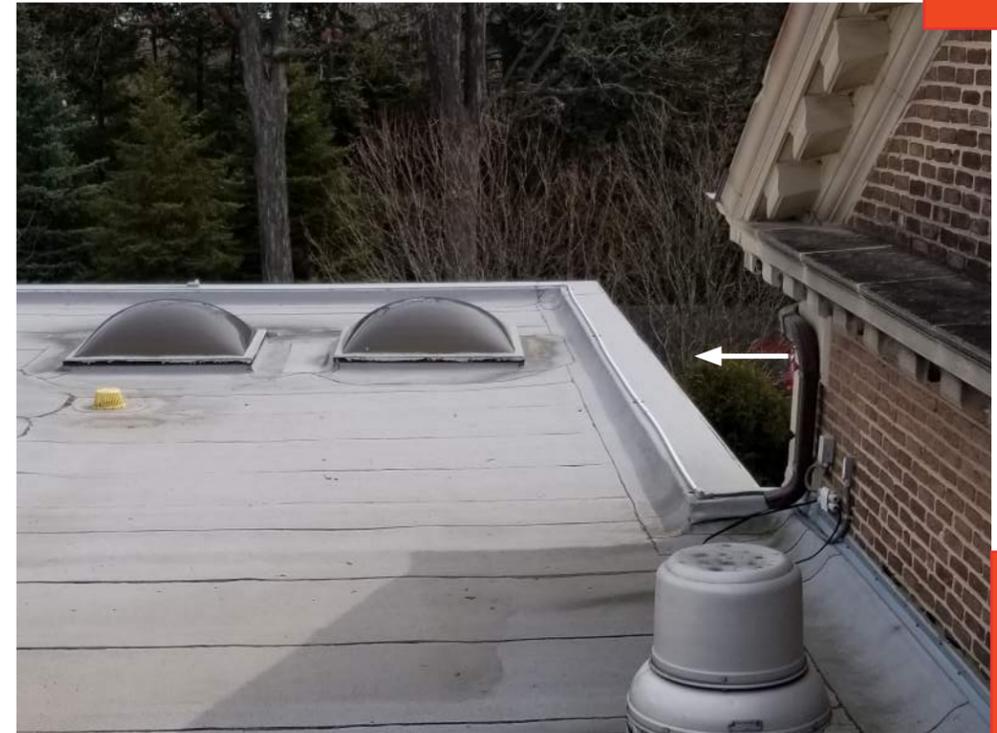
NORTH ADDITION- EAST END

The perimeter of the north wing addition is capped with a shallow coping unit. Built-up roofing extends over the top of the coping all the way to the face of the wall. The arrow indicates the location of failed masonry joint between coping and brick described in adjacent image.

REPAIR PRIORITY - **D**

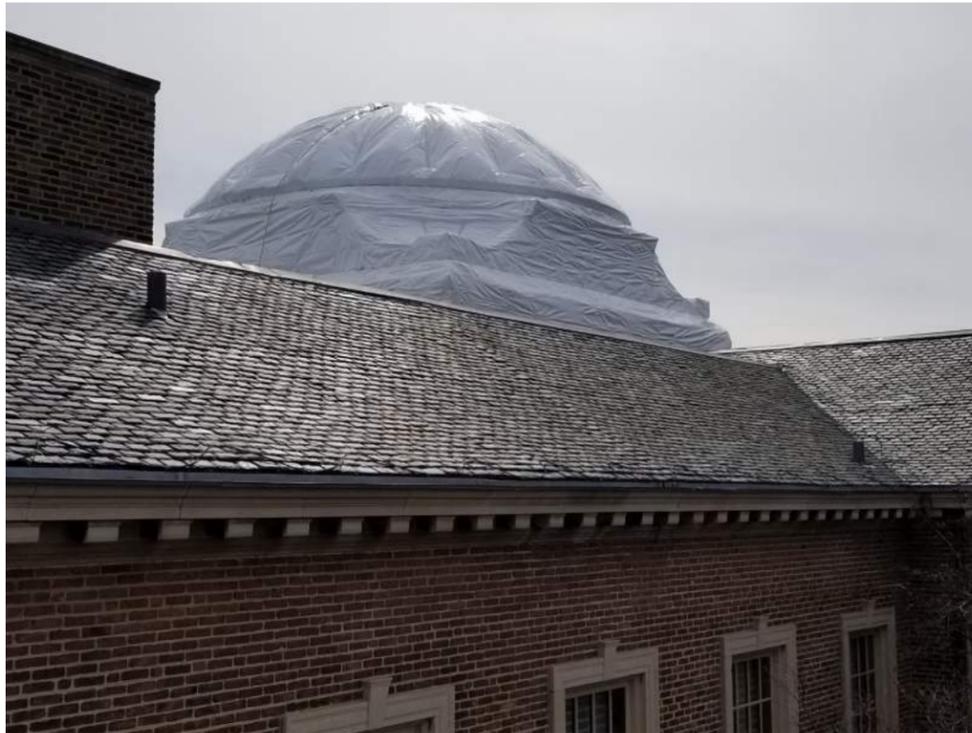
COPPER DOME

Staff reports that water infiltration through the copper dome is causing damage to the rotunda murals below. Preventative measures were taken to cover the dome and pedestal with a large plastic tarp. The A/E team was not able to directly observe the copper dome and top of the pedestal but did access the attic between the dome and rotunda.

REPAIR PRIORITY - **A**

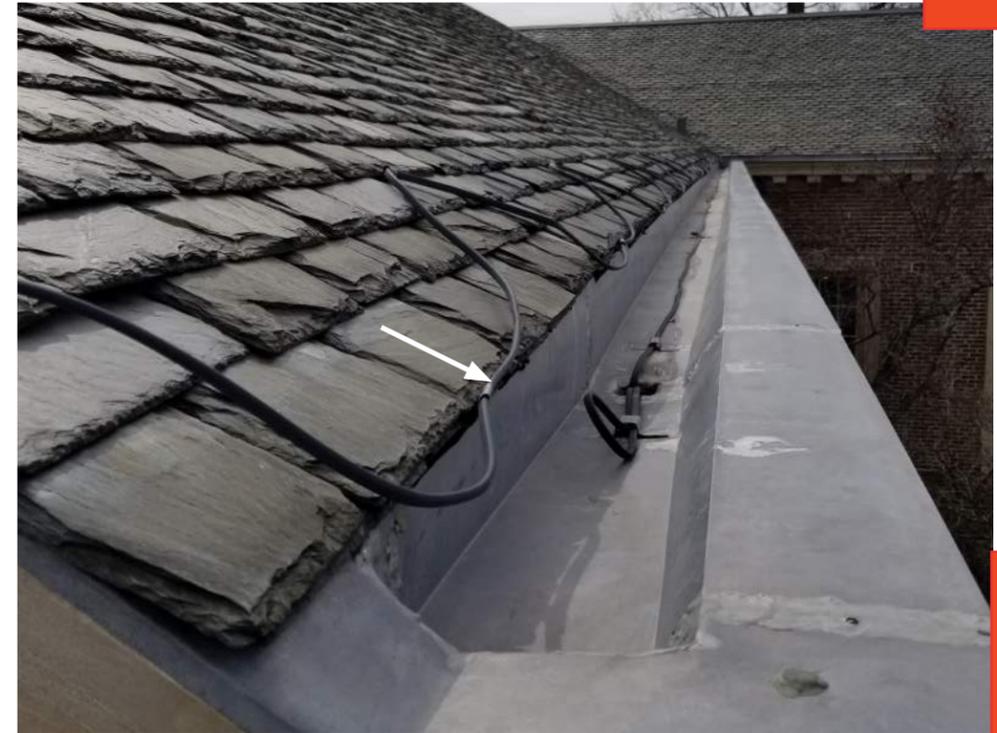
LEAD COATED COPPER GUTTERS

The gutter system is integrated with slate roofing. Heat trace has been added at roof edge, gutters and downspouts.

REPAIR PRIORITY - **D**

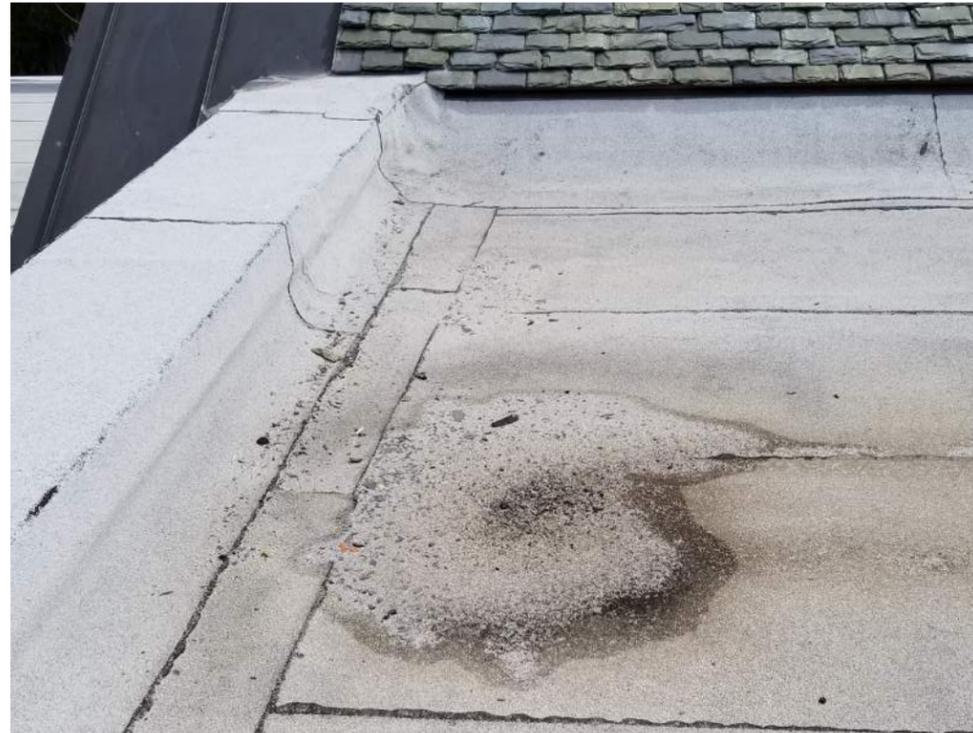
FLAT ROOFING MATERIALS

Low slope roofing is covered with granulated cap sheet.

REPAIR PRIORITY - **E**

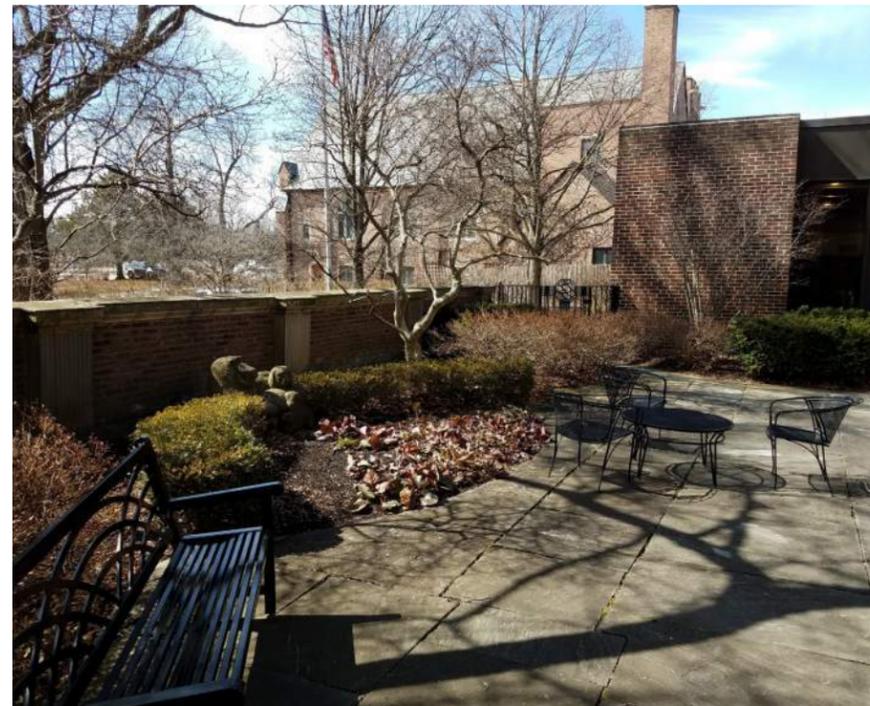
Overall, the exterior of the building appears to be in good condition with no obvious signs of settlement or cracking. At the front of the building there are some garden walls that form courtyards on each side of the main entrance. These walls show signs of some foundation settlement and/or frost heave resulting in walls that are leaning in places. This condition will have to be addressed over time. Library staff also pointed out that leaking occurs at the foundation walls on either side of the main entrance during heavy rains. This leaking was thought to be a result of honeycombing of the existing concrete foundation walls, but the condition of the foundation walls was not visible during the site assessment to verify this. Hand excavation of the walls in these areas will need to be done to properly assess the condition of the existing foundation walls and determine the cause of the water intrusion.

Garden walls that show signs of settlement

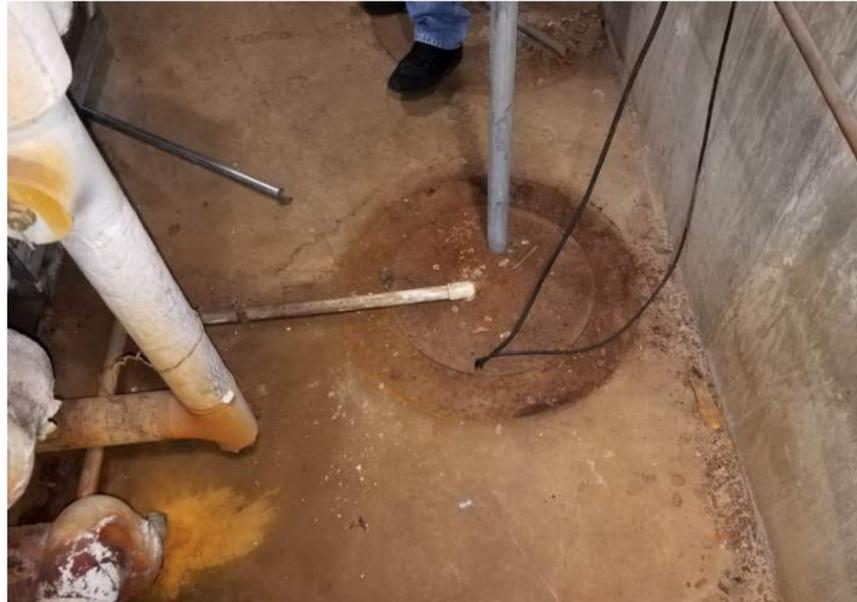
5. There are two or more sump pumps in the basement of the building. They are original to the building, typically provide drainage of foundation ground water and appear to be in fair condition.

Typical foundation ground water sump pump

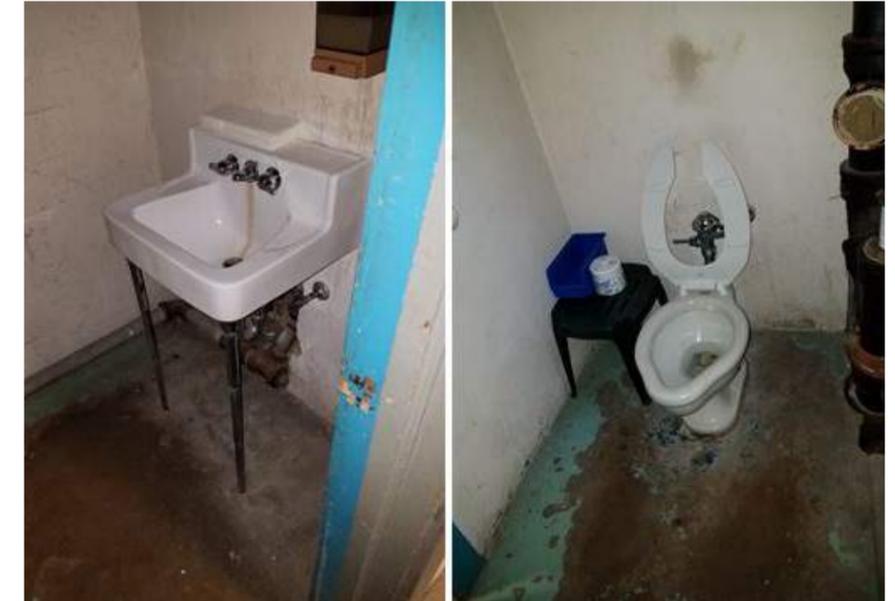
9. Plumbing fixtures in the building consist of sinks, lavatories, toilets, urinals and floor drains. Some fixtures appear to be original to the building and in need of repair or replacement. Other fixtures appear to be fairly new and in good condition.

Lavatory and toilet original to building having reached their useful life

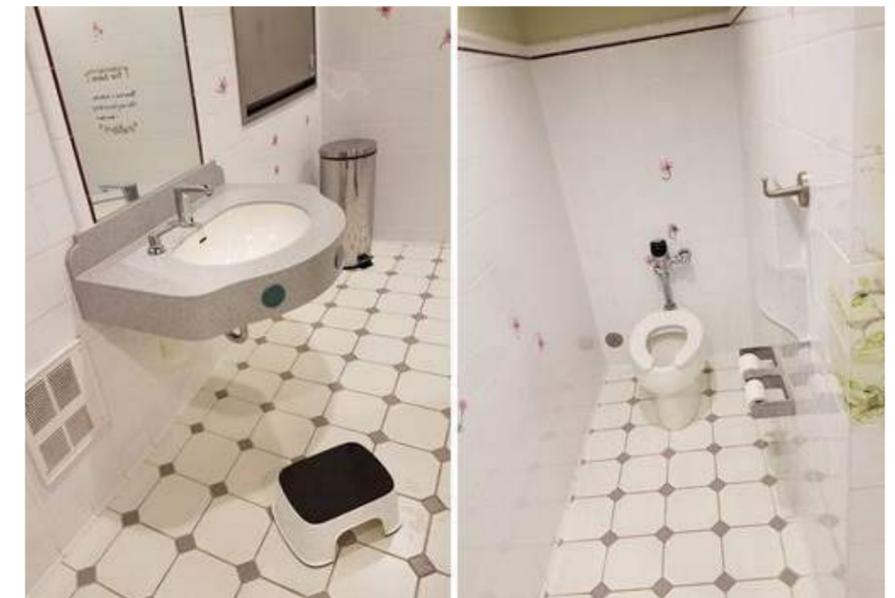
Newer plumbing fixtures in good condition
