Lake Forest Library

Dome and Pedestal Repair Recommendations

This report presents findings from site investigation of the copper dome, masonry pedestal, and rotunda attic space performed December 2018.

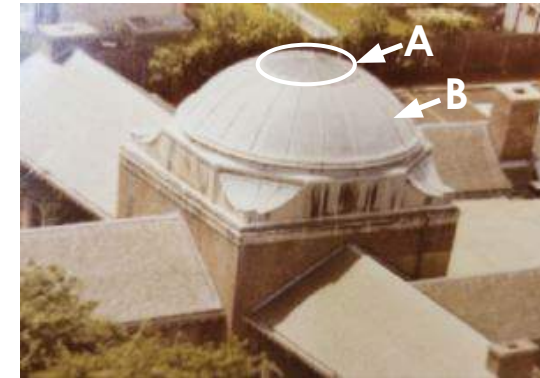
The skylight at the top of the dome was not accessible from the outside. Observation was limited to what could be seen looking up from the plaster light shaft.

- ▶ The skylight size appears to match that of the layight, about 10-feet in diameter.
- ▶ There are 20-panes of glass equally spaced and pie shaped.
- ▶ There appears to be a copper condensate gutter visible around the outside perimeter.
- ▶ Tape for the temporary tarp suggests there are battens over each radial mullion.
- ▶ Just under the condensate gutter, an east-west beam spans the opening. In the same plane, a smaller beam spans north-south. At the intersection of these two beams, the steel rod extends down to support the laylight frame and chandelier. It appears a center post sits on top of the beams in the center to support the skylight peak.

Skylight at top of dome

1. Reglaze skylight glass panes.
2. Repair condensate gutter and connections to condensate drain lines.

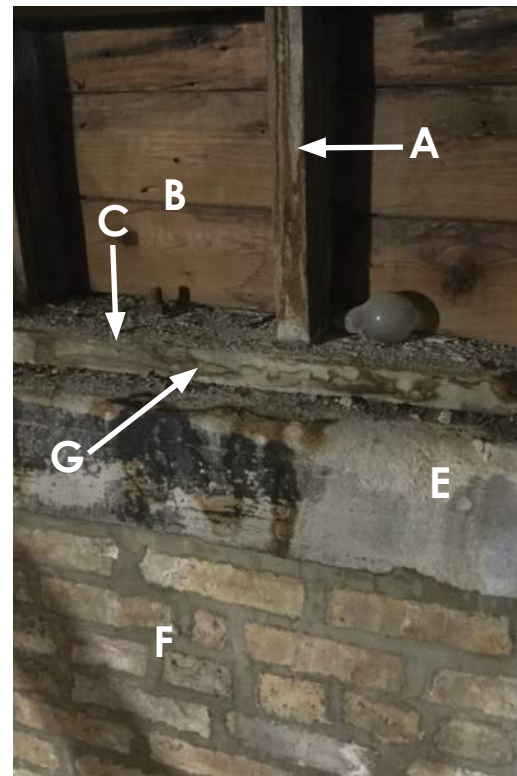
- ▶ Top and bottom wood plates are not in the same plane. Vertical wood frame members, 2x4 studs at 16-inches on center, are seated on the bottom 2x wood plate and extend upwards and behind the top double plate. The top edge of these studs are cut at a 45-degree angle matching the roof slope. The high edge of these studs aligns with the joint of the double top plates. The outside height of the studs is 14-inches tall.

Wood knee wall bearing on masonry wall

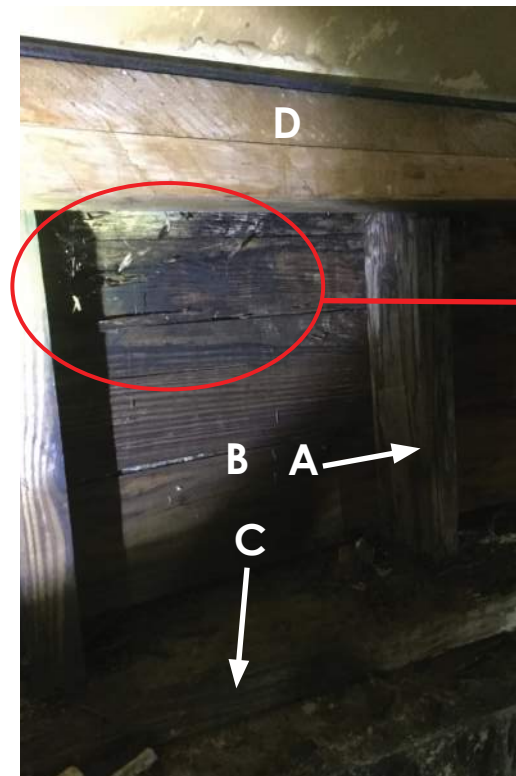
- ▶ The outside face of the knee wall is covered with three courses of 1x6 tongue and groove sheathing boards. The top board is cut short, to about 3 1/2". The top slope of the wood studs is also a clad with what appears to be a similar 1x wood board which extends over the wall sheathing. Ferrous nails were noted projecting through this roof sheathing board that suggest additional blocking may be applied on top of these boards to help build a base to support the perimeter copper profile.

Wood sheathing at wood knee wall

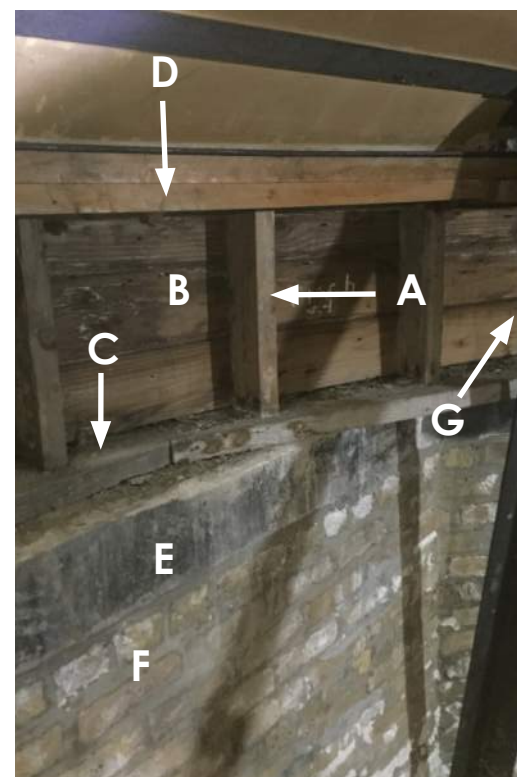
Wood knee wall between dome and base

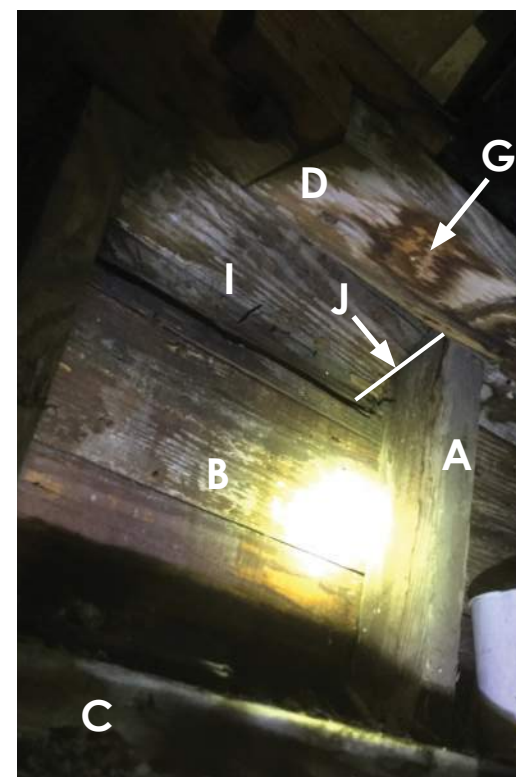
Wood knee wall sheathing, studs, and top plates

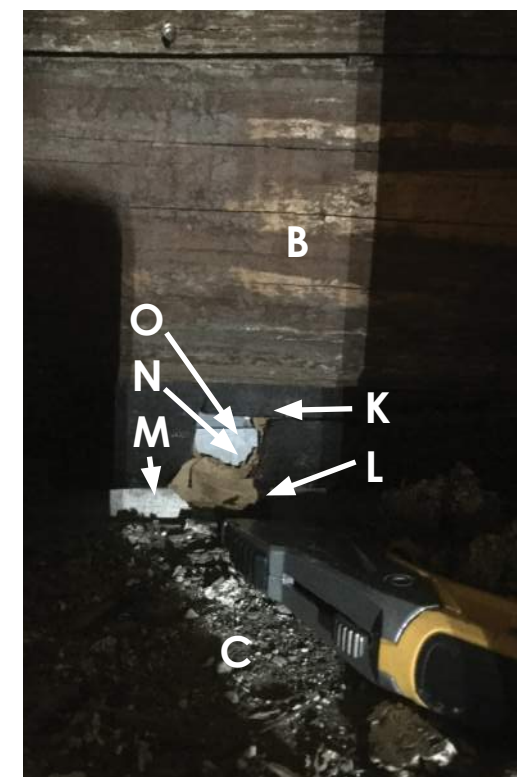
View thru hole in wood sheathing

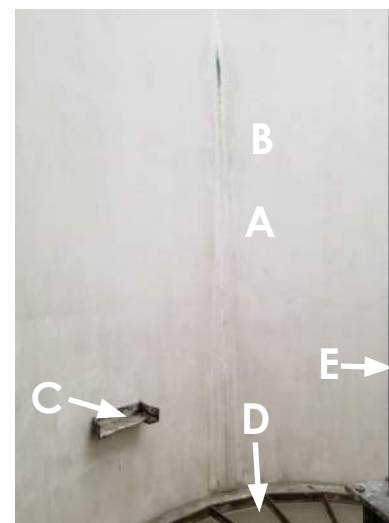
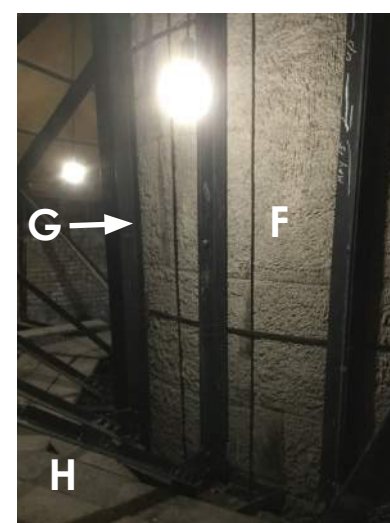
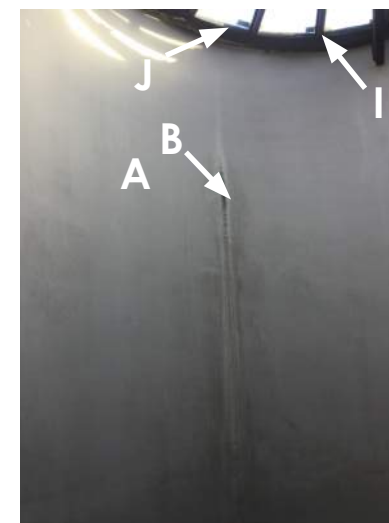
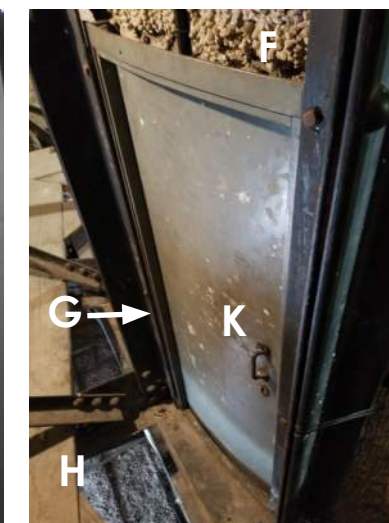
Plaster light shaft - SE direction

Plaster light shaft - view from attic

Door into plaster light shaft from attic

1. Clean and repaint inside plaster of light shaft.
2. Further investigation is required to determine the cause of the streaks.
3. Add weather stripping to door to seal against air leakage to and from the lightshaft.

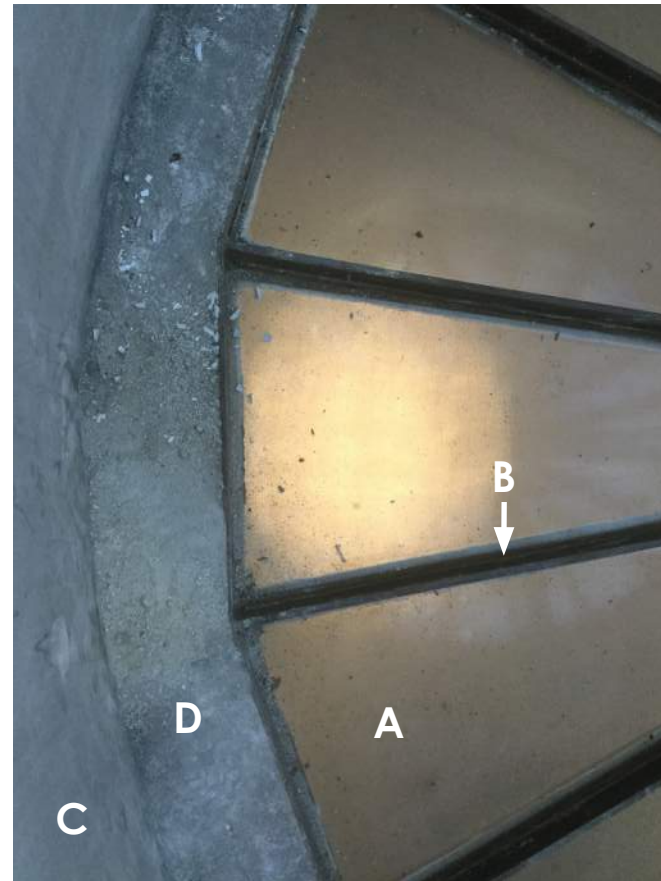
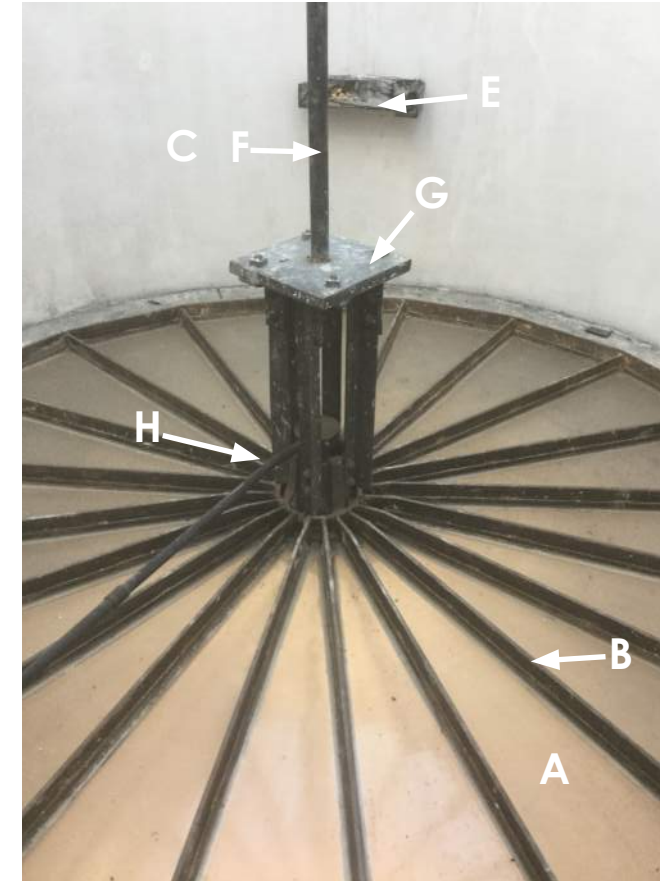
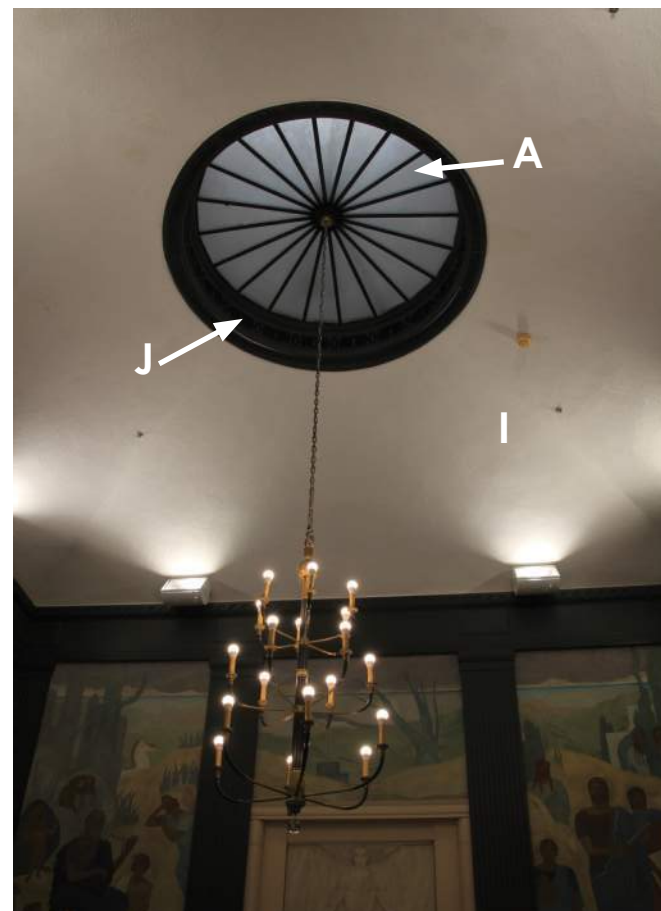
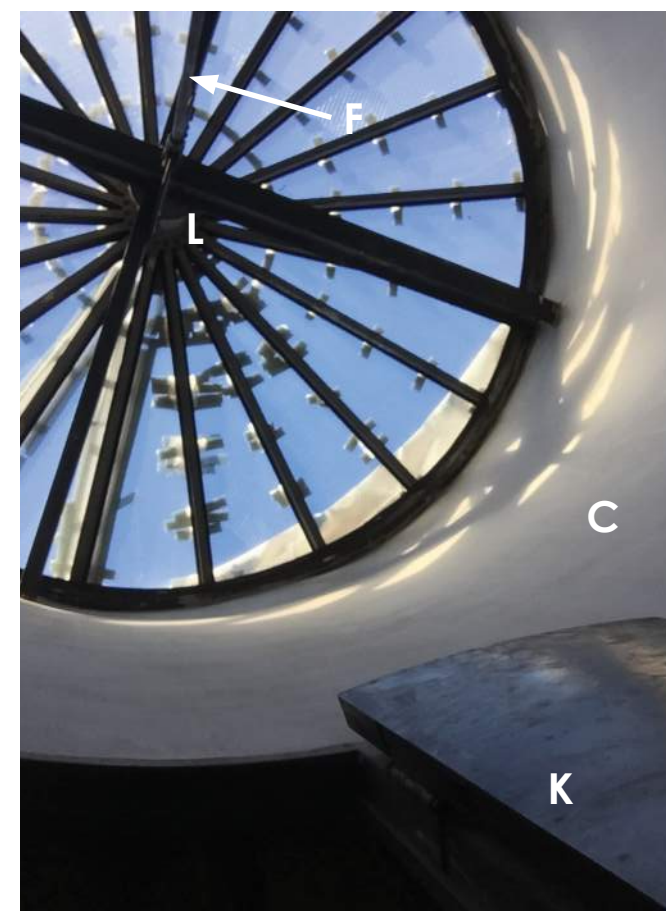
Laylight in plaster shaft

Laylight view from rotunda

Skylight view from within light shaft

1. Clean laylight glass.
2. Seal gaps between frame and plaster and at chandelier attachment.

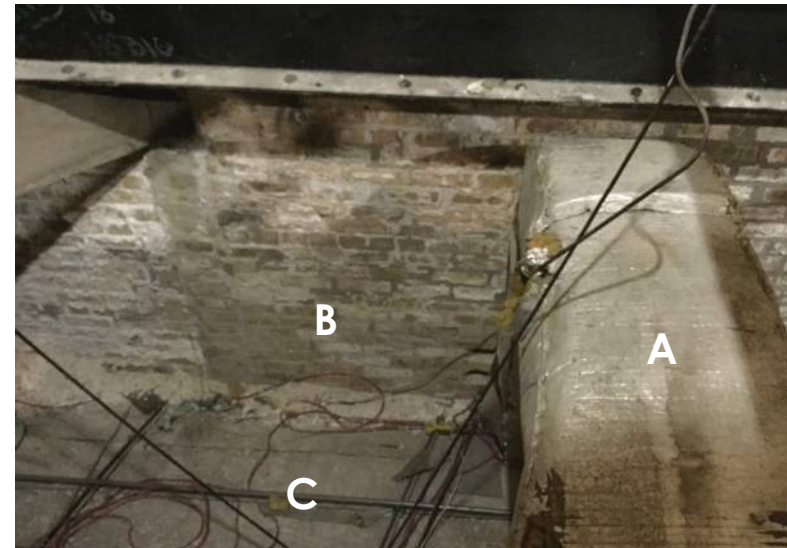
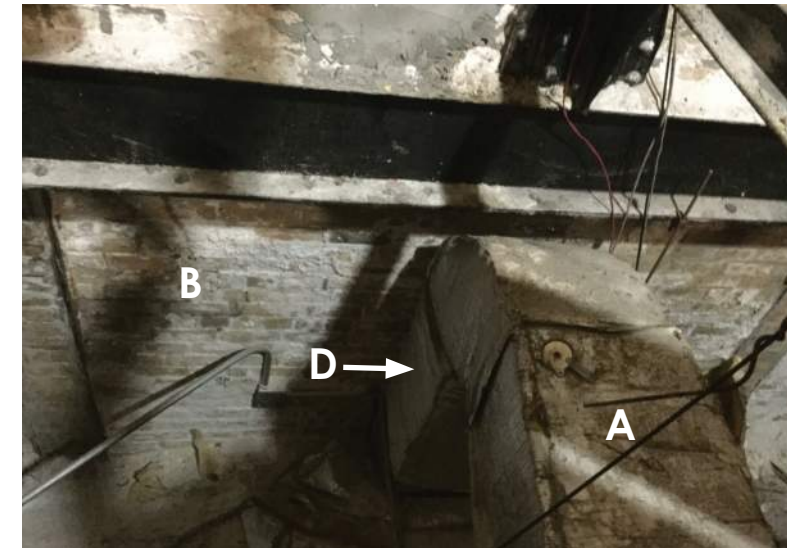
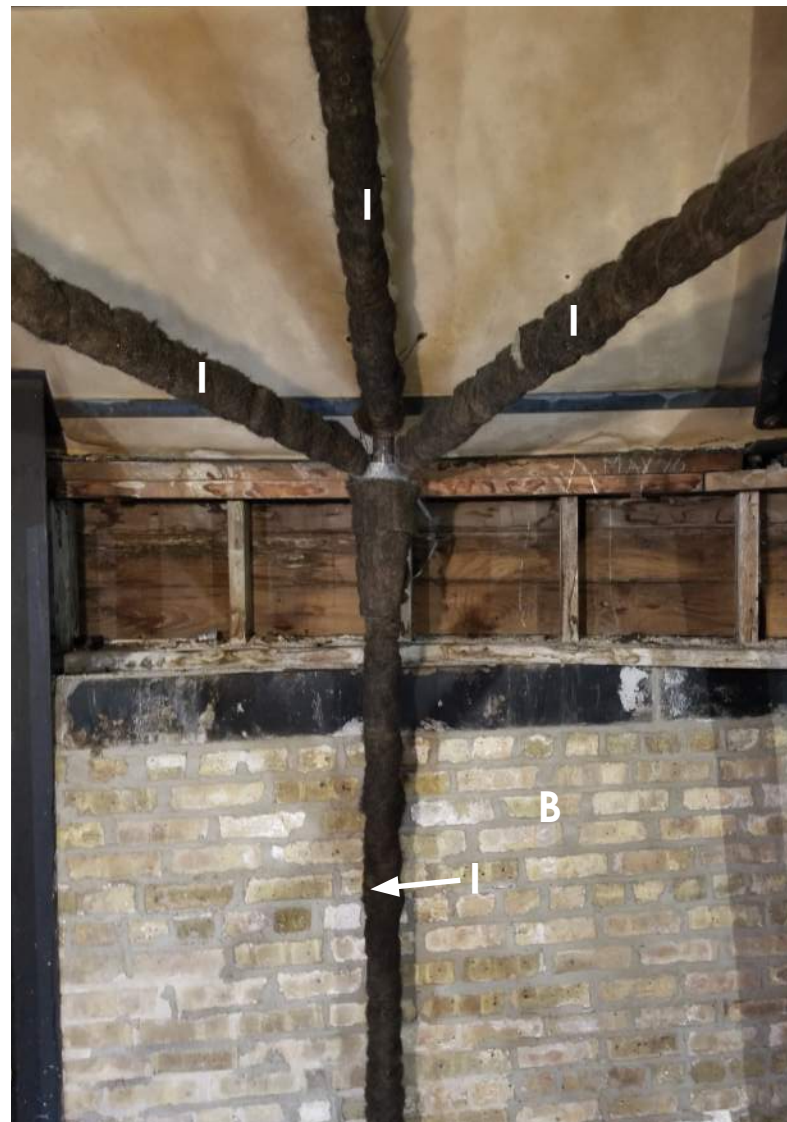
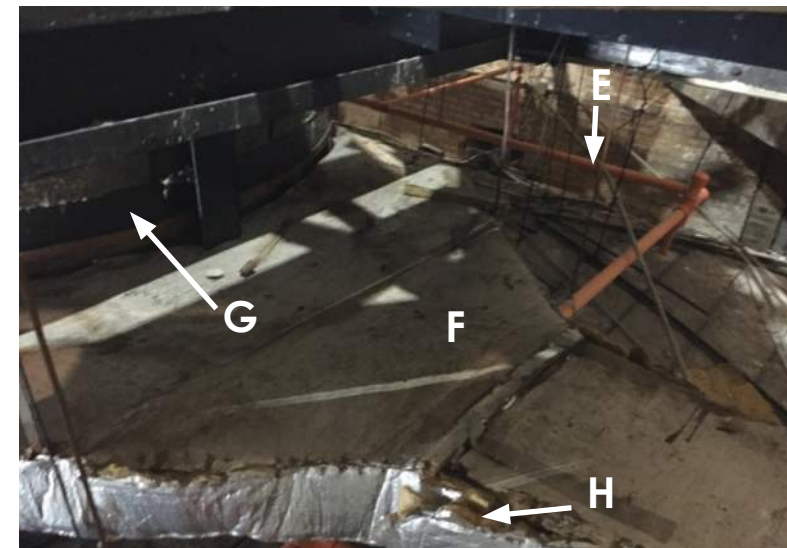
Ductwork on the east side of the attic

Ductwork on the west side of the attic

Skylight condensate piping collects on the north side of the attic

Ductwork spreads around the base of the plaster light shaft

1. Remove old ductwork insulation wrap and install new insulation over ductwork.
2. Separate ductwork from steel truss members to prevent condensation due to thermal transfer.
3. Inspect and repair condensate piping.
4. Remove old condensate piping insulation and install new sealed piping insulation.
5. Repair condensate pipe thru exterior wall. Install new drip spout to prevent water from running on face of masonry.

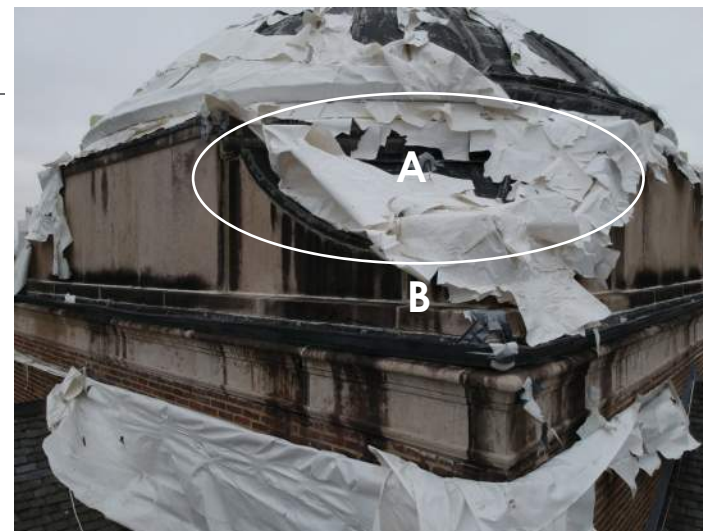
Northwest sloped corner - obscured by tarp

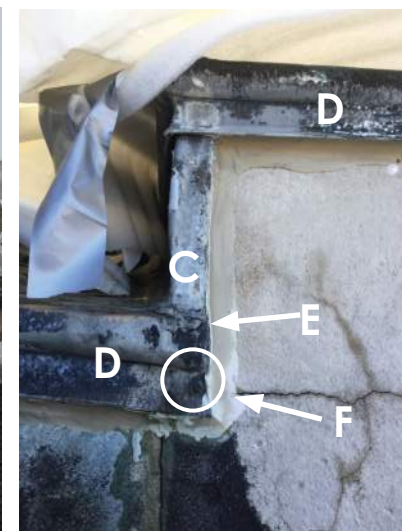
- ▶ Soldered joints were thin, and some cracks were noted, however, it was not clear if these cracks continued through the joint.
- ▶ The copper roof edge wraps the face of the stone pier and terminating about 2 1/2" from the corner. This copper edge is a rolled, radius with a vertical leg and an angled drip. The vertical leg is anchored into the stone or substrate with copper or brass screws with washers at no particular interval. Under the drip edge is a consistent, large sealant joint. It appears as if this is the top of the stone panels.

Copper and pier juncture

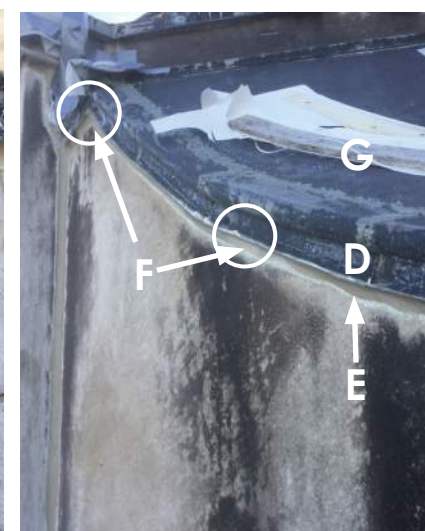
Typical copper roofing edge

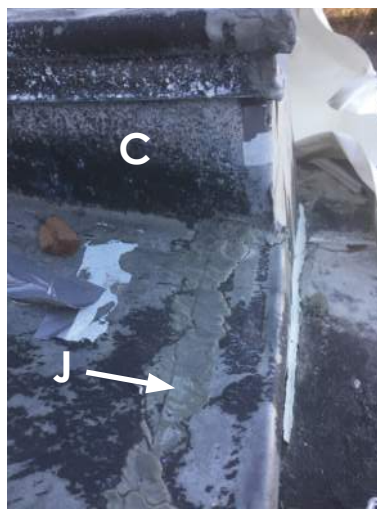
Pier and copper roof juncture

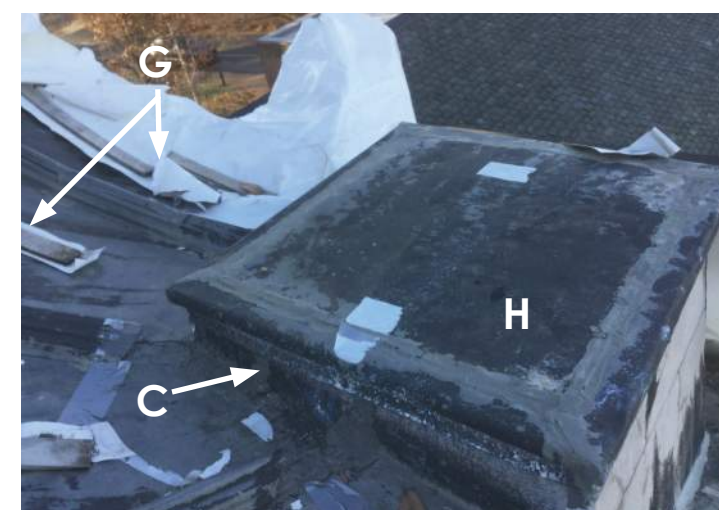
Typical pier at sloped corner

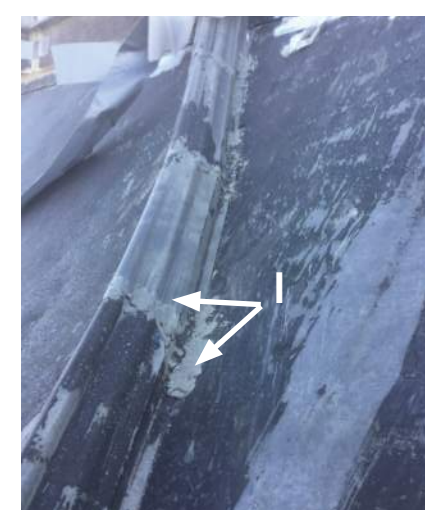
Typical batten on sloped corner roof copper

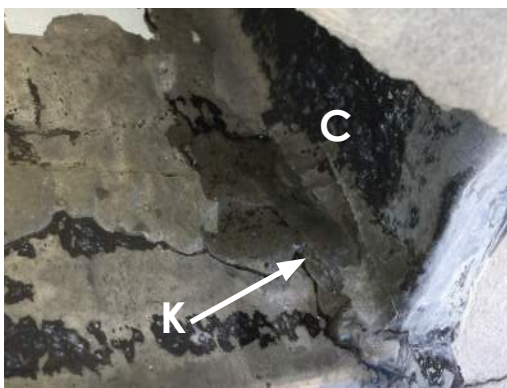
Stone joint at corner pier

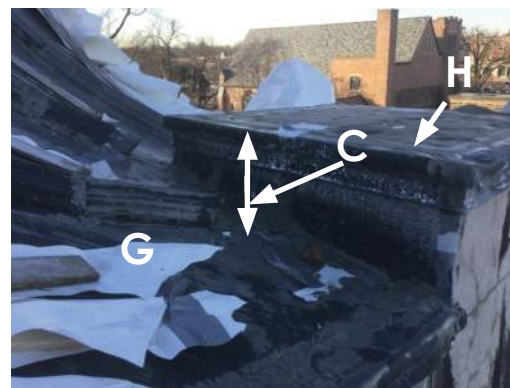
Copper and pier juncture

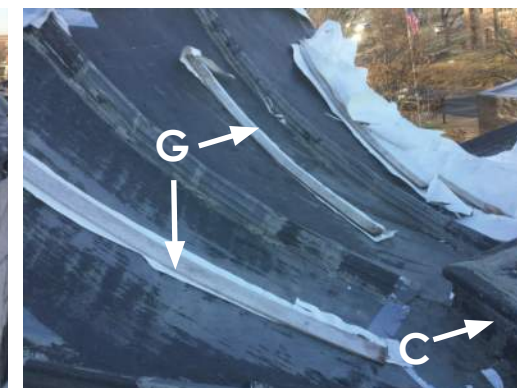
Battens on typical sloped corner roof copper

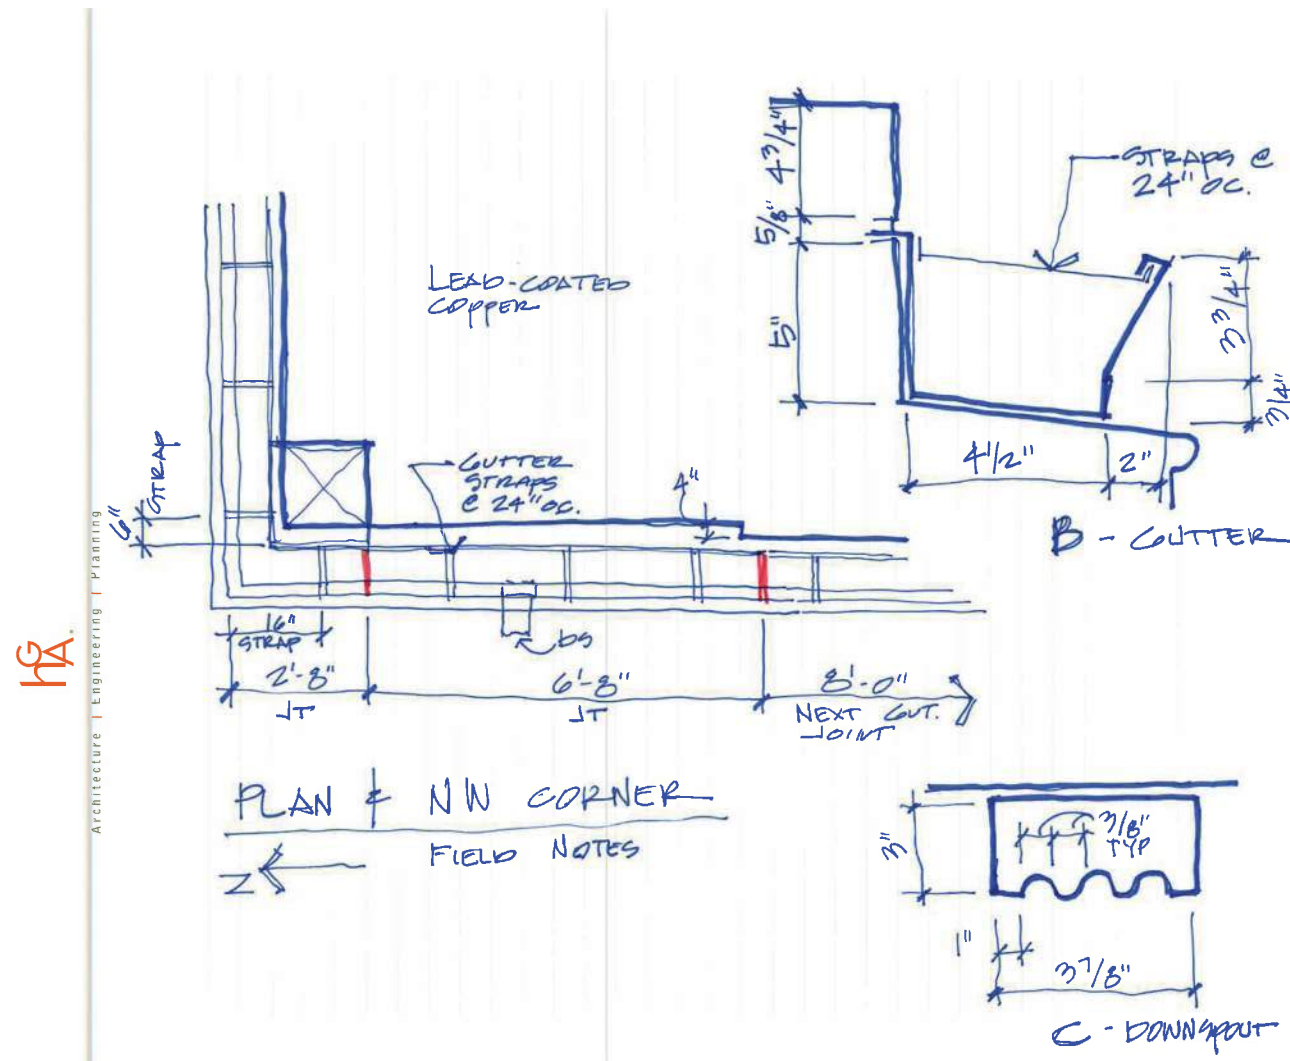
- A. STONE PEDESTAL.
- B. LEAD-COATED COPPER GUTTER AROUND PEDESTAL.
- C. COPPER DOWNSPOUT ELBOW.
- D. COPPER DOWNSPOUT - ONE ON THE EAST AND ONE ON THE WEST SIDES OF THE PEDESTAL.
- E. FERROUS ANCHOR AT ELBOW TO GUTTER SLEEVE.
- F. REGLET JOINT WITH SEALANT WHERE BACK WALL OF GUTTER TERMINATES AROUND PEDESTAL.
- G. DAMAGED GUTTER STRAPS.
- H. SOLDER JOINTS AT SLEEVE AT GUTTER DISCHARGE ARE BROKE

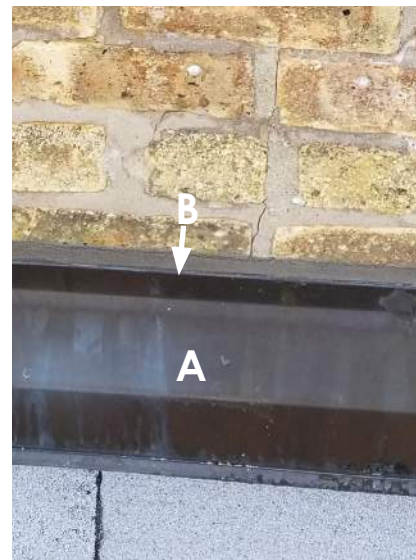
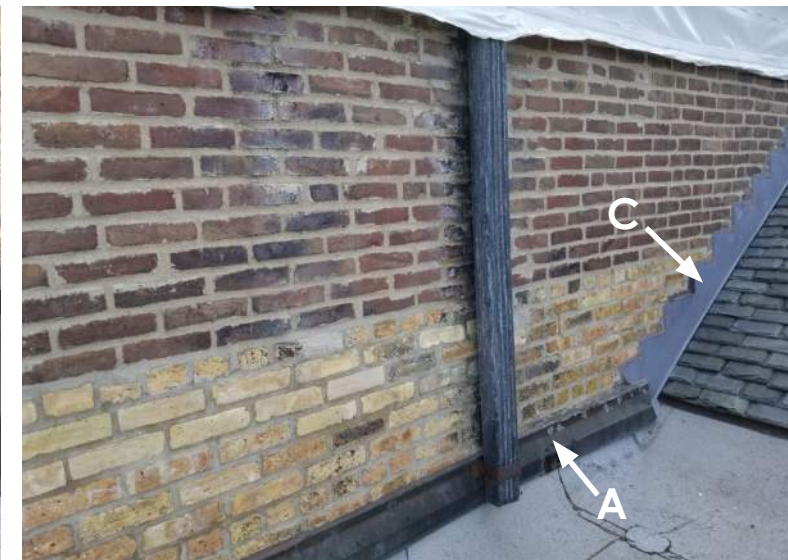
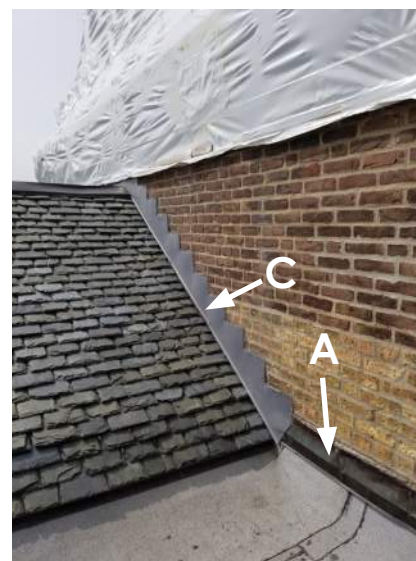
The masonry (brick) walls of the pedestal terminate three ways. On the East, South, and West elevations, the adjacent slate roof butts up to the pedestal wall and is flashed. On the North elevation, and for about 12-feet of the East and West elevations, the flat roofing system terminates against the pedestal wall and is flashed. On the South elevation, two small sections of brick wall continue all the way down to the grade.

Dome flashing at flat roof

Flashings at west side of dome

Flashings at east side of dome

1. Remove and replace all flashing sealants- color to match substrates.
2. Replace flashings with new copper flashings where visible to public.

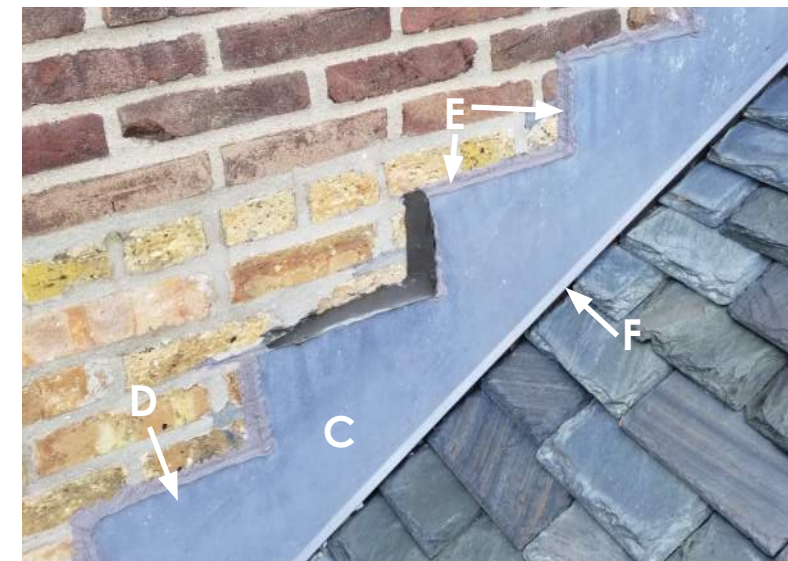
The flashings on the sloped slate roofs is a stepped galvanized flashing. The bottom leg of this flashing rests on the top faces of the sloped slate shingles and the top edge is stepped and tucked into the brick mortar joints. These reglet joints are filled with a similar urethane sealant which is also brittle and cracking the end edge of the stepped flashings, where they transition to the flat roof flashings, is just a hemmed, returned edge along the face of the brick. This edge is closed with a bead of sealant. It is not clear how the sloped slate roof waterproofing membranes terminates along the pedestal brick walls.

Stepped flashings at the sloped tile roofs

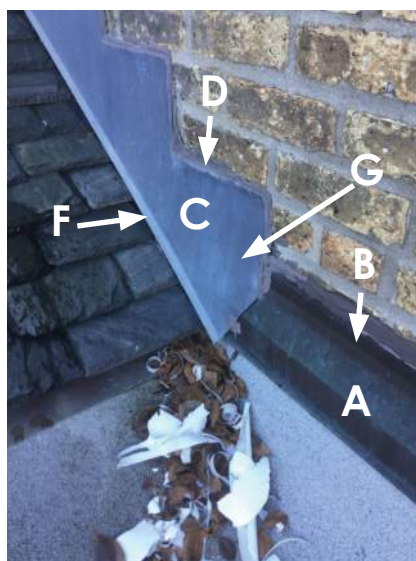
1. The sealants at all the roof flashings have reached the end their service life and are now cracking and separating.
2. Sealant color does not match the brick or the flashings.

Flashing transition at east roof junctures

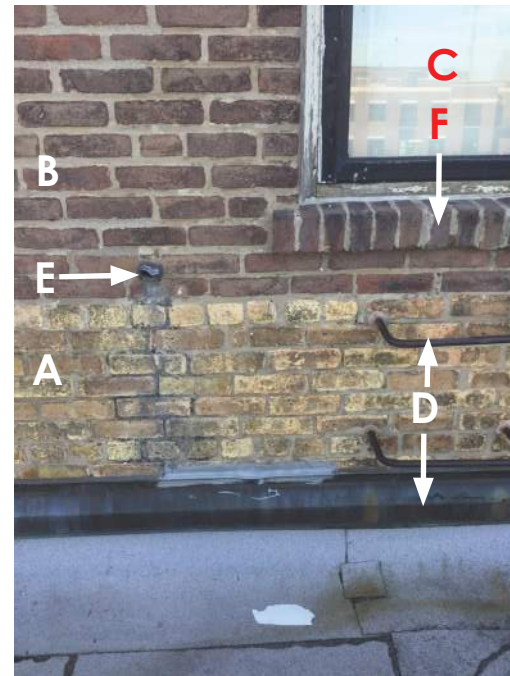
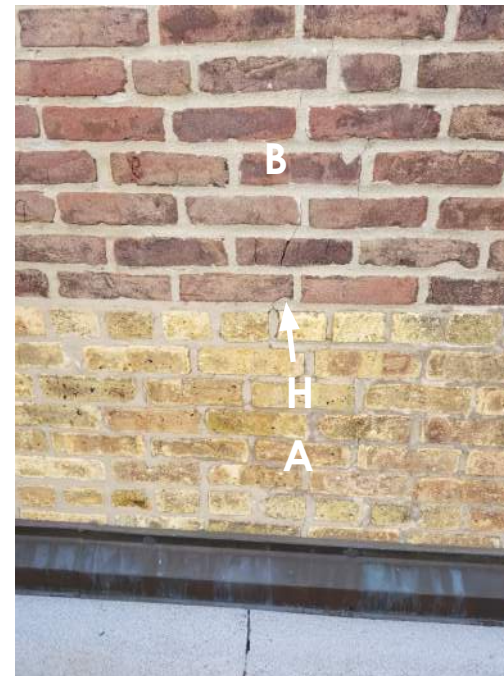
North elevation at entry door/window

- ▶ Compressible weatherstripping has been installed around the wood door.
- ▶ Sealant was observed at the joint between the wood frame and the masonry wall and sill. The sealant has separated from the surfaces and was also cracked and hard.

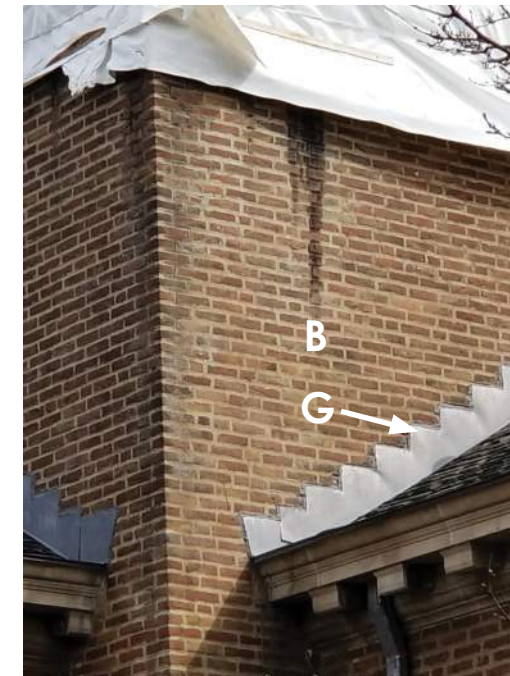
1. The sealants at all the roof flashings have reached the end of their service life and are now cracking and separating.
2. Sealant color does not match the brick or the flashings.

Stepped counterflashings at the northeast corner

1. Remove and replace all flashing sealants- color to match substrates.
2. Replace flashings with new copper flashings where visible to public.

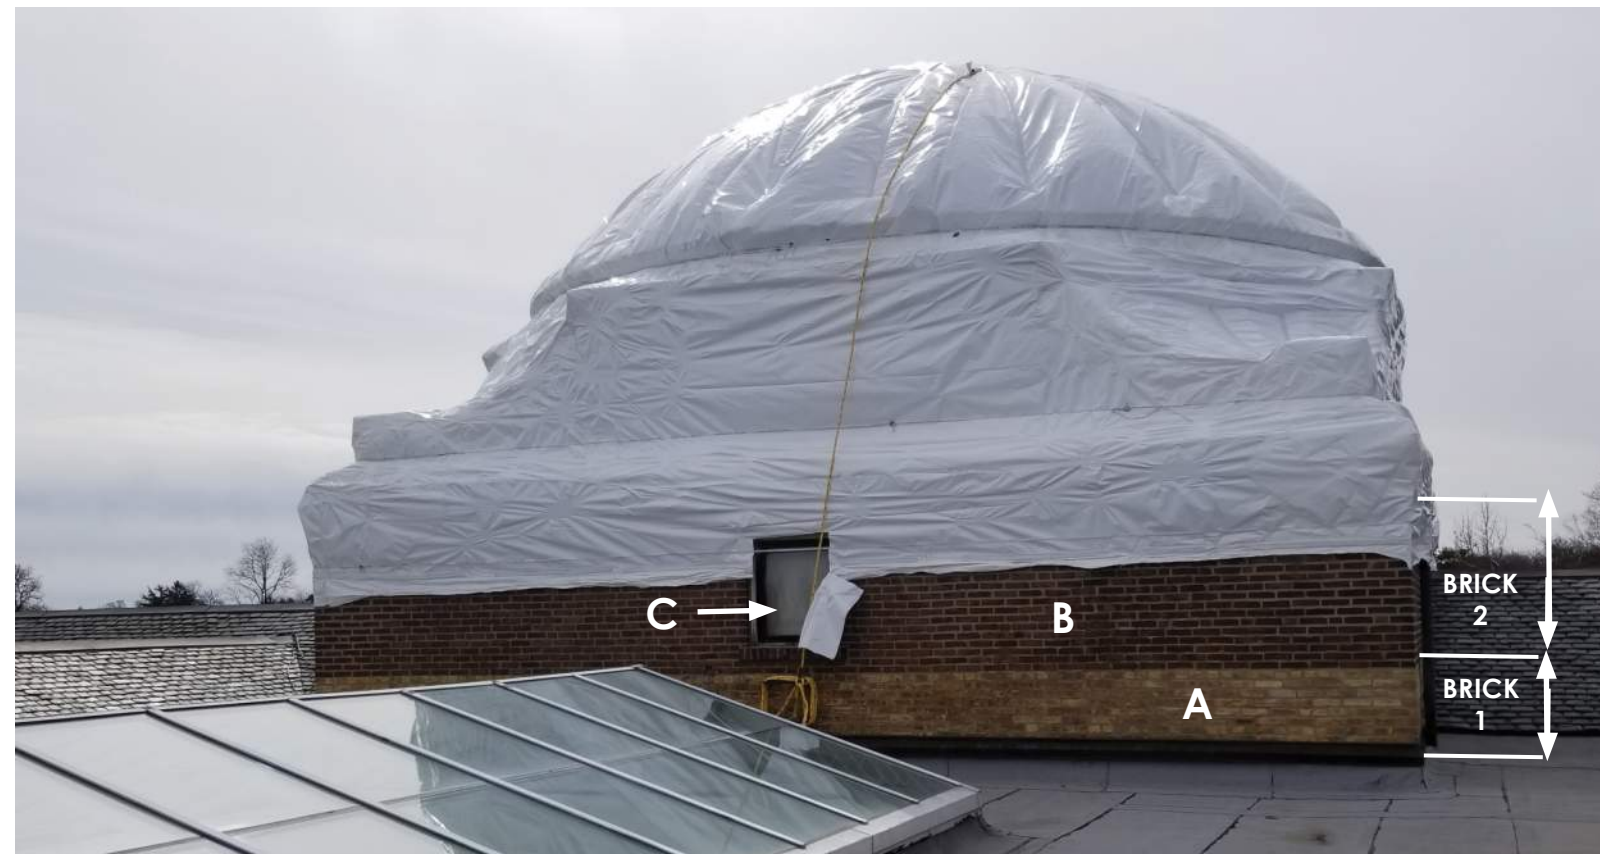
North elevation of the dome pedestal

- A. BRICK 1.
- B. BRICK 2.
- C. ATTIC OPENING - WOOD FRAMED DOOR WITH A NEWER ALUMINUM WINDOW WITH A CONTINUOUS HINGE THAT SWINGS OUT.
- D. REBAR RUNGS EMBEDDED INTO THE BRICK.
- E. SKYLIGHT CONDENSATE DISCHARGE PIPE. PIPE END IS DAMAGED AND IT IS NOT CLEAR IF IT IS FUNCTIONAL. STAINING ON BRICK BELOW SUGGESTS THIS MAY STILL DRIP WATER.
- F. BRICK SILL.
- G. STEPPED GALVANIZED COUNTERFLASHING WITH SELANT APPLIED TO TOP EDGES.
- H. CRACKED MORTAR JOINTS TO BE REPOINTED.

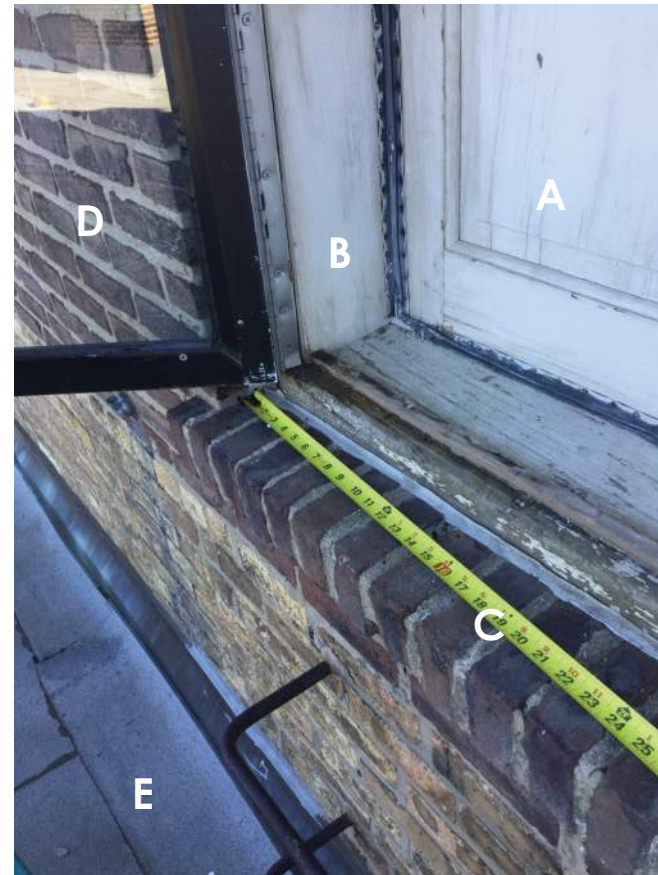
Exterior access door and rung ladder

1. Install new permanent catwalk system in attic, allowing access around the light shaft and to critical perimeter points.
2. Remove rebar rungs on the exterior brick and replace with new steps to access door on north facade.
3. Replace wood ladder in attic with compliant ship ladder stair.
4. Replace wood planks in attic with permanent walk system.

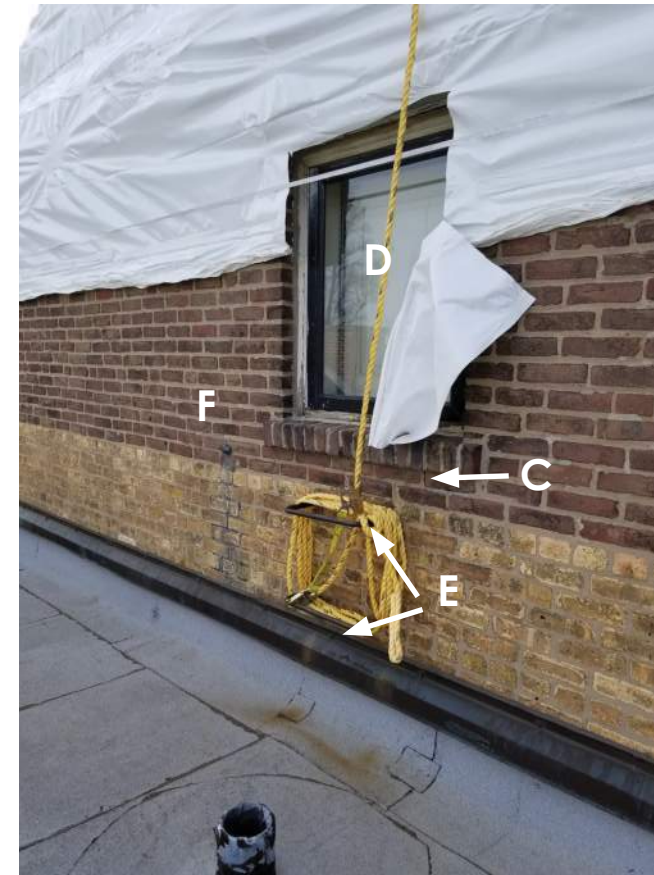
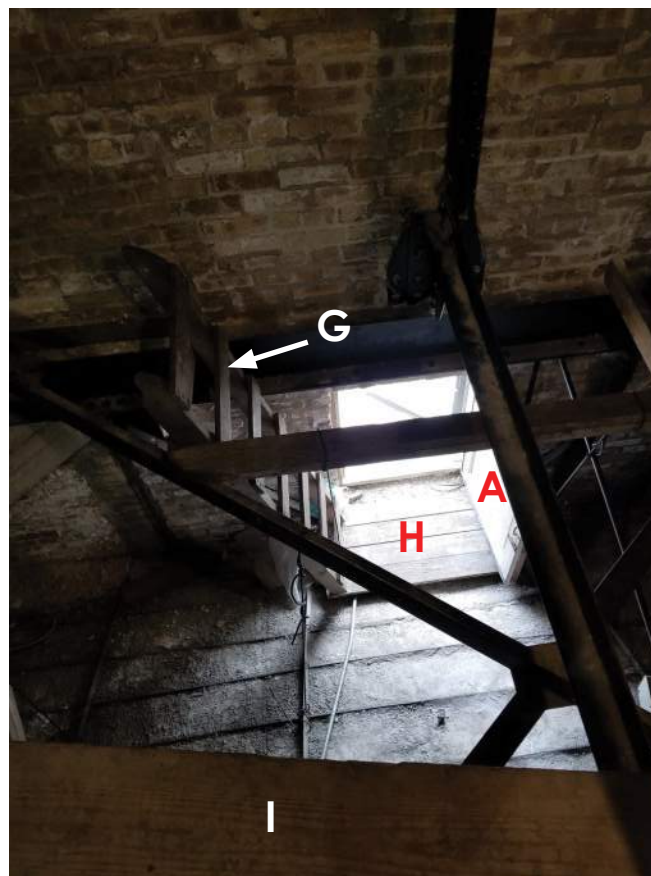
Exterior access door off north facade inside attic looking down to exterior access door

Inside attic looking down to exterior access door

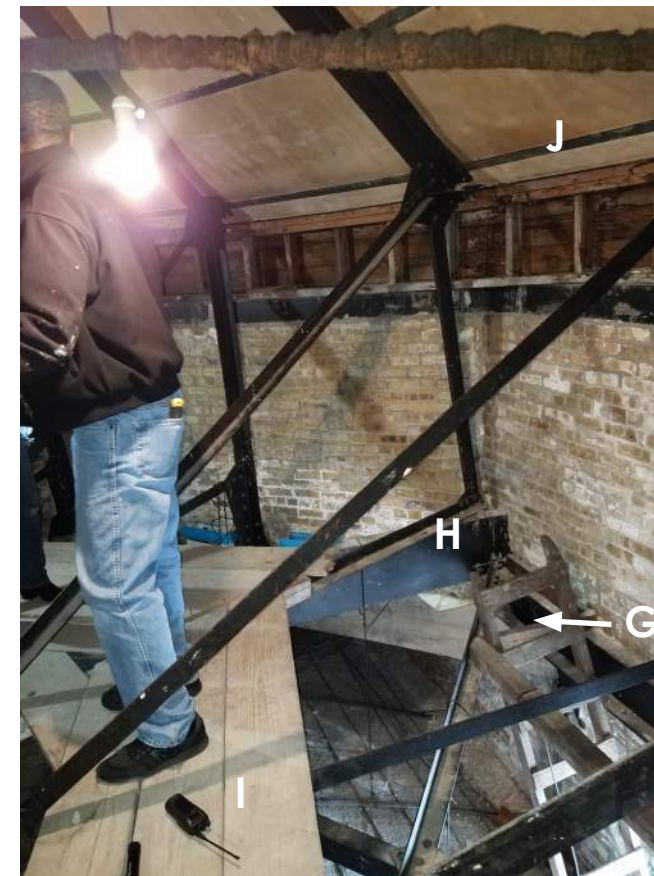
1. The wood ladder and loose laid 2x plank catwalk system is not OSHA compliant.

Inside attic looking at ladder to truss beam
