Lake Forest Library Feasibility Report

4.0 Condition Assessment

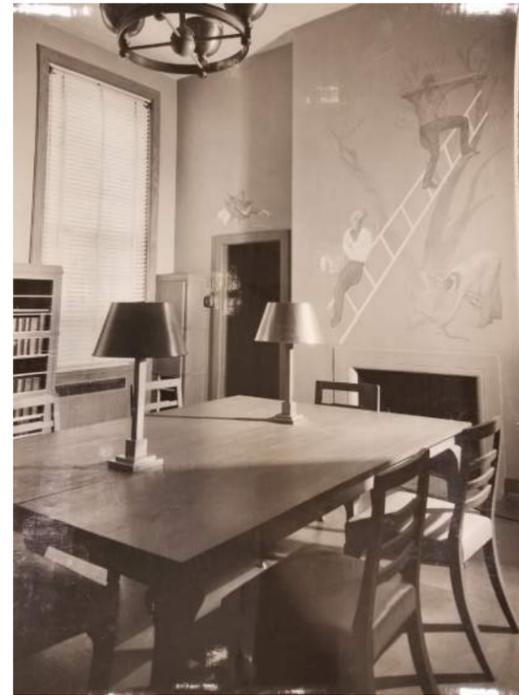
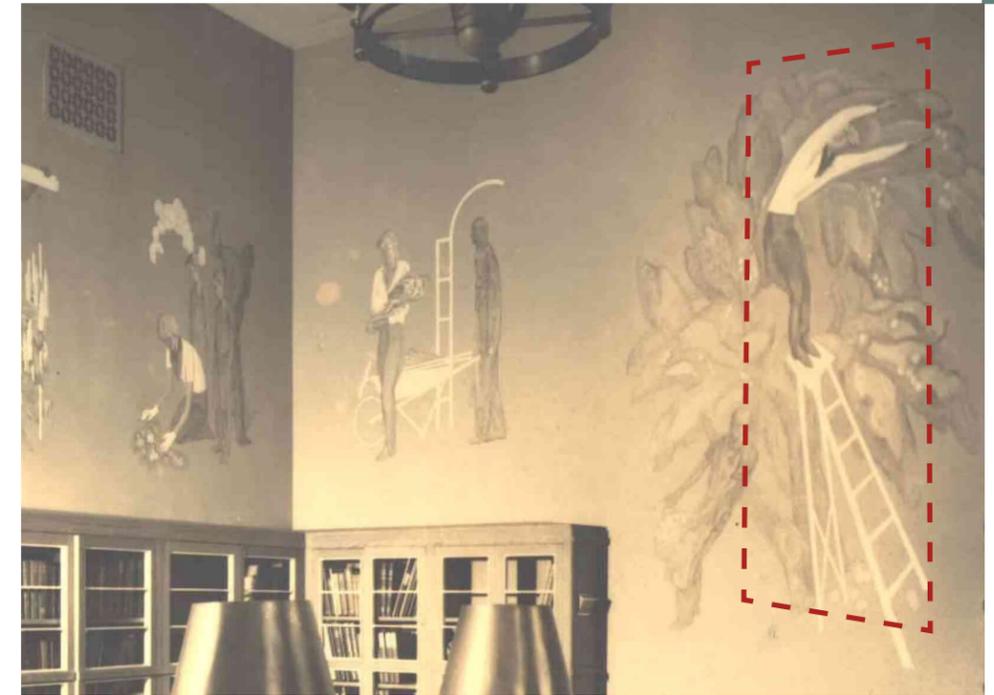
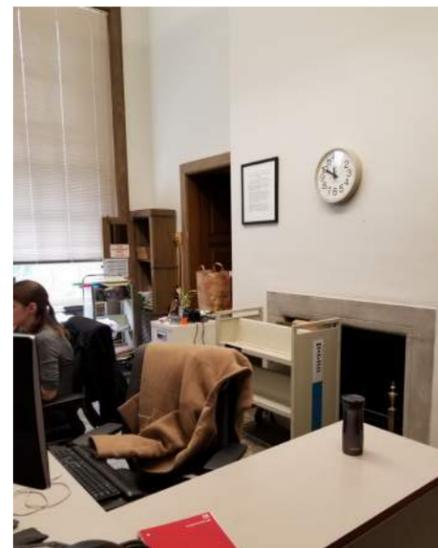
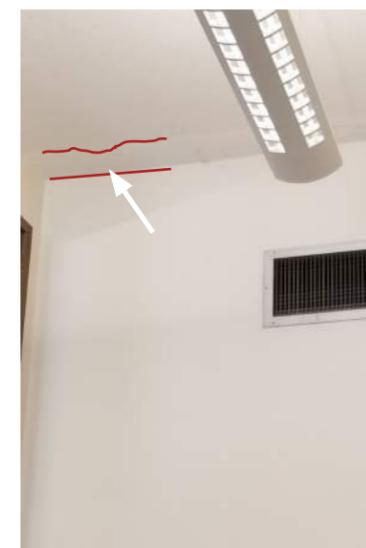
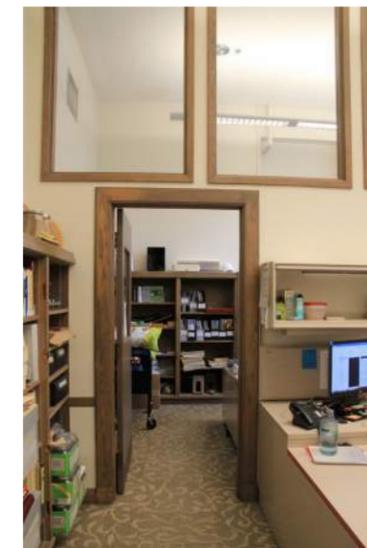
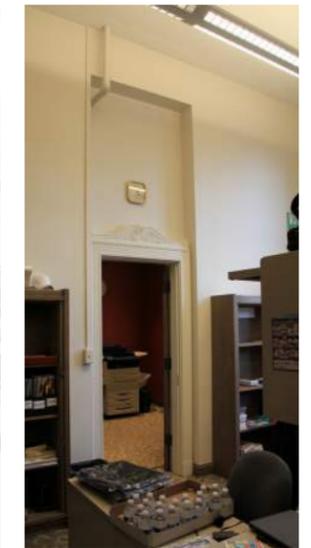
The murals have been painted over and the former "Garden Room" has since lost most of its historic character. The original 4-lamp chandelier and bookcases have been removed and a contemporary partition with glazed panels along the top of the wall divides the room into two small office spaces.

In spite of these alterations, restoration of this room is possible. The fireplace surround is original. Traces of a low relief plaster ceiling border, visible at the perimeter, provide information on the width of the removed feature. Although one of the larger scenes is not recoverable, corresponding to the location of the north wall door opening (shown dashed), other sections could potentially be salvaged with careful conservation.

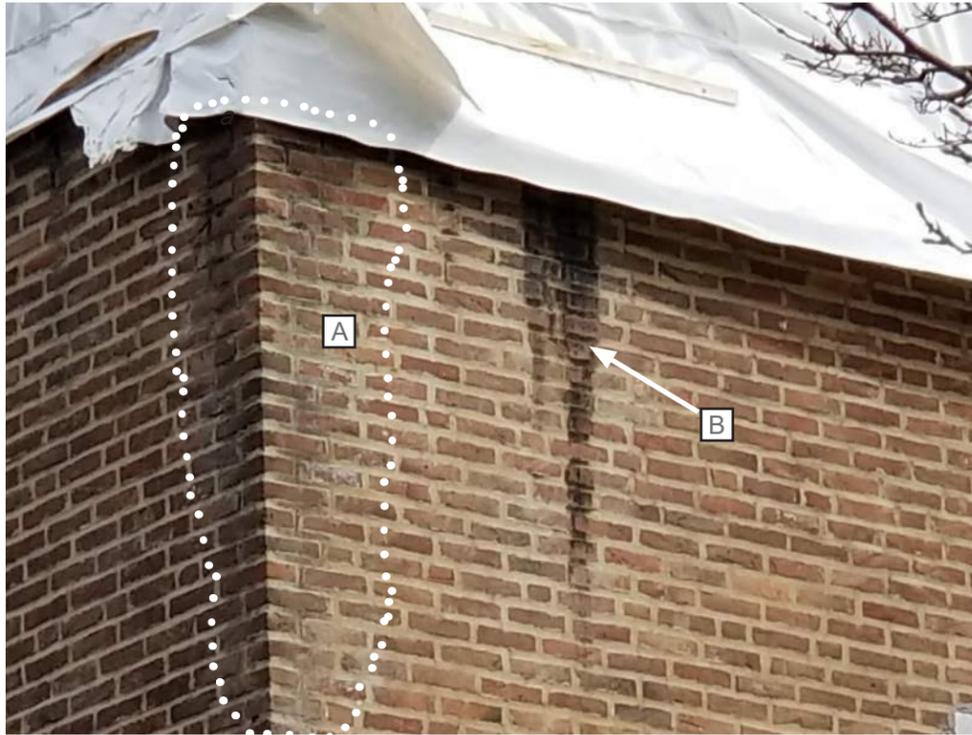
DOMESTIC PEDESTAL

The dome is constructed on top of a brick masonry pedestal that matches the color and coursing of the main building wings. The pedestal is square in plan with no distinguishing architectural features.

- ▶ A. DETERIORATION AT SW CORNER APPEARS TO BE EROSION. THE CAUSE OF FOCUSED WATER RUN-OFF IS UNKNOWN AT THIS TIME.
- ▶ B. DARK STAINING OF UNKNOWN ORIGIN
- ▶ NO PROVISIONS FOR EXPANSION

Determine cause for focused water run-off. Spot clean and repoint pedestal masonry

REPAIR PRIORITY - **C**

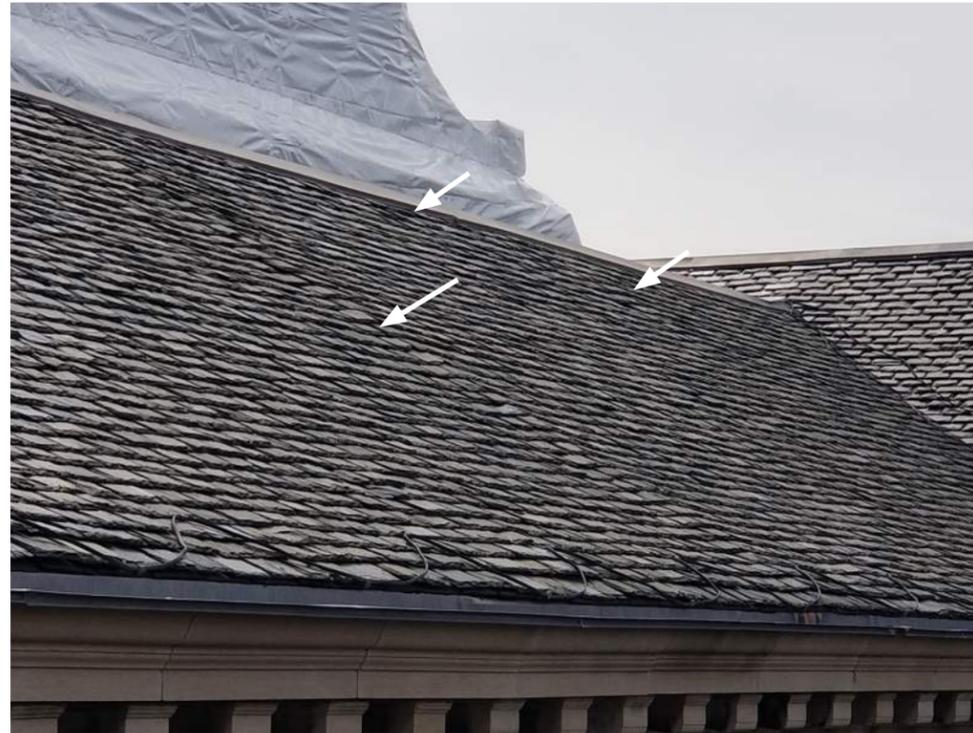
SLATE ROOF - NORTH WING

Original slate tiles were removed and reinstalled. The slate tiles appear to be in good condition. These are traditional tiles with a thicker dimension (1/2"-3/4") than the standard tiles typically manufactured today (3/16"). High quality hard slate can last 150-200 years. It is unclear how much of the substrate was repaired or replaced.

- ▶ SLATE TILES DO NOT LAY FLAT
- ▶ A PRONOUNCED HUMP IS NOTED AT THE MIDPOINT OF THE ROOF

REPAIR PRIORITY - **D**

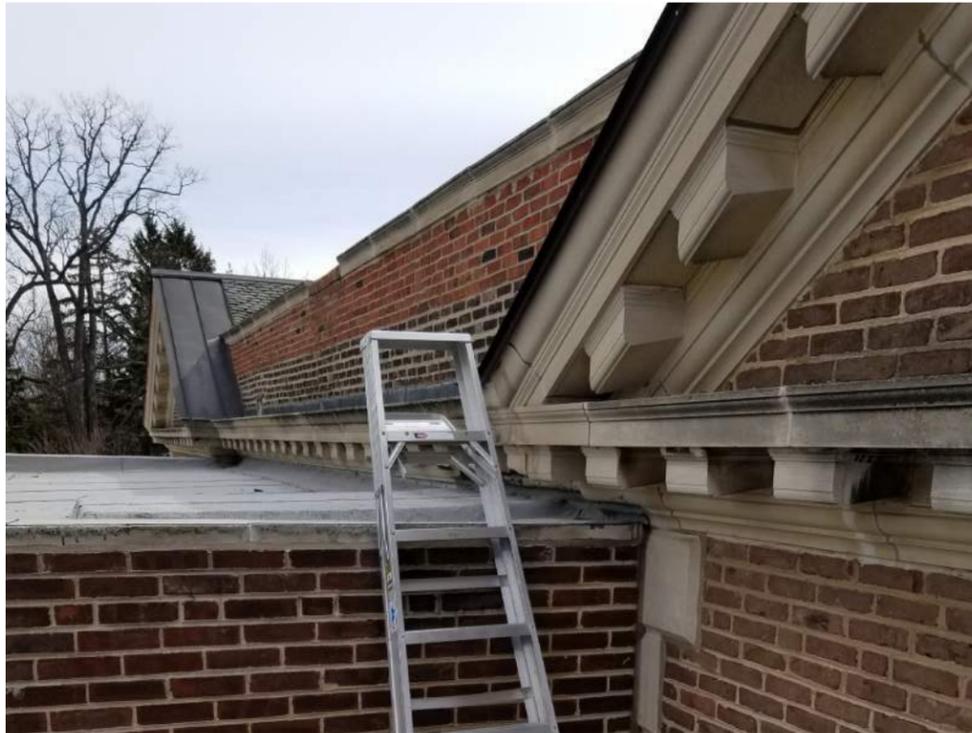
NORTH WING- ROOF ALTERATIONS

The original north wing roof was removed in 1978. The new roof elevation is slightly higher than the original. Seven courses of new red brick above the original north wing parapet demonstrate different construction periods.

REPAIR PRIORITY - **E**

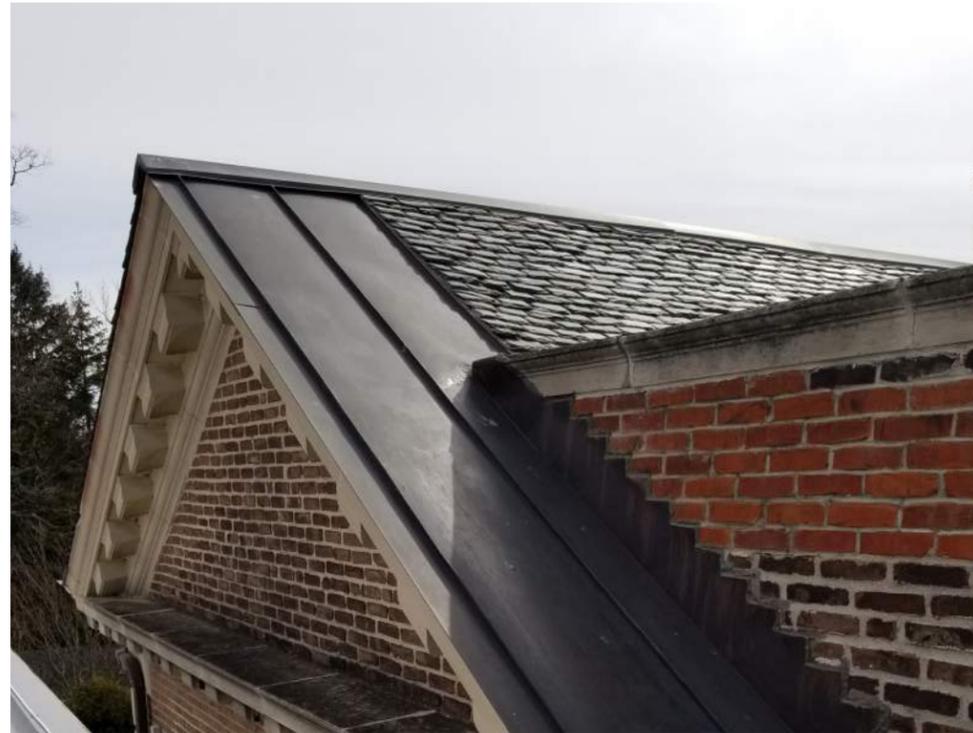
NORTH WING- ROOF ALTERATIONS

Roofing materials at the gabled portions of the north wing have been altered, possibly to facilitate the transition between "new" and original construction.

- ▶ THE FIRST FEW FEET OF SLATE ON THE INSIDE FACE OF THE GABLE HAVE BEEN REPLACED WITH STANDING SEAM METAL PANELS.
- ▶

No work required at this time.

REPAIR PRIORITY - **E**

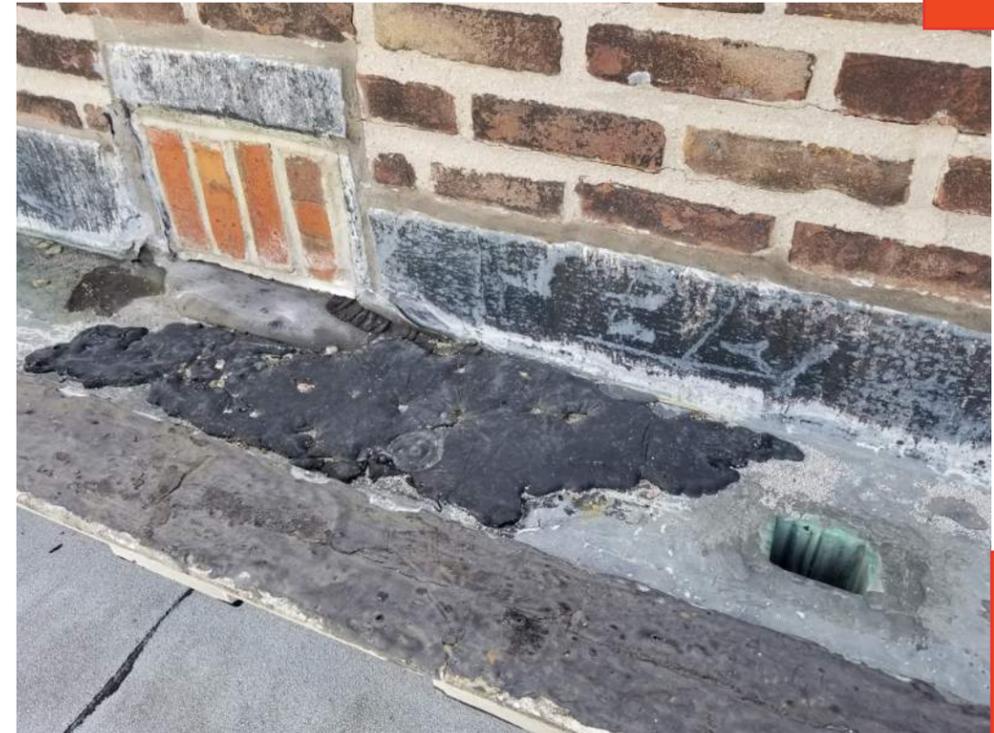
NORTH WING- ROOF ALTERATIONS

Roofing is for the most part in serviceable condition, however, there are isolated areas where the intersection of different systems, long with ad hoc repair, create a higher probability for water infiltration.

- ▶ CONVERGENCE OF ROOFING SYSTEMS W/ NON-COMPATIBLE PATCH REPAIR
- ▶ ALTERED DRAINAGE SYSTEMS
- ▶ NO DRAIN BASKET

Monitor area for leakage, remove non-compatible patch repair, add drain basket

REPAIR PRIORITY - **D**

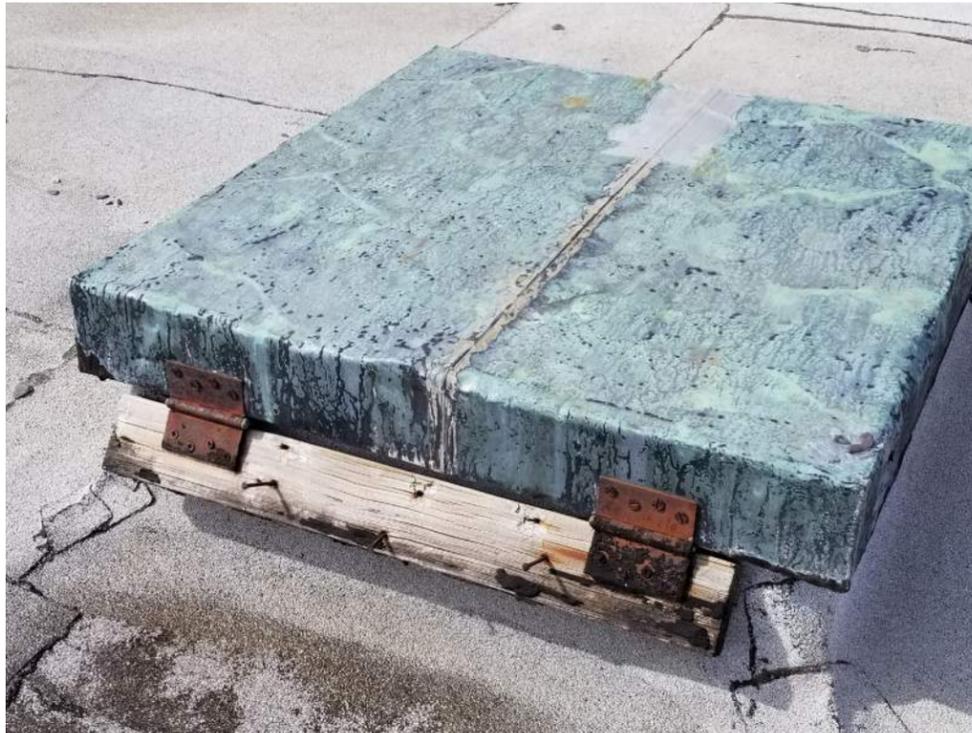
NORTH WING

Copper clad roof hatch - although serving its purpose, the installation detail could be improved

- ▶ NAILER BOARD IS UNTREATED, AS A RESULT WOOD IS DRY AND UV DAMAGED
- ▶ NAILS ARE NOT HAMMERED FLUSH, CREATING A POTENTIALLY HARMFUL CONDITION
- ▶ NAILER IS FASTENED THROUGH CAP FLASHING, CREATING POTENTIAL AVENUE FOR WATER INFILTRATION

REPAIR PRIORITY - **D**

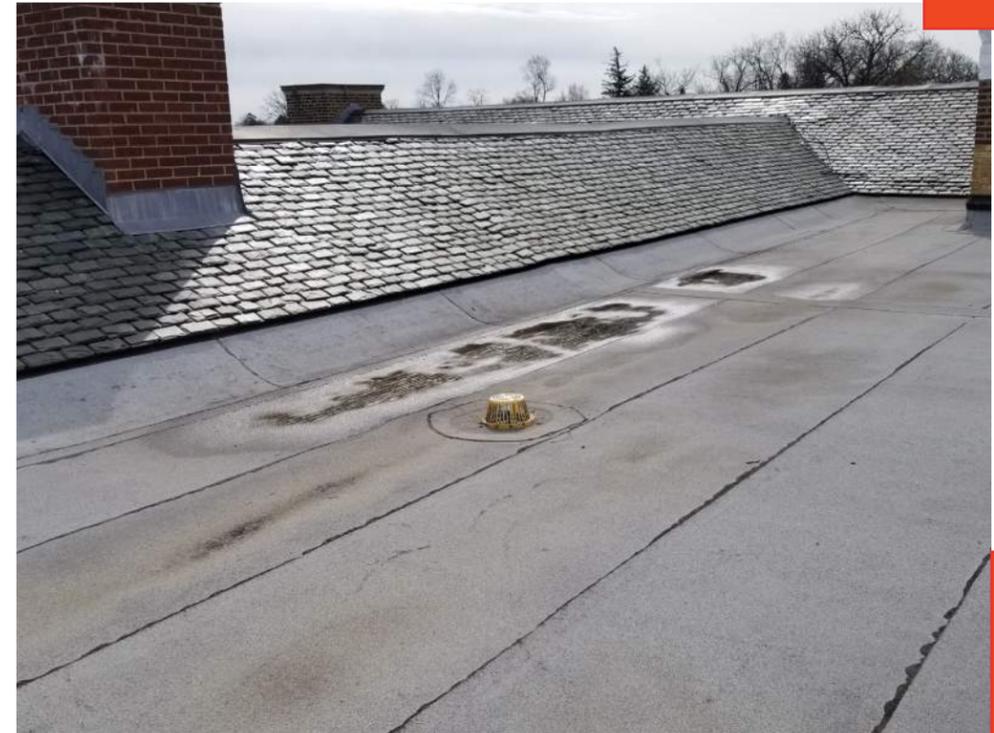
FLAT ROOFING MATERIALS

Low slope roofing is covered with granulated cap sheet.

- ▶ INADEQUATE SLOPE- PONDING SEVERAL FEET AWAY FROM ROOF DRAIN

Inspect roof annually.

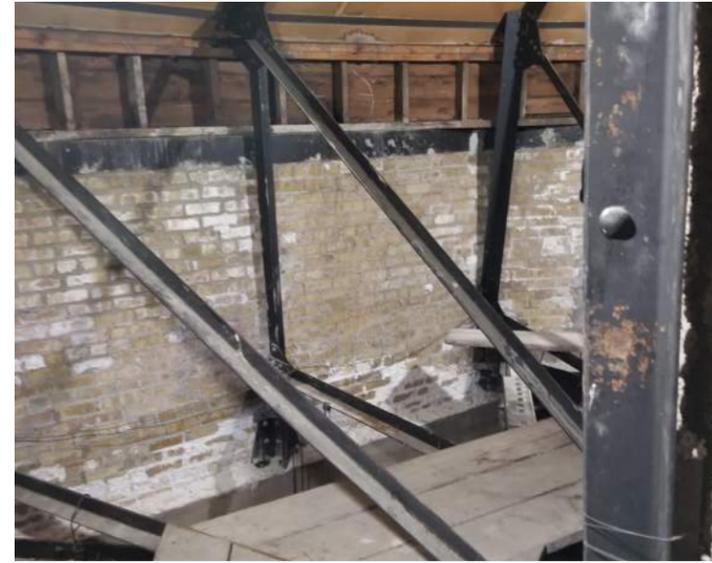
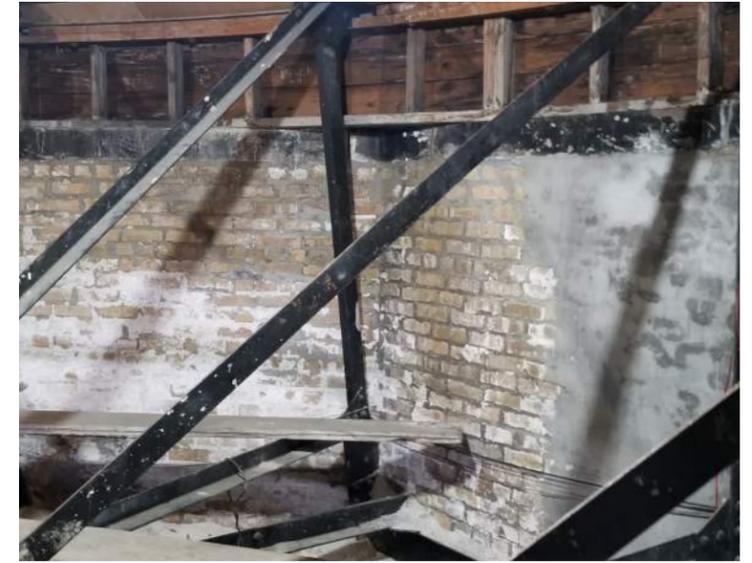
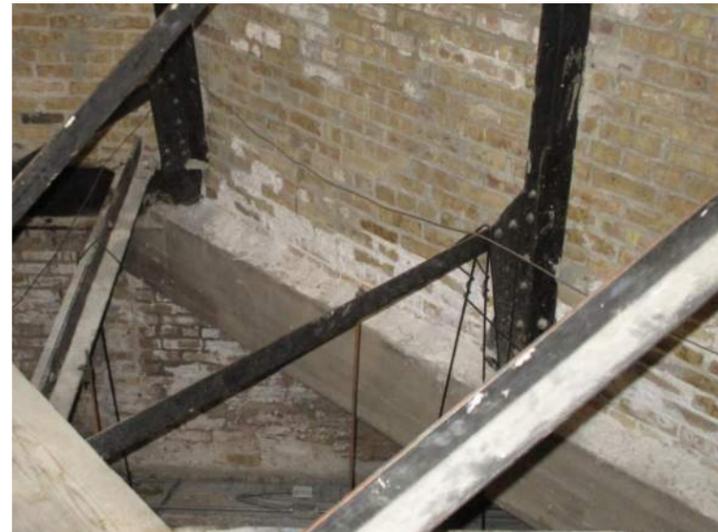
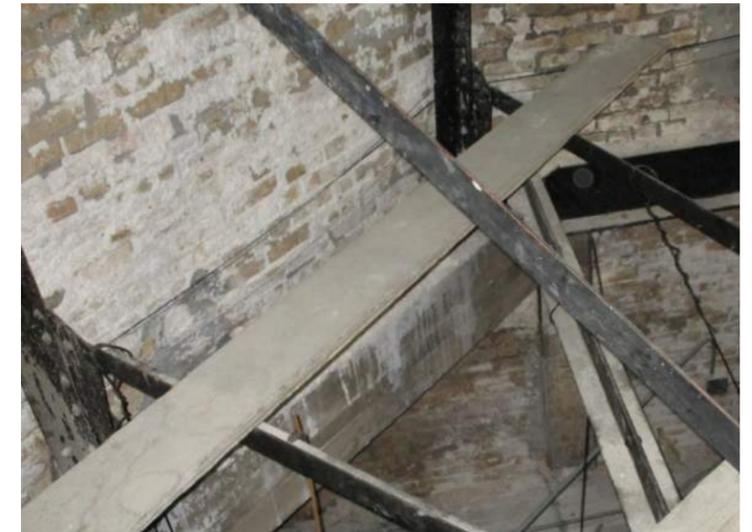
Current condition of the inside face of the dome pedestal observed from the attic space above the rotunda. Extensive efflorescence corresponds to locations near roof system transitions. Signs of prolonged water infiltration, including areas of heaviest accumulation of efflorescence, occurs adjacent to sloped corners.

Attic- The attic space above the rotunda is accessible from the north wing roof through a small hinged panel on the north wall of the pedestal. The inside face of the brick pedestal wall is unfinished. Large areas of thick, white, powdery efflorescence are noted throughout. Efflorescence is most severe toward the base of the wall, a zone located 15-17 courses below the top of the masonry wall. Although some moderate water damage to the wood framed upper section of the wall is noted, there are no obvious signs of deflection, splitting or evidence of severe deterioration to suggest that structural integrity is compromised.

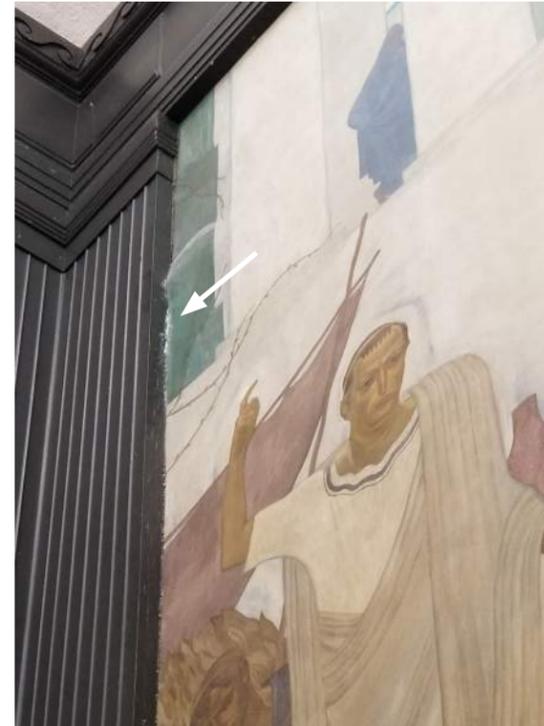
Panel V- loose edge, friable substrate at upper (L) corner.

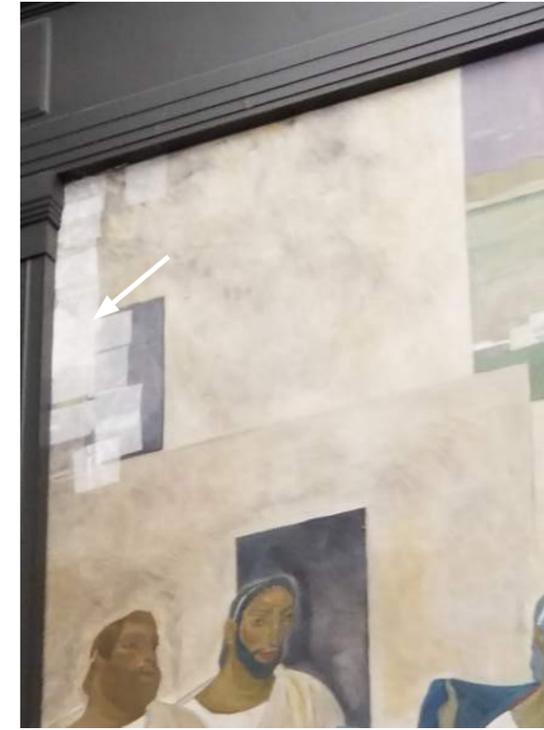
- ▶ Panel III. Greek dramatists Aeschylus, Aristophanes, Sophocles, and in the foreground, Euripides (SW corner of the rotunda)- several surface patch repairs at upper (L) corner.
- ▶ Panel IV. Roman epic poet Virgil, pictured with a waning moon (SW corner of the rotunda)-
- ▶ Panel V. Roman orator Cicero in the Roman marketplace with statesman, philosopher, and writer Seneca (SE corner of the rotunda)- loose edge, friable substrate at upper (L) corner.
- ▶ Panel VII. Greek philosopher Diogenes with philosophers Aristotle and Socrates (NE corner of the rotunda)- horizontal wrinkle in the canvass at panel midpoint

Panel III- patch repairs at upper (L) corner.

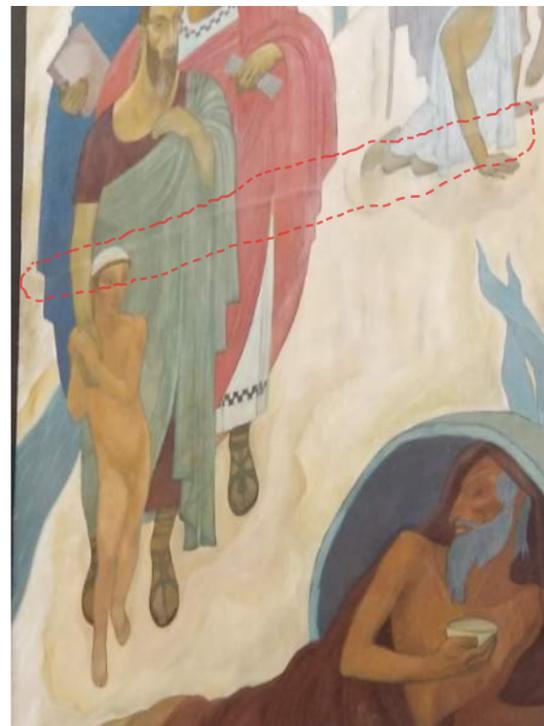
Panel VII- horizontal wrinkle in the canvass at panel midpoint

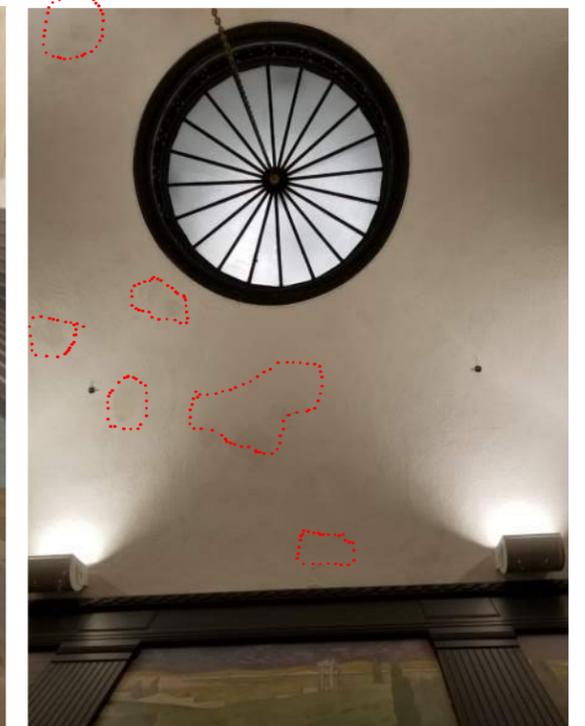
Plaster ceiling staining (viewed facing west wall) occurs on the south side of the room and which corresponds with observed mural damage.

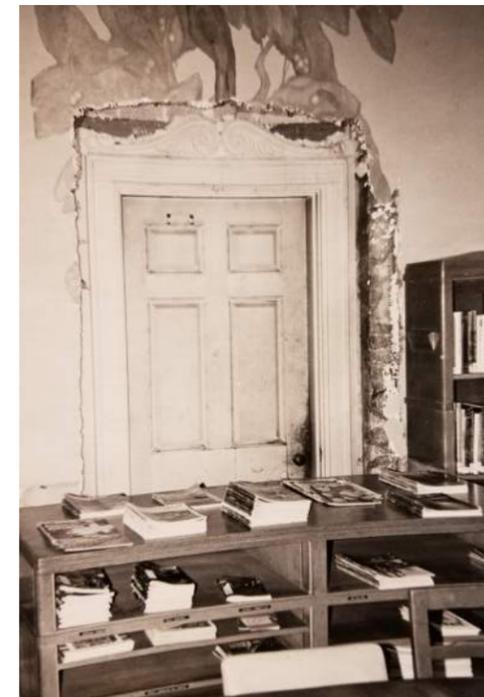
North wall - door was added later, probably when the Garden Room was converted to a music room. Insertion of the door destroyed portions of the mural.

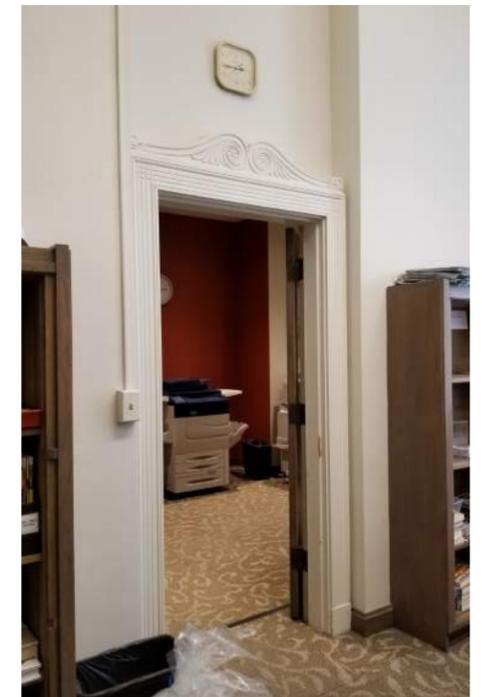
Current condition of the original north wall. Opening height was increased, destroying the rest of the large central north wall mural.

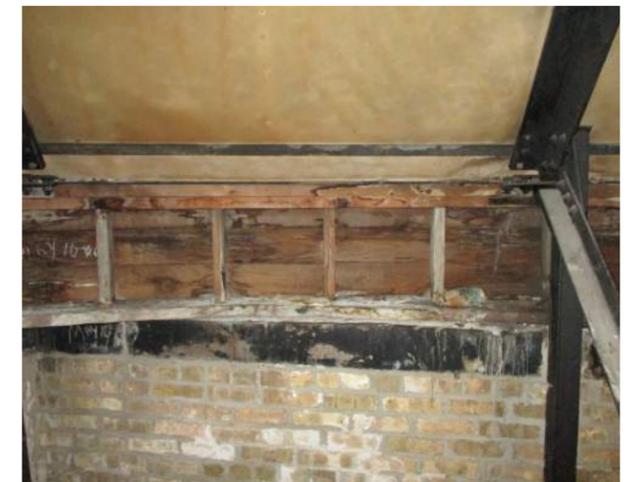
Poor condition of wood cricket wall below dome structure

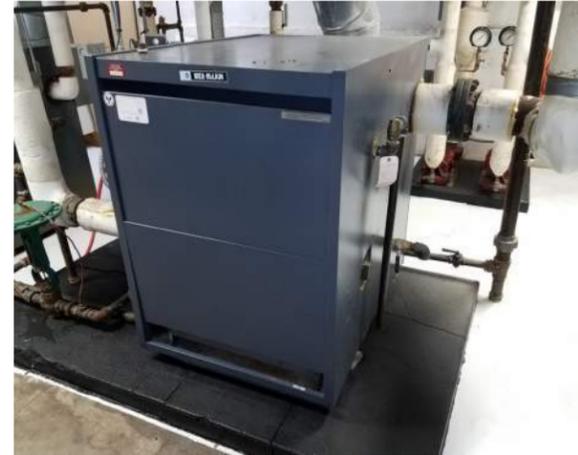
Steam Boiler

1. The steam boiler is not original to the building. The present boiler appears to be in good condition with years of useful life left.
2. The steam boiler condensate feed unit appears to be in fair condition.
3. The steam condensate transfer unit appears to be in fair condition.

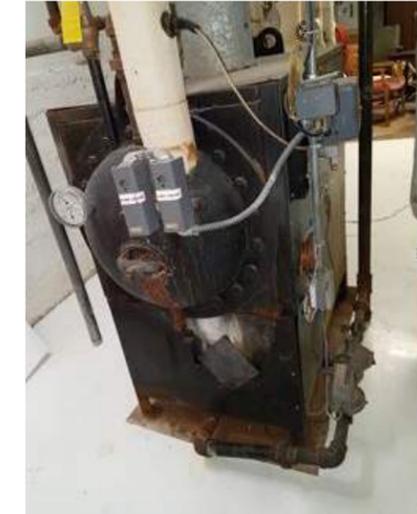
Original Hot Water Boiler

1. There are two hot water boilers. One appears to be original to the building and reached its useful life. The other boiler is not original to the building and appears to be in fair condition. Each boiler is a separate system. They appear to not be combined into a one system.

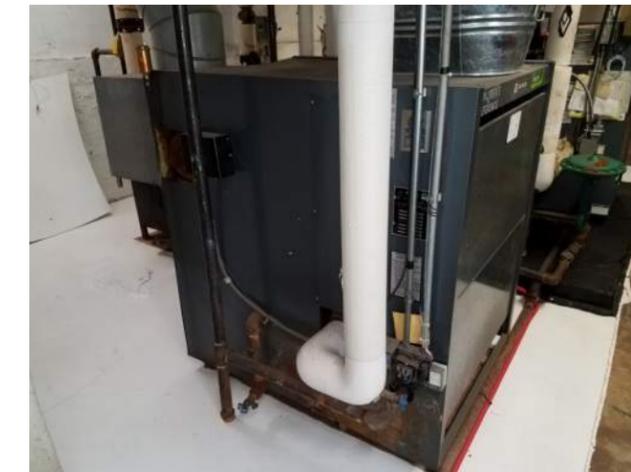
Slightly Newer Hot Water Boiler

2. Each hot water boiler system includes two end suction base mounted circulating pumps. These pumps are constant speed and appear to be in fair condition.

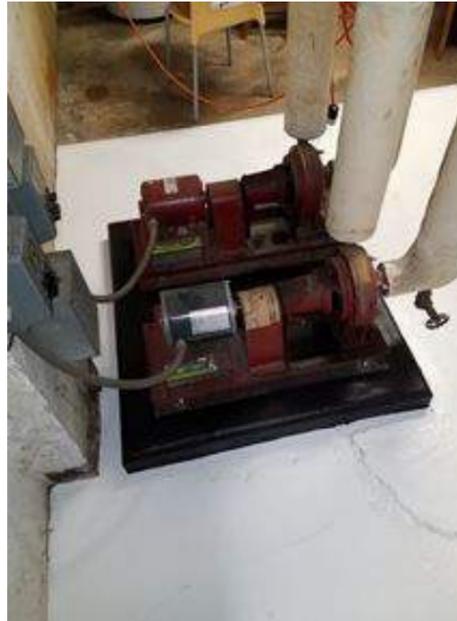
One set of hot water pumps

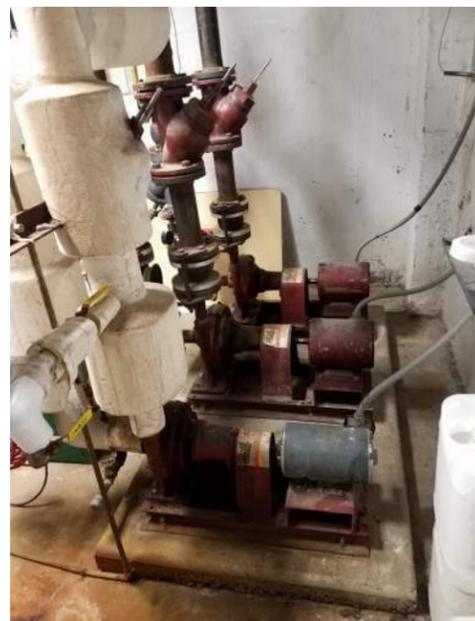
Second set of hot water pumps and chilled water pump

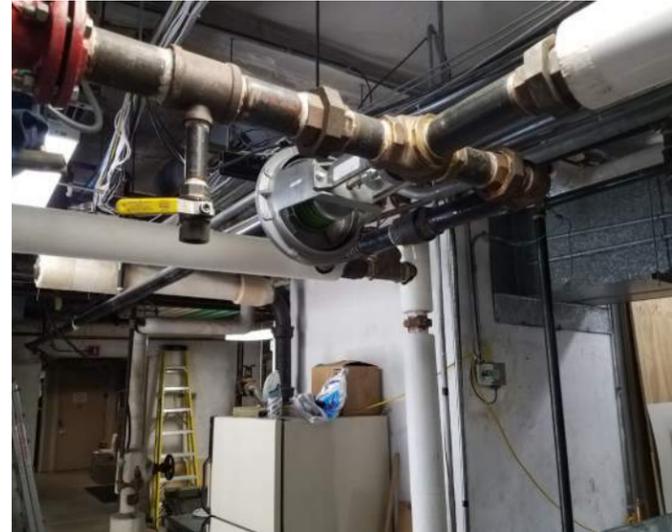
3. The hot water piping distribution system appears to be in fair condition. Pipe insulation is in fair condition.

Piping missing insulation

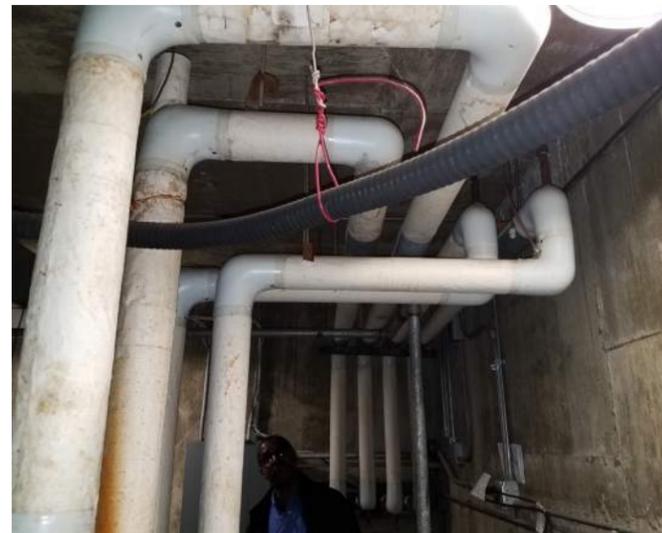
Typical condition of pipe insulation

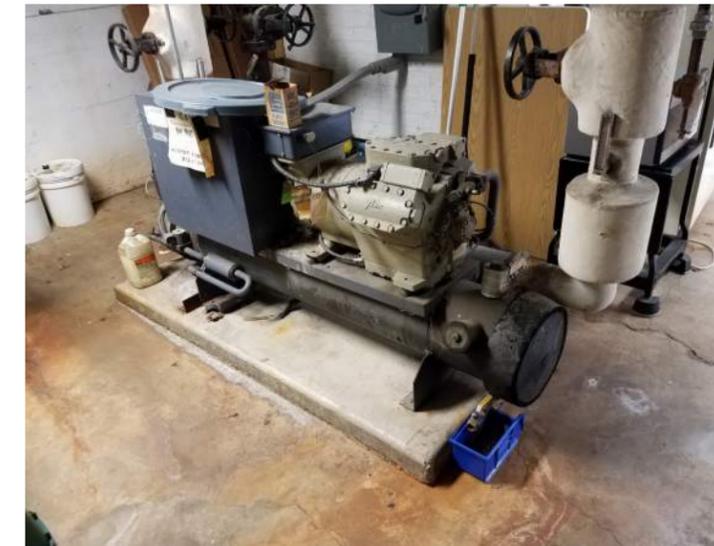
1. There is a single water cooled reciprocating chiller serving three chilled water coils in air handling units. The chiller appears to be in good condition with exception of its age, corresponding refrigerant used most likely being a banned refrigerant and poor efficiency. The operating efficiency of this chiller most likely does not meet present energy code requirements. The chiller is served by a single pump (shown in previous picture).

Trane water cooled chiller

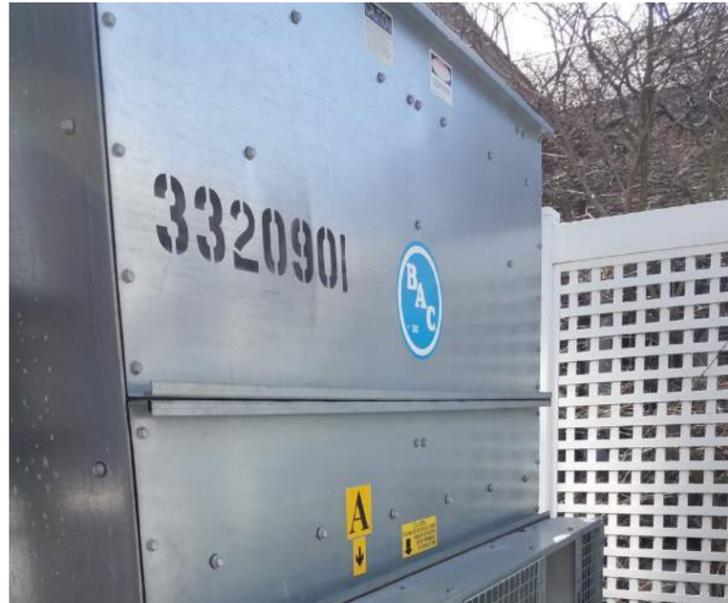
2. The chiller is served by an outdoor closed circuit fluid cooler (cooling tower). The cooling tower appears to be fairly new and in good condition. This unit should have many years of useful life to come.

Cooling tower and air cooled condensing unit

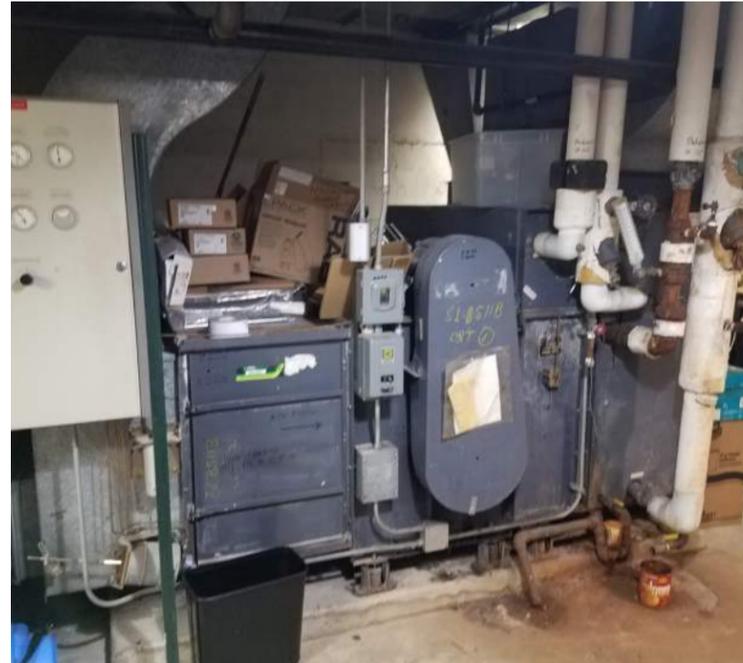
3. The three air handling units served by the chiller that appear to be original to the building and have reached their useful life. One air handling unit is a multi-zone unit.

Multi-zone air handling unit with hot and chilled water piping connections.

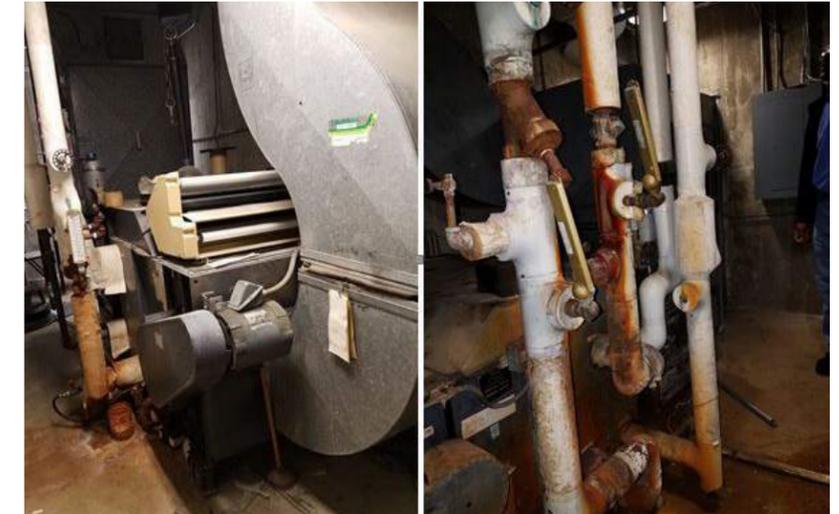
Single zone air handling units with hot and chilled water piping connections

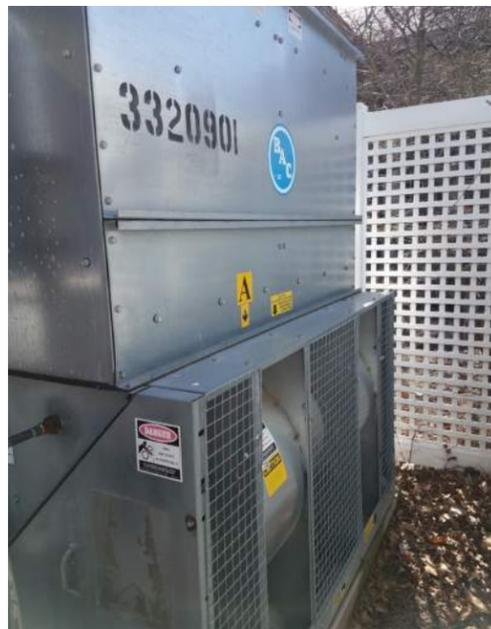
Cooling tower

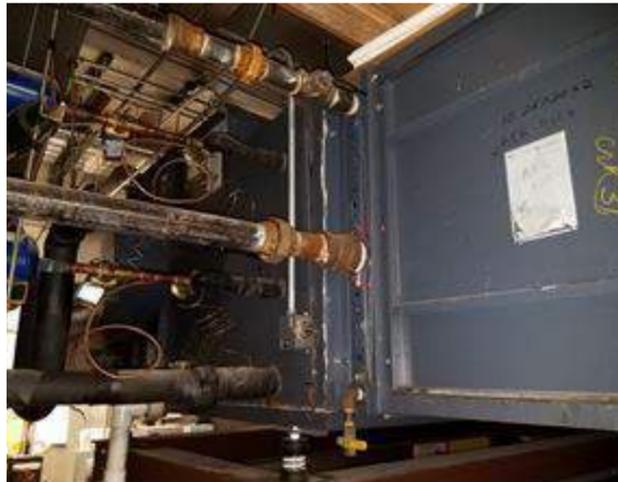
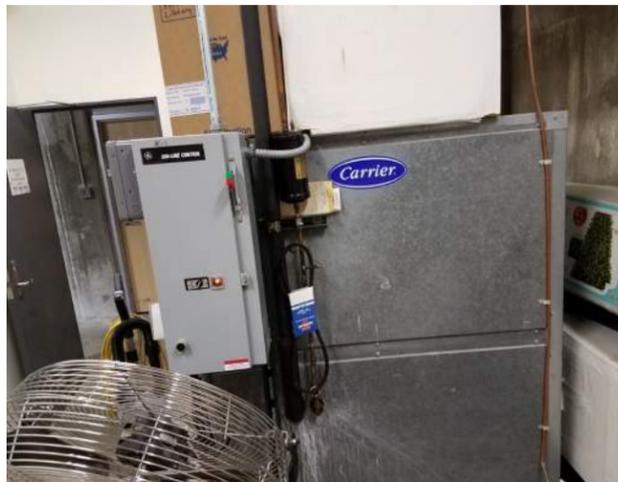
1. There are several air handling units with direct expansion refrigerant cooling coils served by respective air cooled condensing units. The units were installed when Additions to the building were constructed. The units are original to their respective additions. Some units appear to be fairly new in good condition and some units have reached their useful life.

Typical AHU's with DX cooling coils. One old and one fairly new

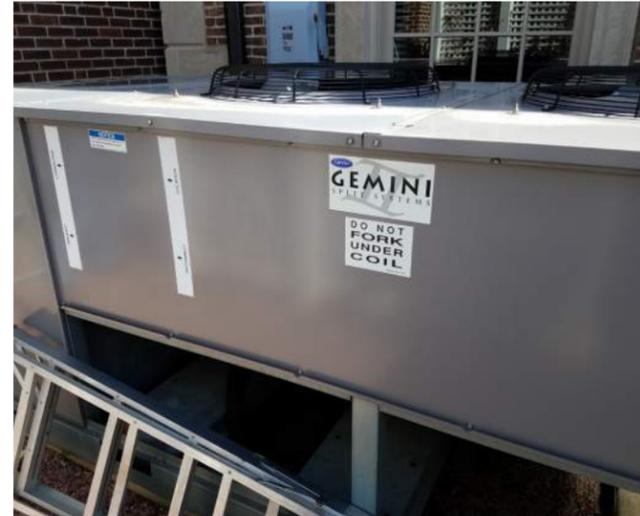
2. The air cooled condensing units serving air handling units are not original to their respective additions and appear to be in good condition. (see previous picture of air cooled condensing unit with cooling tower)

Large capacity air cooled condensing unit (unit shown in previous picture with cooling tower)

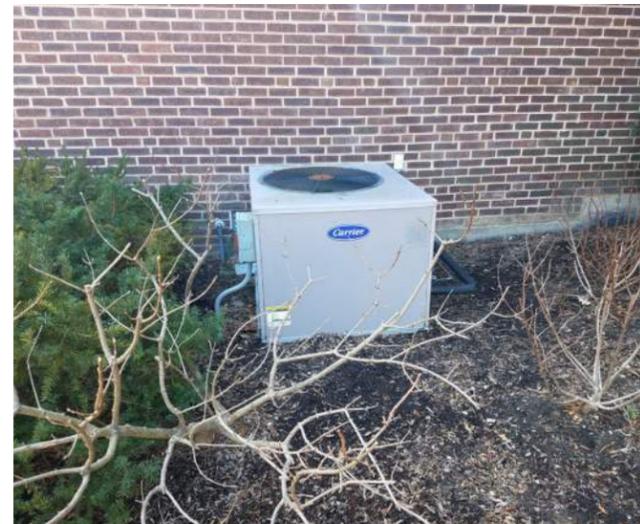
Smaller capacity air cooled condensing unit

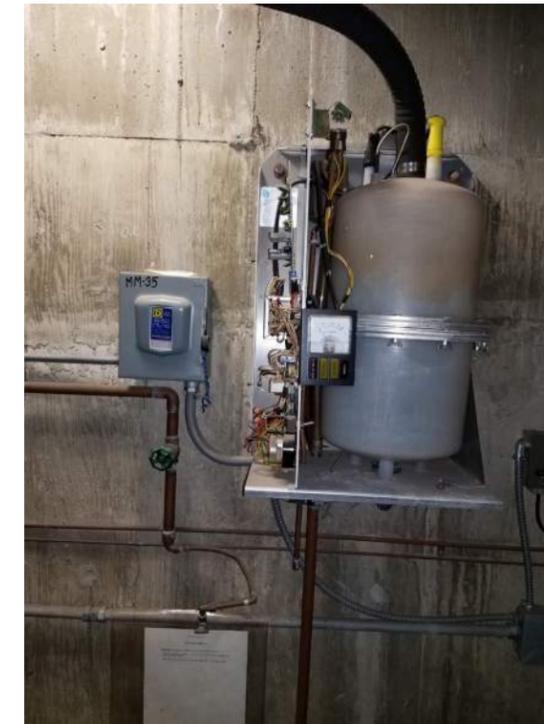
1. The building used to have humidification. There are one or more humidifiers that are in dis-repair and abandoned in place. Humidifiers were electric powered, canister type.

Canister type humidifier abandoned in place

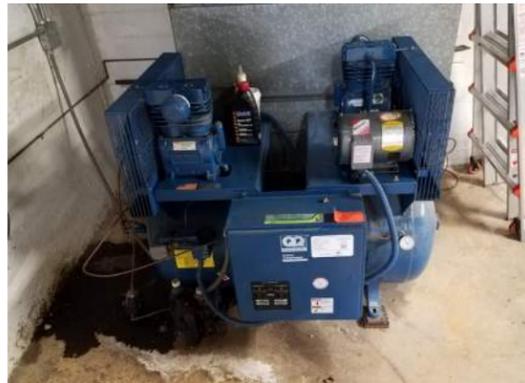
1. Most of the temperature control system in the building is pneumatic with some electric controls. The pneumatic controls consist of an air compressor, control panels, pneumatic control air tubing, and pneumatic damper and valve actuators. Pneumatic controls are an out of date obsolete technology. Pneumatic controls are no longer used in new building construction due to inability to meet present energy code requirements.

Pneumatic control air compressor in good condition

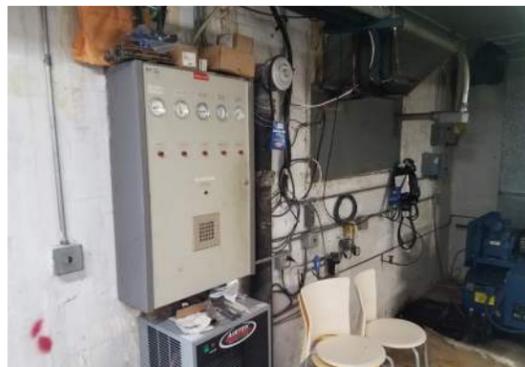
Typical pneumatic temperature control panel

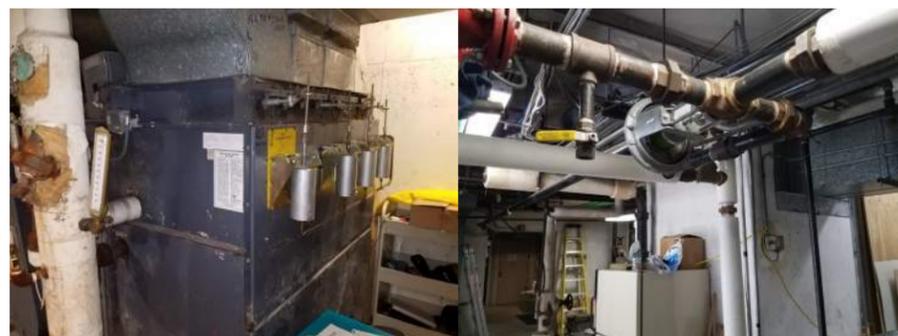
Typical pneumatic damper actuators on AHU Three way pneumatic control valve

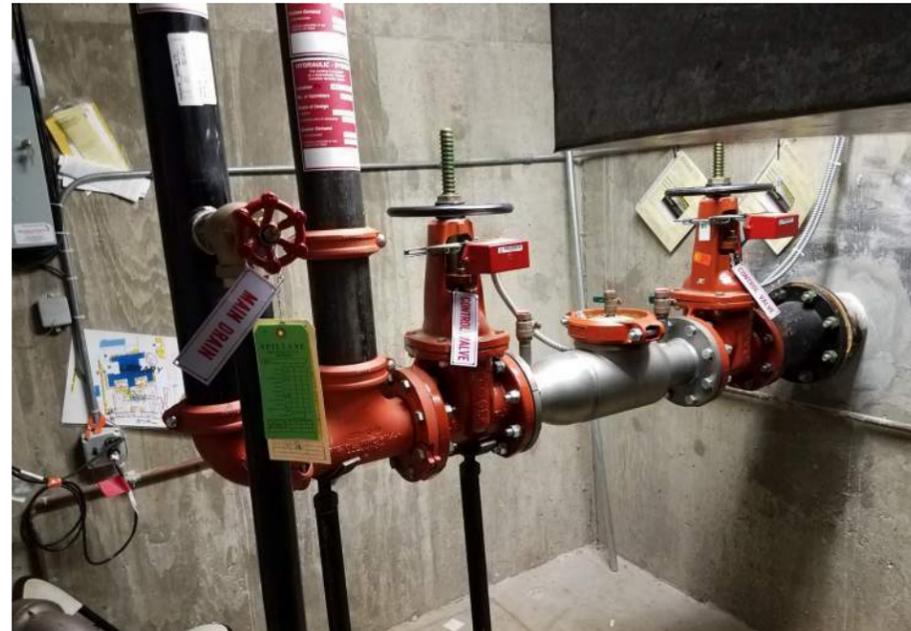
Fire protection service entrance

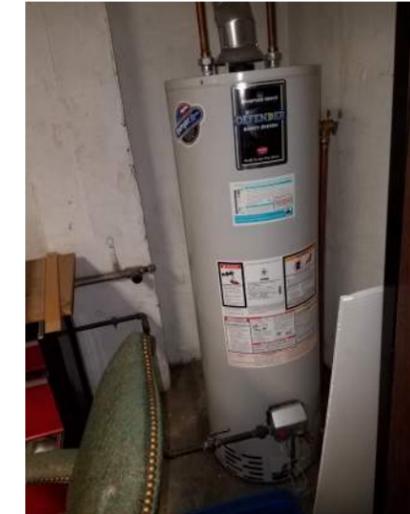
4. There are two domestic water heaters serving this building where both are not original to the building. They both appear to be fairly new and in good condition. One unit is a 40,000 btuh natural gas fired unit with 40 gallon storage capacity. The other unit is 40,000 btuh natural gas fired unit with 50 gallon storage capacity. The 50 gallon unit also has a dedicated domestic hot water circulating pump that keeps hot water in the piping close to fixtures.

40 gallon, 40,000 btuh gas water heater

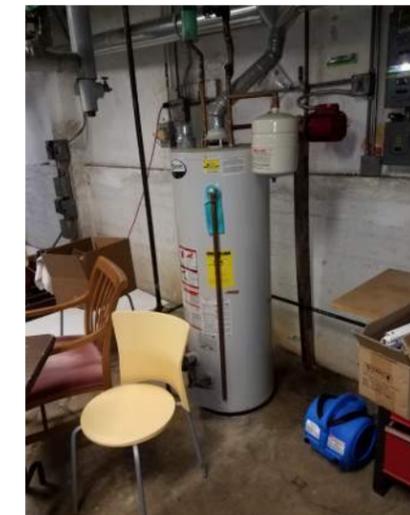
50 gallon, 40,000 btuh gas water heater

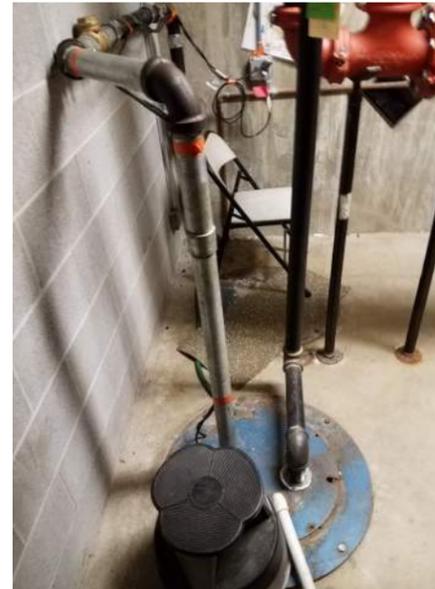
6. There are one or more sewage ejectors in the basement of the building. They serve floor drains and other basement floor located plumbing fixtures. The sewage ejectors pump sewer water up to an elevation allowing for gravity drainage out of building. The sewage ejectors appear to be in good condition.

Typical sewage ejector

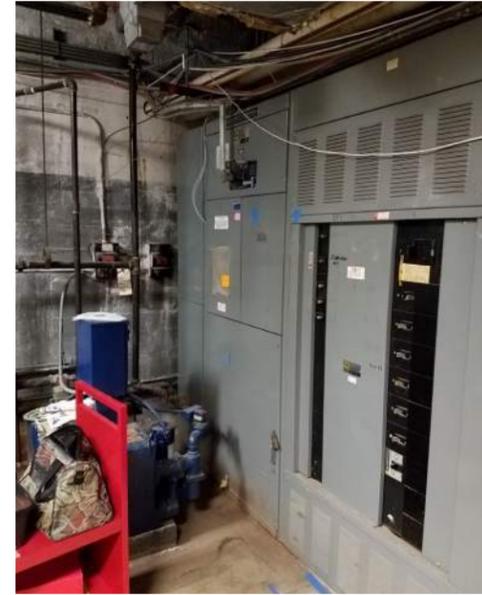
2. The Library electric service is a 120/240 volt, 3 phase, 4 wire, Delta service. The service equipment is Square D was installed as part of the 1977 addition project. The main service switch is a Bolt-Loc, electric trip, 1600 amp, bolted pressure switch. The distribution section of the switchboard is an I-line construction HCW panel with group mounted circuit breakers.

Main Electric Service Switchboard

A. The National Electrical Code (NEC) requires a minimum of 36" of working clearance in front of electrical equipment. This is a safety requirement for operation and maintenance of the electrical equipment. The mechanical equipment installed directly in front of the main switch is a violation of this code requirement. Consideration should be given to relocating the mechanical equipment to provide code required clearances.

B. The NEC does not allow "foreign piping or systems" to be installed above certain electrical equipment. There is a significant amount of mechanical piping installed directly over the switchboard that would seem to violate this code requirement. The code requirement is written to protect electrical equipment from leaks in equipment installed above the switchboard and to allow electrical conduit to be installed out of the switchboard. Consideration should be given to provide at a minimum some sort of physical protection, i.e. a gutter or drip pan to protect the switchboard.

C. Based on an installation date of approximately 1977 for the equipment it is approximately 41 years old. The manufacture of the equipment is still in business and parts are still available for servicing the circuit breakers, however, the switchboard is nearing the end of its useful life and the molded case circuit breakers are generally rated for about 30 years if they are properly exercised and maintained. In general the equipment appears to be in good working condition but if the plan is for continued use of the library, replacement of the electrical service equipment should be considered.

D. The current electric service arrangement and voltage appears to be somewhat unique. The recommendation for a new service would be to consider a 208Y/120 volt, 3 phase, 4 wire service.
