Lake Forest Library Feasibility Report

4.0 Condition Assessment

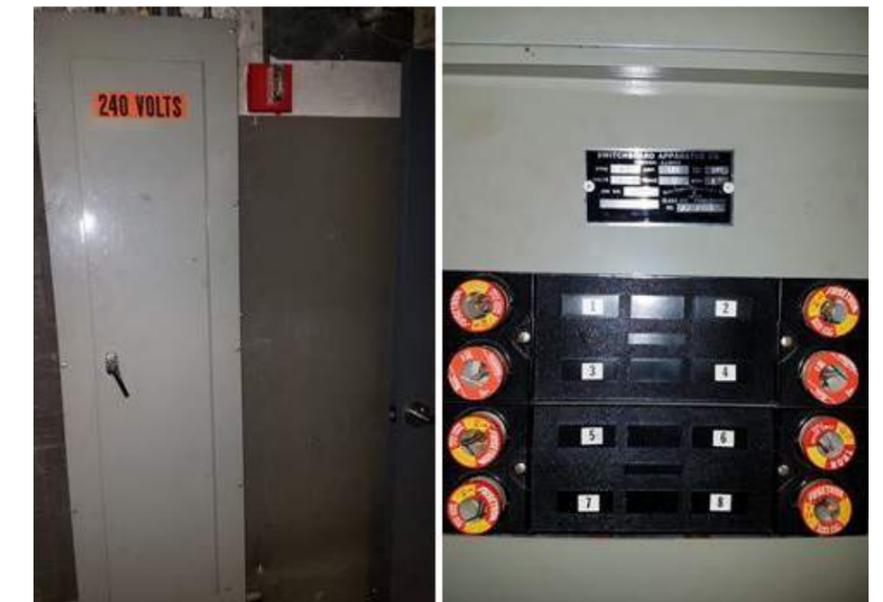
1. The building has a "Tap Ahead of The Main" emergency service. At one time this was recognized by the NEC as an acceptable source of emergency power for buildings. However if there is a loss of utility service this emergency service also lost power. The NEC does not recognize this service arrangement as a source of emergency power.

2. The "Emergency Panel" is manufactured by Switchboard Apparatus, Co. The company still exists but appears to be a manufacturer of custom electrical equipment for the mission critical industry. The panel is fusible so it requires the replacement of fuses vs. resetting circuit breakers should a circuit trip. Our recommendation would be to eliminate this panel as part of a replacement of the existing normal service equipment.

"Emergency" Panel

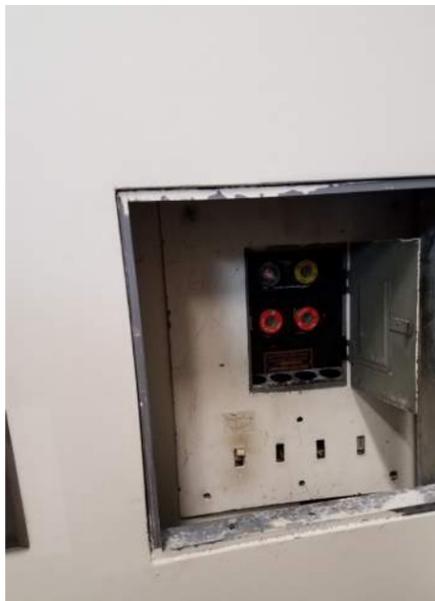
5. On the second floor, by the large rectangular skylight, in the northwest corner of the room a (4) circuit fusible panel with several switches were observed behind a unlocked cover. It is unclear what this serves or controls. Access to these fuses should be limited and not be accessible to library patrons for safety reasons. Consideration should be given to replacing these fuses with circuit breakers if these panels are still in use and required.

“Hidden” Fused Panel – Second Floor

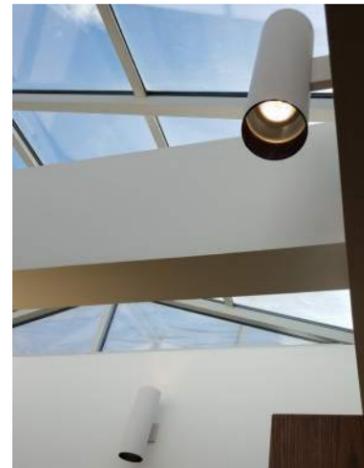
1. A significant portion of the building has had lighting upgraded to T8 or T5 style fluorescent fixture or LED fixtures or LED retrofit type lamps. Care should be taken so that the retrofit lamps do not distract from the historical look of some of the fixtures.
2. The down lights in the higher ceiling areas were changed from incandescent to Metal Halide sources during a 1991 lighting renovation project.
3. Light levels as observed during the day with significant daylight contribution from windows appeared adequate and possibly higher than required for the space uses. There did not appear to be any controls to reduce the artificial light levels when natural light was available.

Lighting on in Daylight Areas

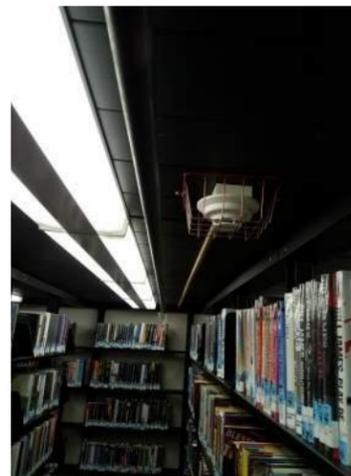
4. Light levels in stack areas, particularly in the area with black racks and black ceiling seemed OK, but the space felt dark and kind of cramped. The low ceilings do not allow for many lighting solutions

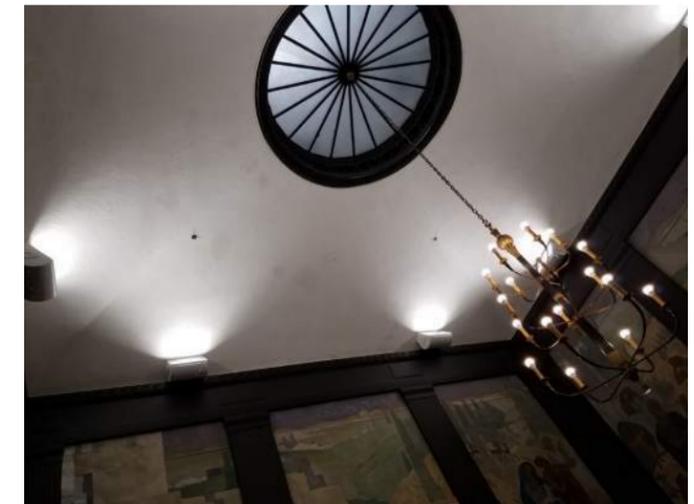
6. The main rotunda, ceiling mounted indirect light fixtures have been retrofitted from their original 1000 watt metal halide to LED. Light levels appear adequate for the space, however the lights do not do a great job of evenly illuminating the high ceiling area. Options for replacing the individual fixtures with a linear led product to evenly illuminate the ceiling while lighting the painted murals could be considered.

Central Rotunda Up-Lights

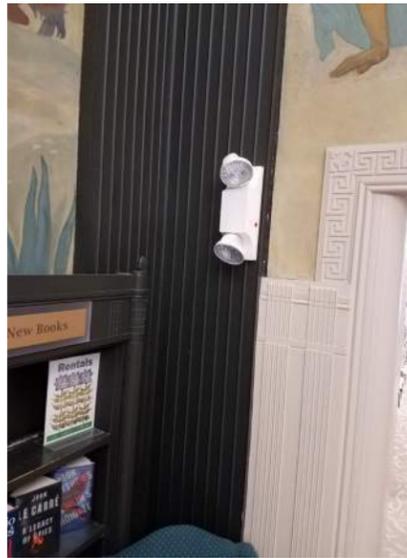
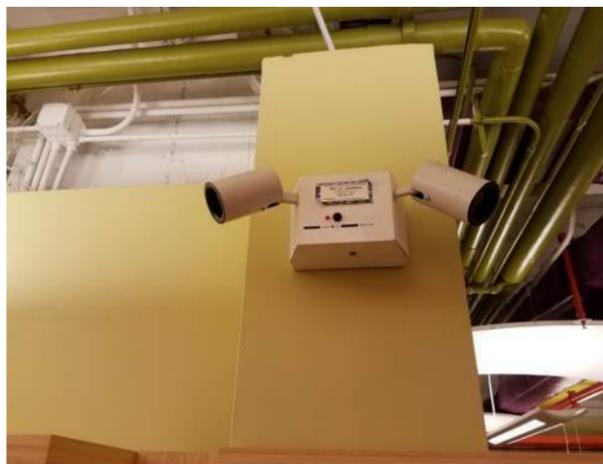
1. Exit lights generally appear to be newer and in good operating condition. There did not appear to be a standard exit light for the building. Transparent, edge lit exits, exits with integral emergency lighting heads and white painted steel exits were all observed. Exit lights appeared to have integral emergency batteries. Exits appeared to be working and generally located as required.
2. Emergency battery equipment was observed for meeting emergency lighting requirements. There appeared to be a significant variety of emergency battery units and some were not very architecturally pleasing and located in very obvious locations.

Emergency Battery Lights

Emergency lighting requirements have changed over time and it is unlikely that the current installation meets current code requirements for levels of emergency illumination. Codes today would require 1 fc average, 0.1 fc minimum and 40:1 maximum to minimum along the paths of egress. Current codes also require exterior emergency lighting outside of exterior exit doors. No exterior emergency illumination was observed during the visit.

- a. Consider standardizing on emergency battery units for emergency lighting to minimize battery types, lamps and parts. Any new units should include self-testing/self-diagnostic features to reduce maintenance testing costs and time. As areas are remodeled, review the quantity, locations and illumination levels to meet current code requirements. Review hidden or more architecturally pleasing units in architecturally significant areas of the building. A central inverter could also be considered and eliminating some remote battery units and using the normal area light fixtures as the source of emergency light.
- b. Consider the addition of exterior emergency illumination to meet current code requirements.
- c. Evaluate installation more architecturally pleasing exit light fixtures, i.e. edge lit types as installed in a few locations of the Library.

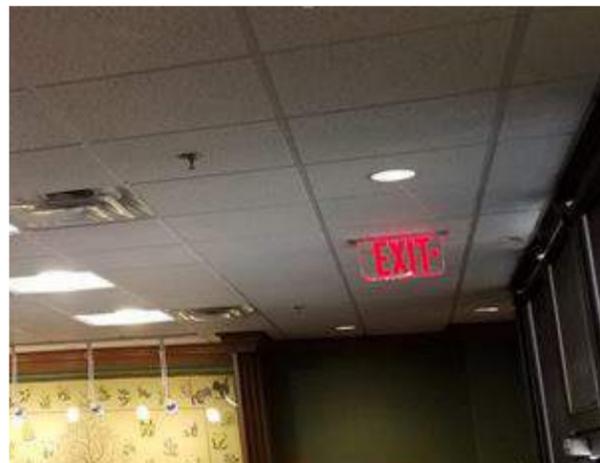
Edge Lit Style Exit Light

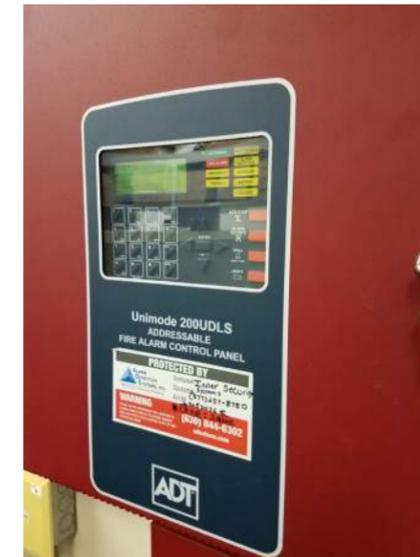
1. The Library has an addressable fire alarm system with manual pull stations, audible and visual annunciation devices, general area smoke detection and monitors the sprinkler system. The main fire alarm panel is an ADT Unimode 200UDLS Addressable Panel. Installation drawings for the fire alarm system were not found in the drawings provided. Age of the system is unknown and last notation in the Building Maintenance Log was “strobes in all rooms: ADA fire alarm” in 1996. Anticipated life of fire alarm systems is 20 to 25 years, if well maintained.

Existing Fire Alarm Control Panel

2. Fire alarm system has a Keltron radio transmitter to relay status of the fire alarm to the local municipality monitor point.
3. Recommendations:
 - a. NFPA 72 specifies requirements for weekly, quarterly, semiannual and annual testing of fire alarm systems. Facility should make sure required system tests and records of test are being completed.
